28 August 2015

GRANTHAM QUARRY - GEOTECHNICAL INVESTIGATIONS & EXPERT OPINION ON FORMATION OF EARTHWORKS

Grantham Floods Commission of Inquiry

Report Number. 1532696-001-R-Rev2

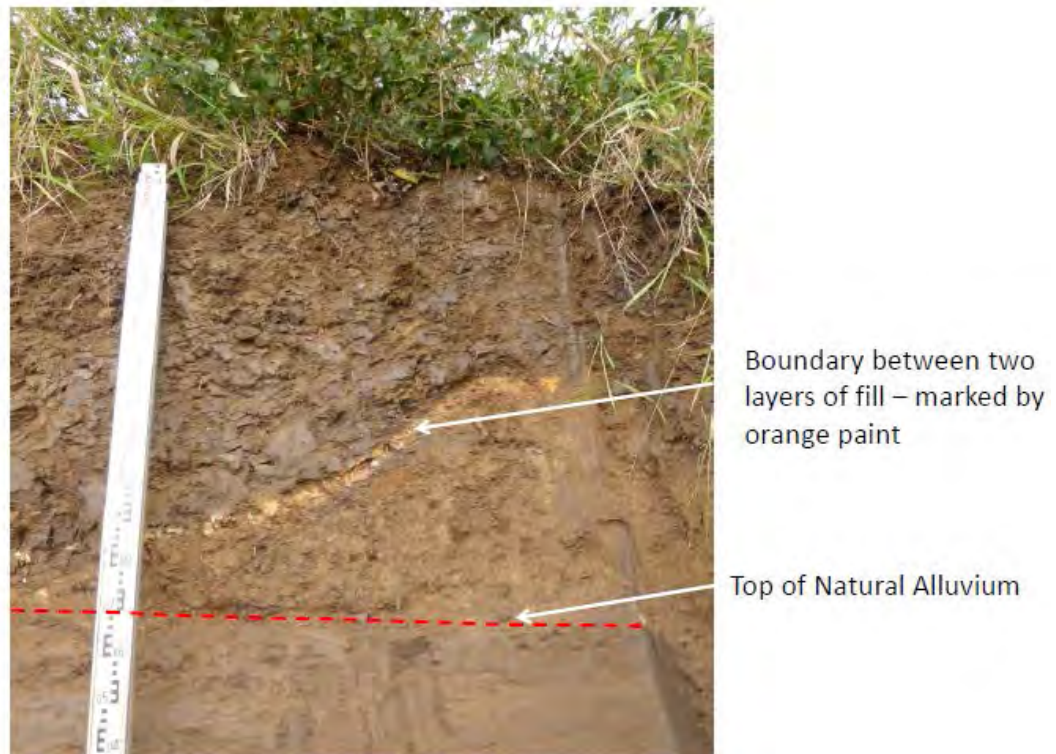
Plate 5: North face of Test pit 113 excavated in remnant portion of western bund

- d. Evidence from one Test Pit (TP 113) which indicates that the construction of the bunds probably developed over time in stages.

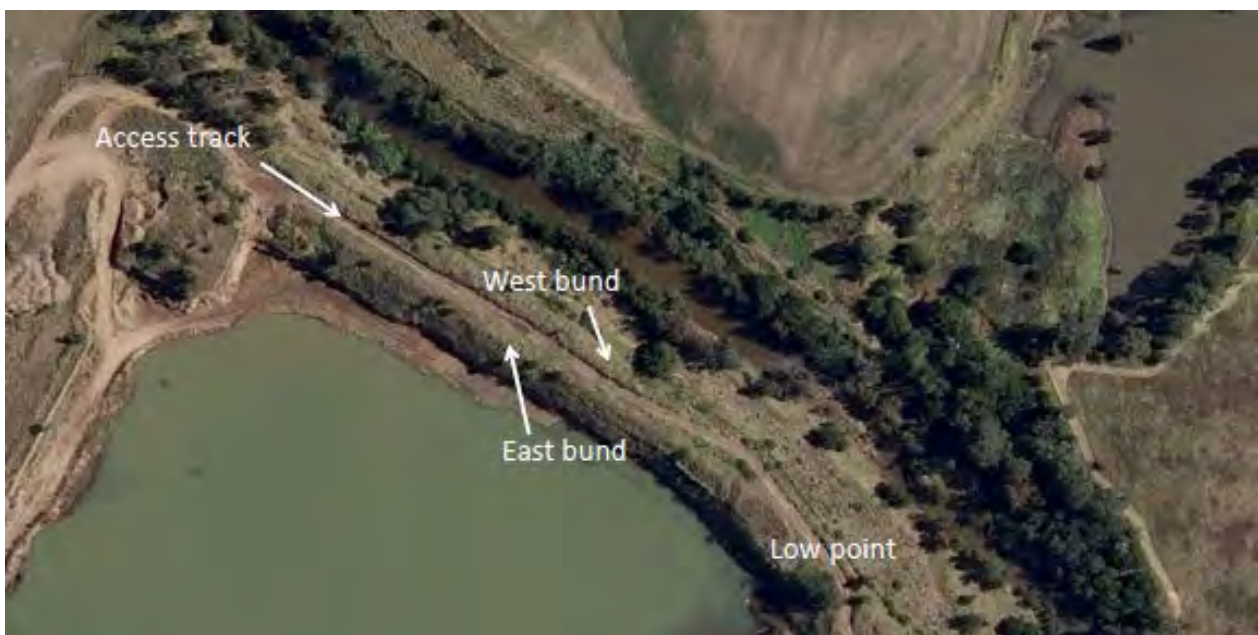
*Plate 6: Annotated view of air photo from 2009
(discussed in Section 12.5 of this report)*

18. Plate 6 shows an annotated view of a June 2009 air photo. For comparison, the 2010 air photo is shown below in Plate 7.
19. The 2005, 2008 and 2009 photos indicate similar conditions of the bunds, and when compared with the pre-flood LiDAR data, in my opinion this indicates that the bunds had possibly reached their pre-flood condition by 2005. The topography of the bunds is confirmed by the 2008 survey plan.

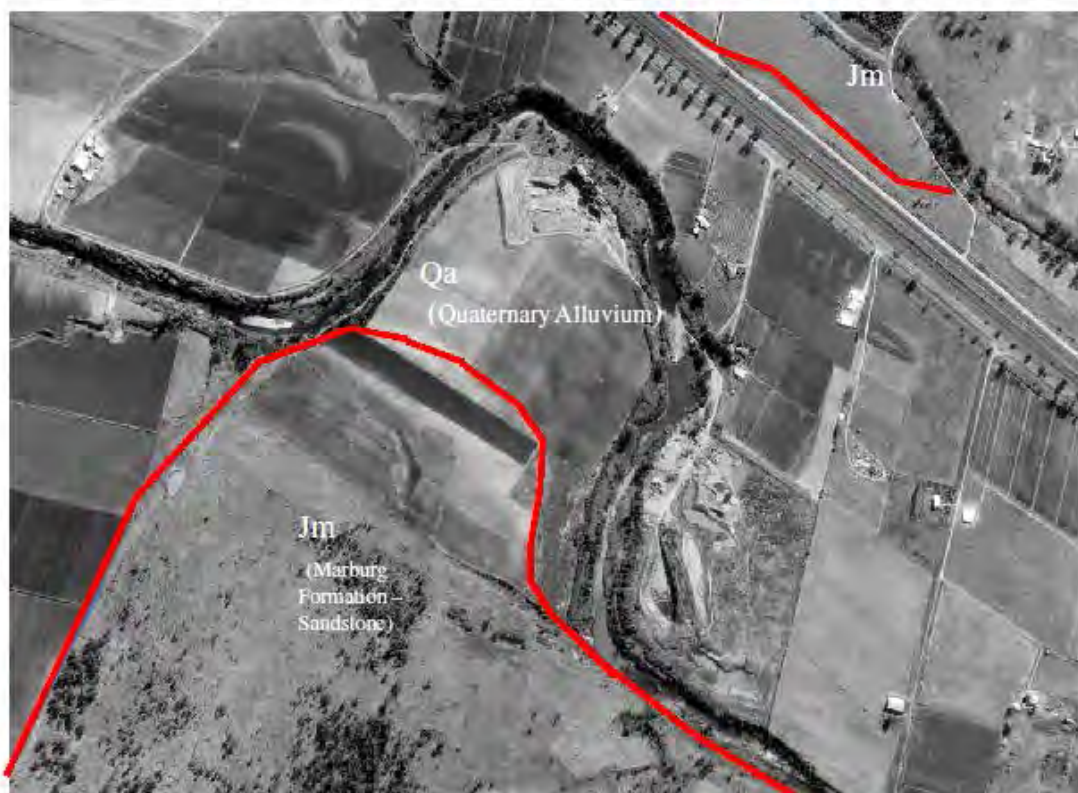
Plate 8: Overlay of 1982 Air Photo Showing Interpreted Geology (Photo Ref QAP4014-13, source DERM)

36. From my general knowledge of the geology of SE Queensland, the Quaternary Alluvium has been deposited by Lockyer Creek over at least the last 12,000 years. The Symbol Qa applied to alluvial deposits on the geological map refers to terraces which are recognisable as present day river flats. These flats are generally considered to be of Holocene Age (11,700 years before present), but the highest terrace in some areas may be of late Pleistocene age (1.8million to 11,700 ybp), an epoch associated with glacial events (ref Land Resources Bulletin QNRM 01215).

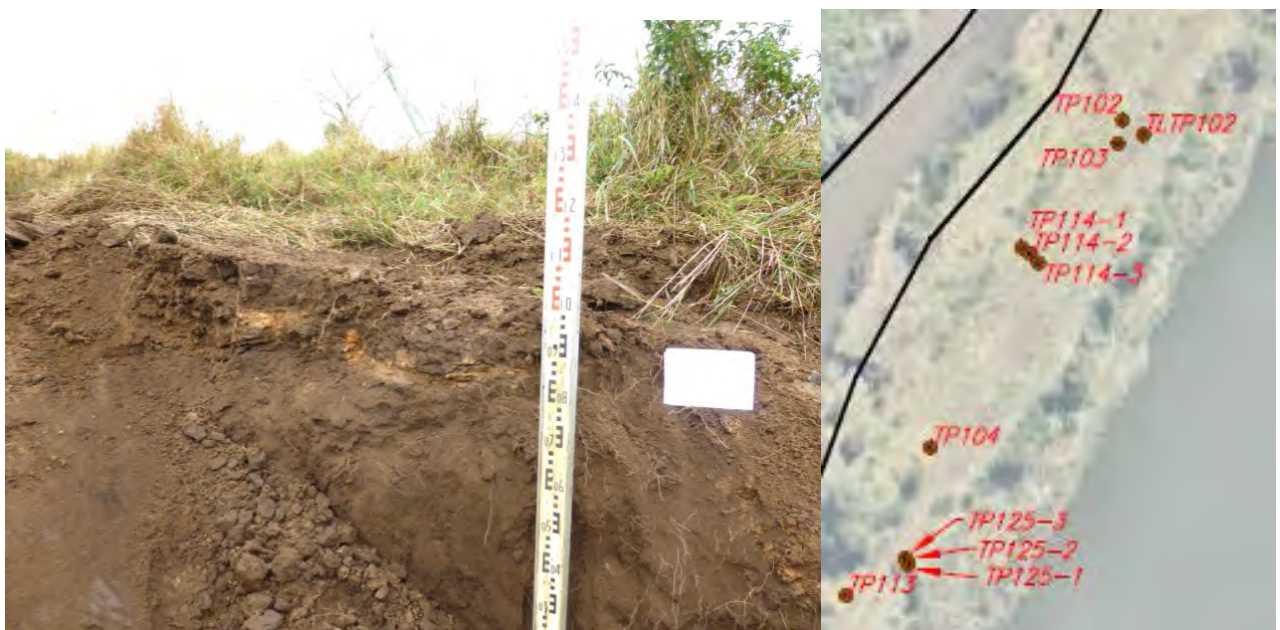
Plate 10: Thin layer of fill and topsoil adjacent to access track, TP101

- a. A thin layer of sandy fill with thicknesses of up to about 500 mm along the access track on the western levee bank. This is sometimes mixed with gravel. This layer may not represent a deliberate attempt at placing fill – it could have accumulated as spillage from truck movements or be a result of local filling of pot holes. *This layer was encountered in or inferred from TPs 101-4, 102-4, 103, 104, and 111-3 (see Plate 10).*

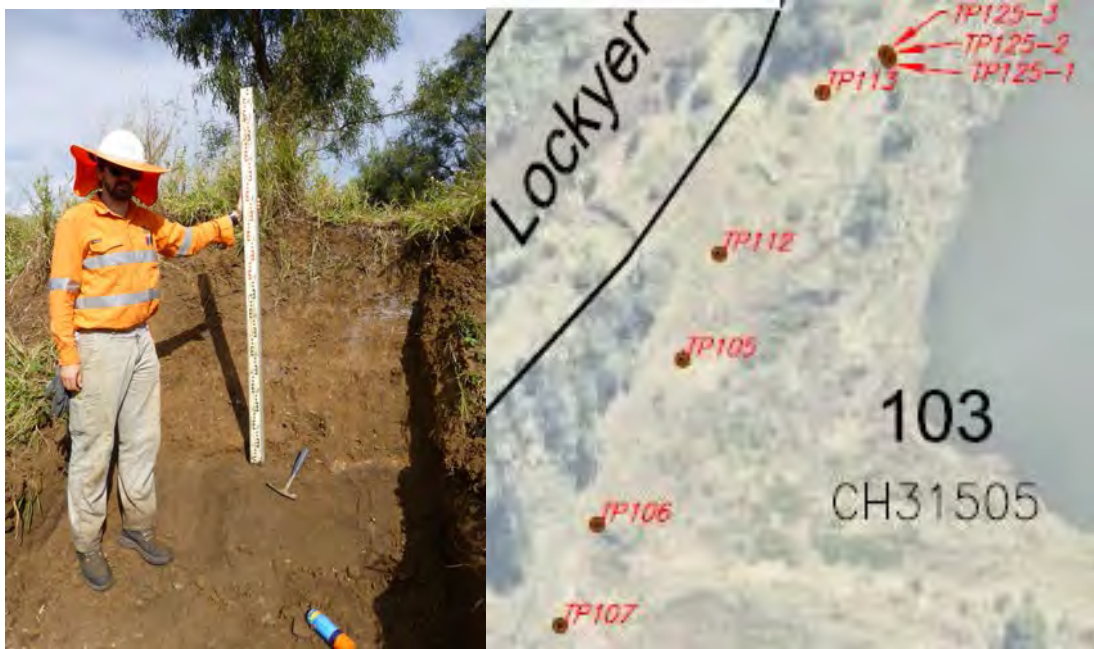
Plate 11: Interface between remnant bund fill and natural alluvium, TP104 (base of staff is on interface)

- c. The fill/natural interface is illustrated in Plate 11 below (TP104). Test pits TP104, 105, 106, 107, 112, 113, and 125 were excavated at the toe of remnant bunds.

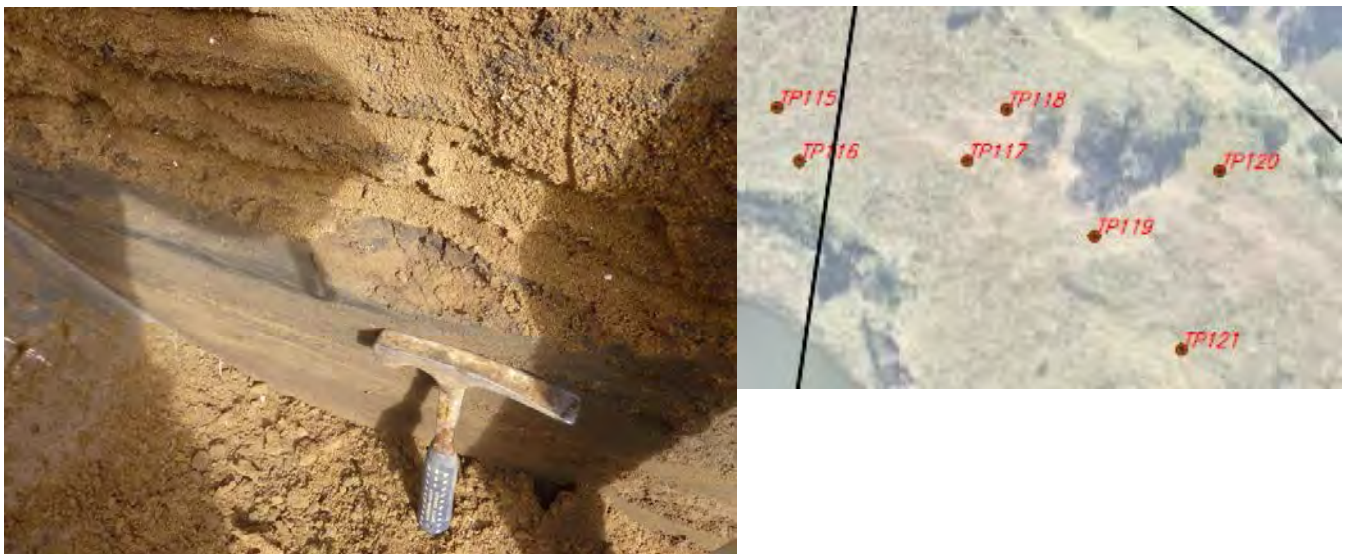
Plate 12: Interface between coarse sand – (possibly reworked material) and alluvium, TP117

- d. A layer of fill in the northern west portion of the quarry site which I observed to vary between about 300 mm and 1.0 m thick, and is probably a result of past quarrying activities (stockpiles and processing operations), and more recently from earthmoving operations after the 2011 flood. The fill platform can be observed in this part of the site on Google Earth image dated 12 August 2011 (see Plate 12, TP 117 and Plate 13 TP 115). This layer was encountered or inferred from TPs 115, 117, 118, 119 and 120.

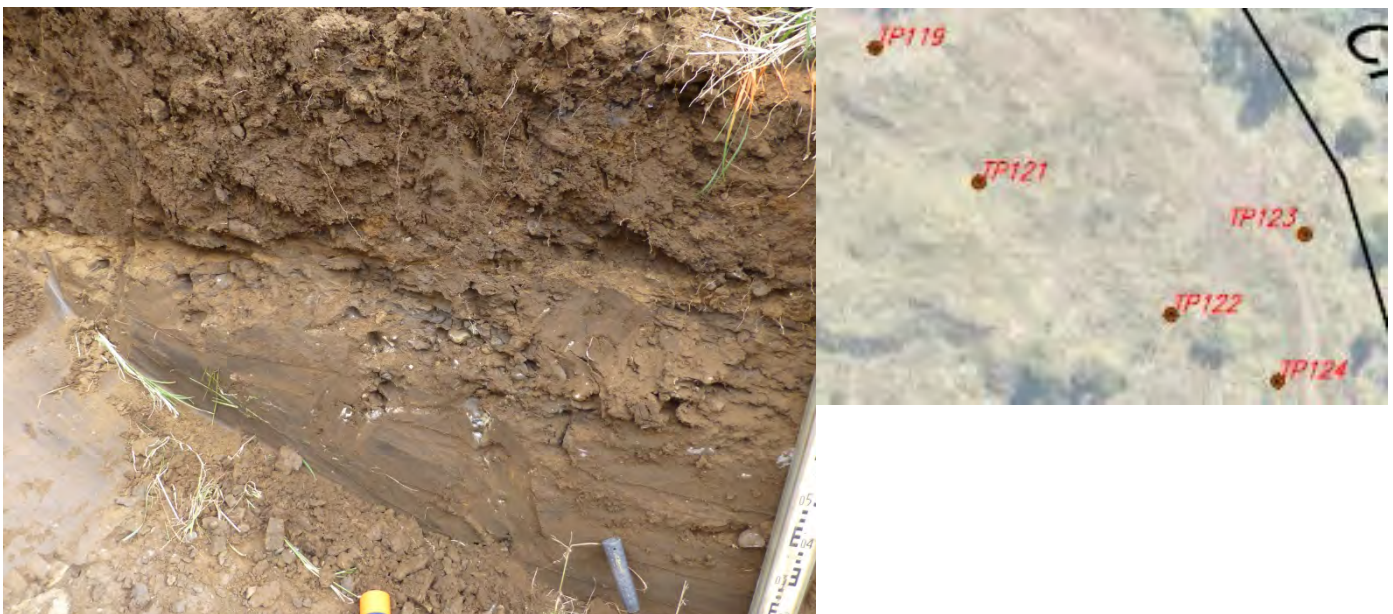
Plate 14: Interface between stockpile fill and natural alluvium, TP119

- e. Stockpiles in the north east portion of the site, now with grass cover. I do not know whether these were topsoil mounds, waste from processing, or product stockpiles. *The interface between the stockpile material and “natural” ground was investigated by TPs 119, 121, 122, and 124, all excavated at the toe of stockpiles (see Plate 14).*

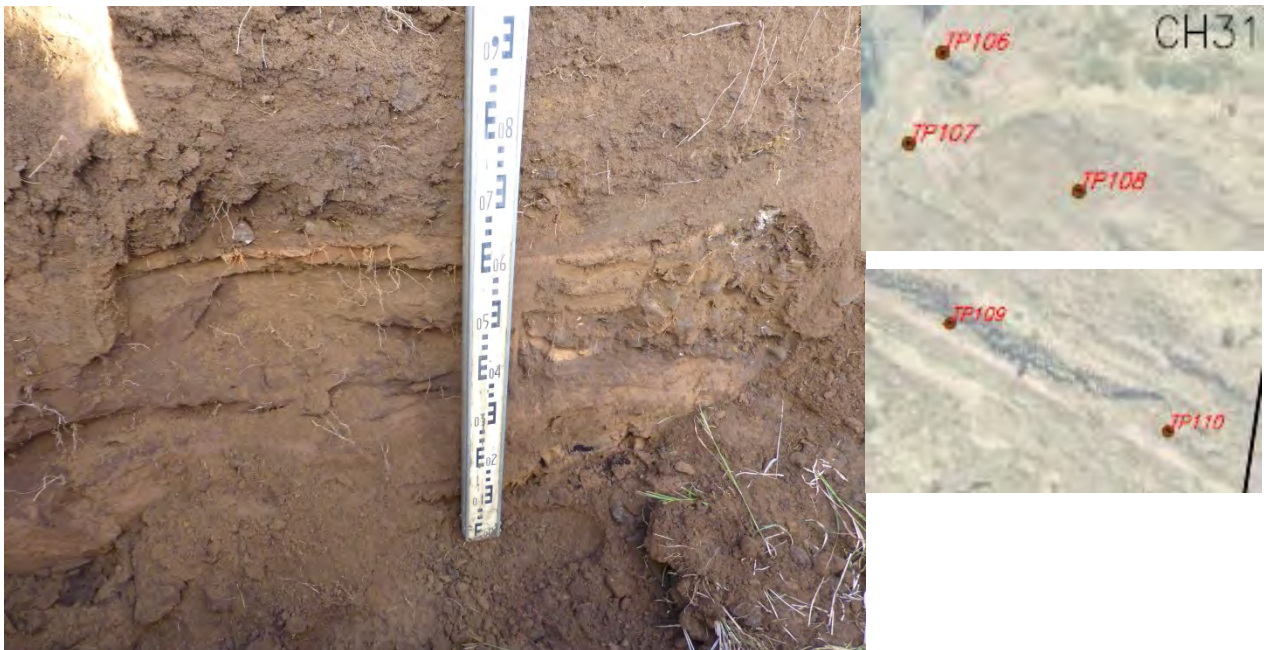
Plate 15: Interface between stockpile fill and natural alluvium, TP109

- f. Stockpiles in the southern side of the quarry lake, now with grass cover. Again I do not know whether these were topsoil mounds, waste from processing, or product stockpiles. The former operators of the quarry would be able to confirm the origin of these and similar fill mounds on the quarry site. The 2008 Survey Plan discussed under Section 11.0 of this report labels them as “dirt mounds”. *The interface between the stockpile material and “natural” ground was investigated by TPs 107, 109 and 110, all excavated at the toe (see Plate 15).*

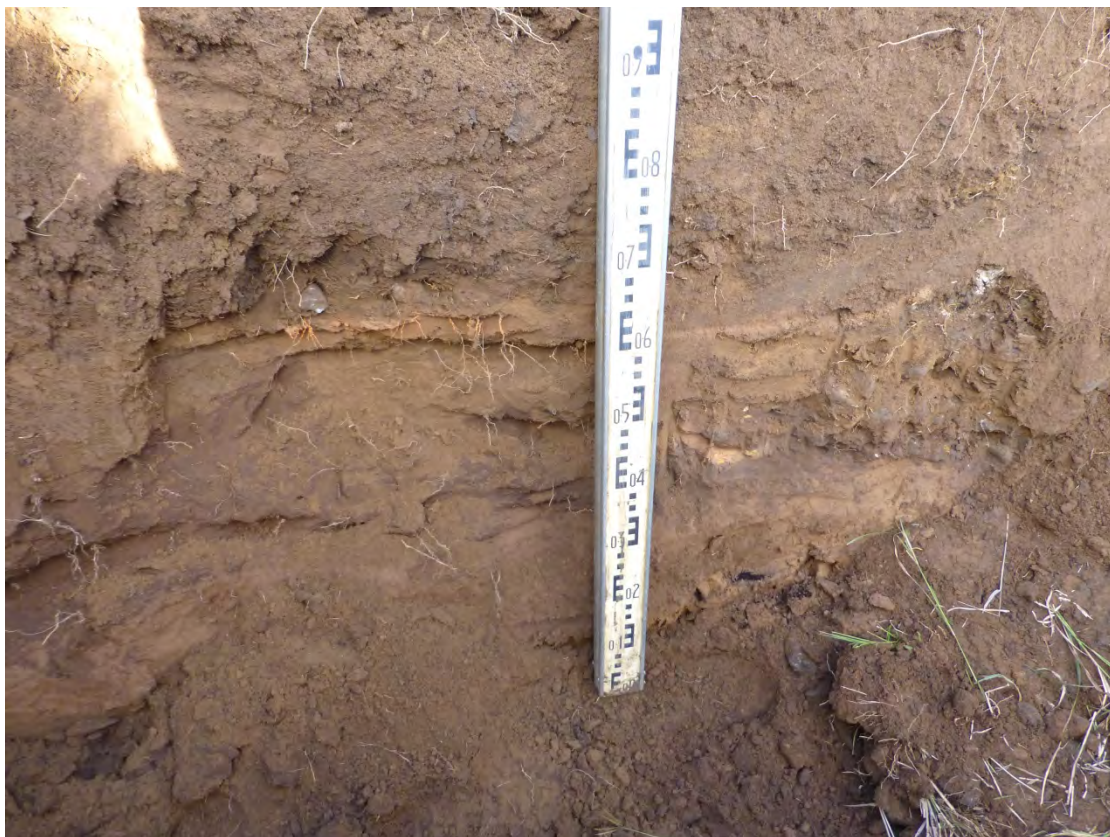
Plate 17: Faint layering within alluvial silty SAND, TP109

98. I observed that the silty fine sand is generally compact and partially cemented (probably due to carbonate content). Structural features observed within the sand were limited to occasional faint layering, and thin sand lenses and organic inclusions (see Plate 17).

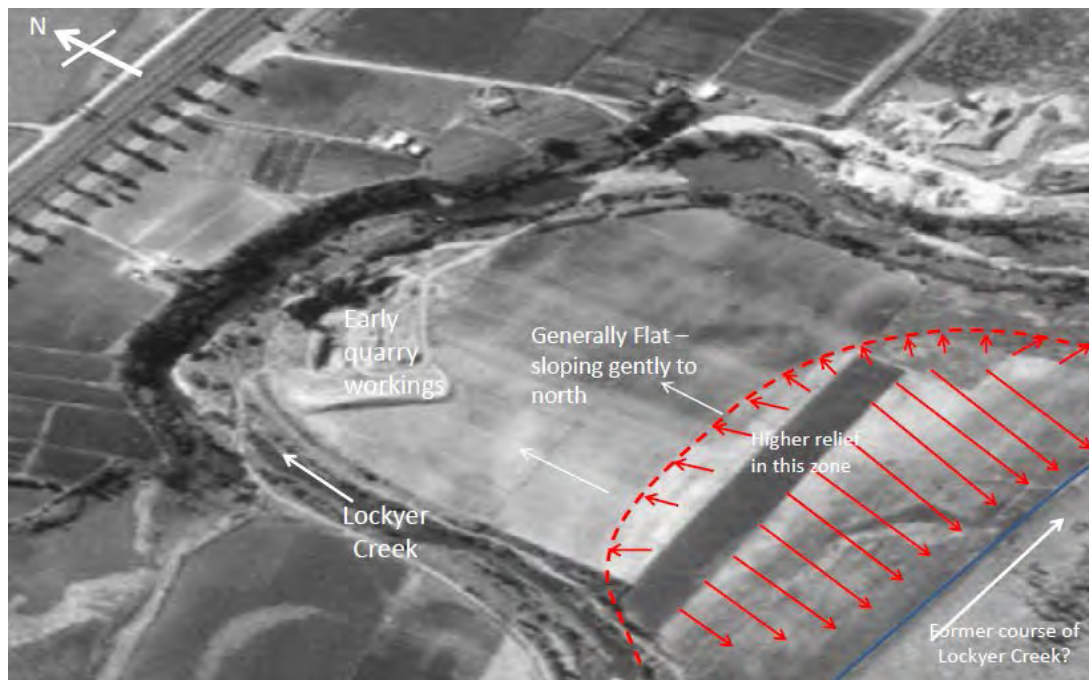
Plate 19: Oblique view generated from 1982 air photo showing relief interpreted from stereoscope

107. I have generated Plate 19 from one of the air photos to provide a visualisation of the relief which can be seen when viewing the air photos with a stereoscope.

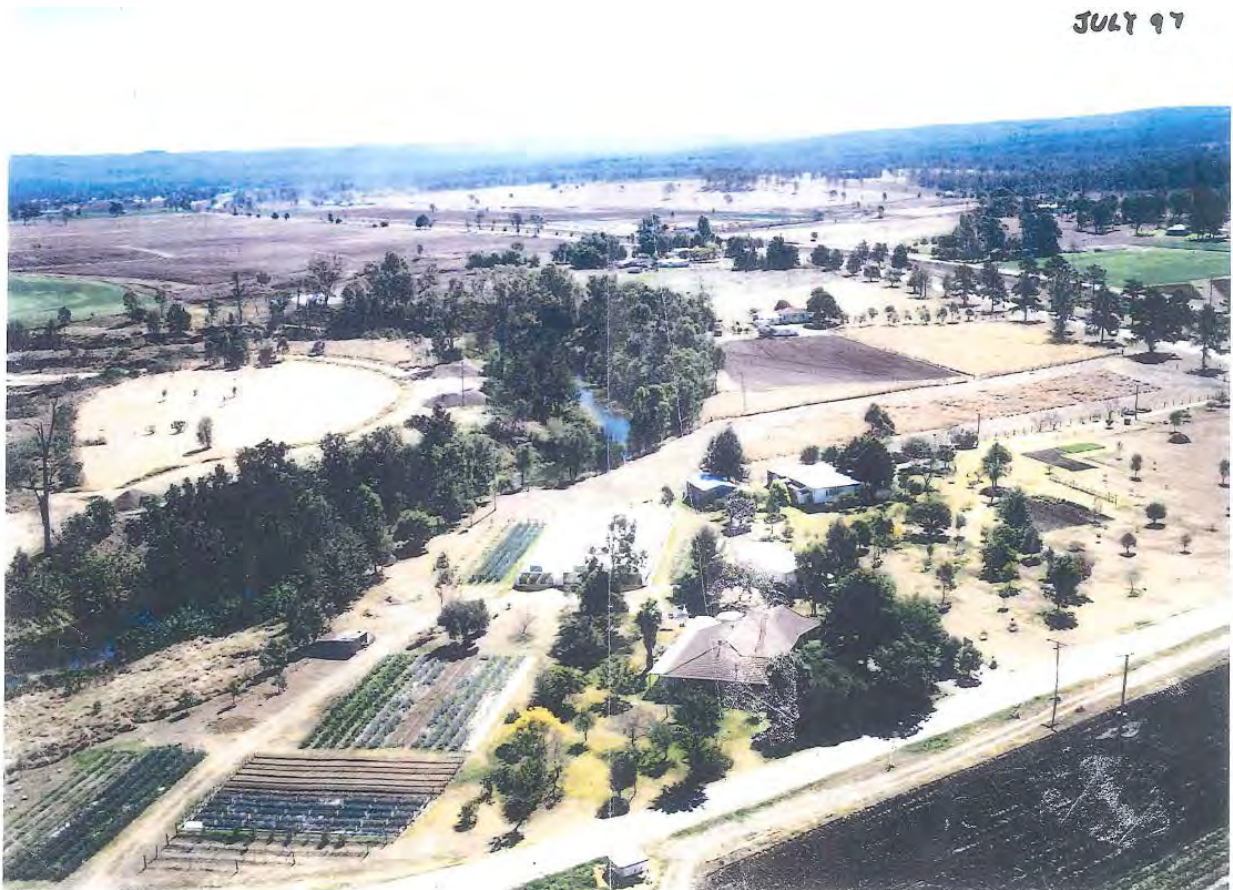
Plate 26: Oblique air photo included in statement prepared by Jonathan Sippel (date shown as July 1997 and supported by stereo air-photos dated August 1997).

145. An oblique air photo included in a witness statement by Jonathan Sippel labelled JS-1 is shown below as Plate 26 (dated July 97). It appears to depict the north end of the quarry site in the middle distance (no apparent grass cover but some small trees). The northern end of the lake can just be seen. There appears to be some vegetation along the north-eastern levee (behind the lake). I cannot determine with certainty whether there are bunds above the natural ground level.

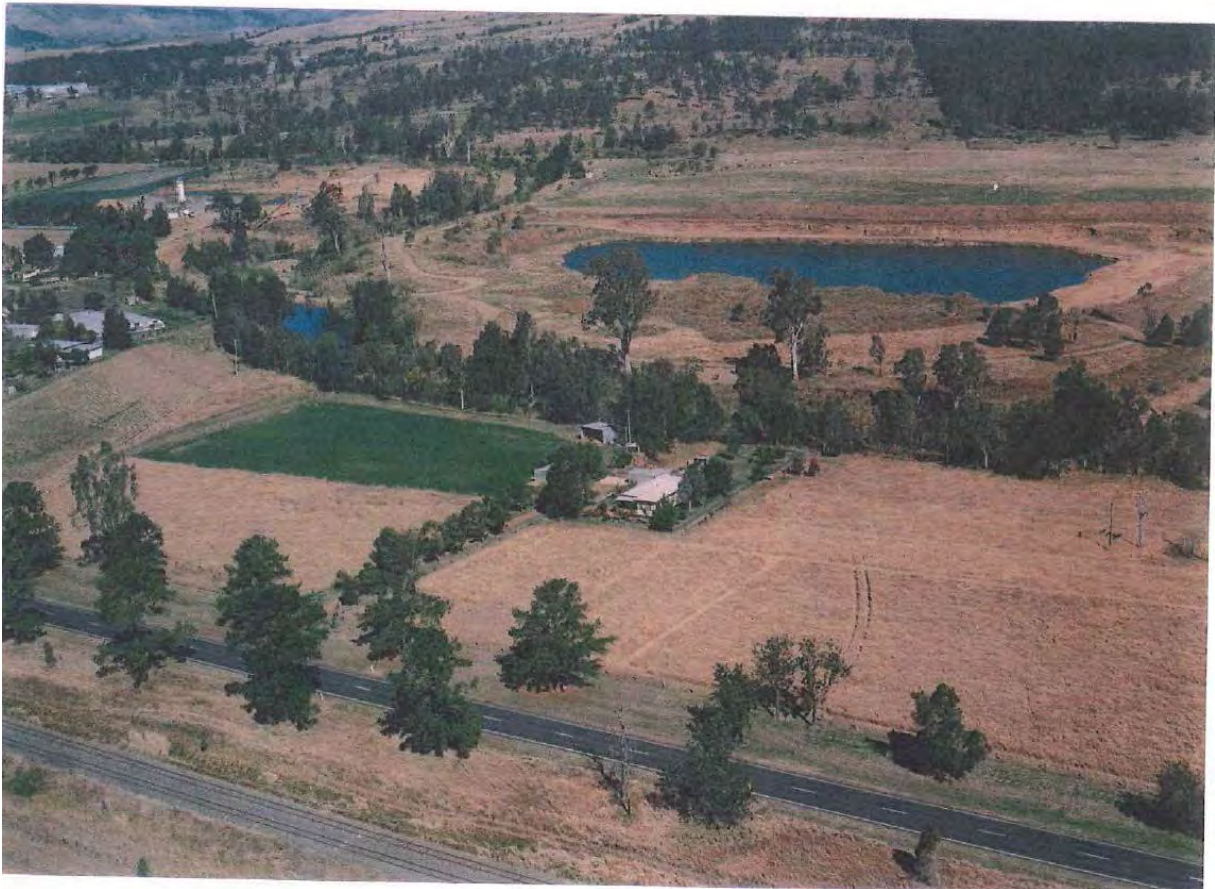
Plates 27a and 27b. Oblique air photo and detail, April 2000 (witness statement C Mallon, CDM-4)

146. An oblique air photo included in a witness statement by Charmaine Mallon labelled CDM-4 is shown below as Plate 27a (dated April 2000 and verified by a receipt). The photo is taken from the north of the quarry (the Helidon to Gatton Road and the railway can be seen in the foreground). I can identify the northern end of the western levee, and a haul road going down to the edge of the quarry lake. I can see some stockpiles of material along the west side of the lake, and possibly some earthmoving machinery. Based on Plate 27b which is an enlargement of a cropped section of Plate 27a, there may be a cutting alongside the haul road. Because the field of view is cut-off at the right side (western end), I cannot see the access track along the western levee, and am not able to comment on the presence of any bunds either side of the track.

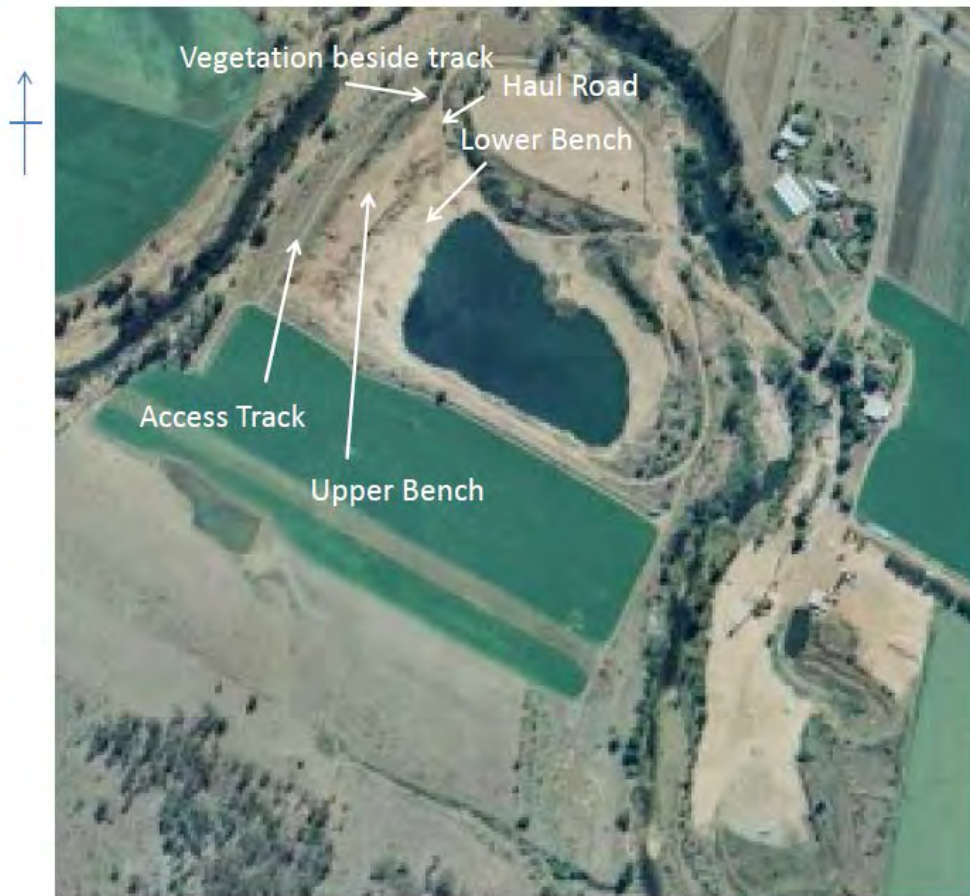
Plate 31a: Air photo of Grantham Quarry, 1997

156. Figure 31a shows an annotated view of a section of air photo from 1997 (ref QAP 5558024) flown on 9 August 1997. I can see no evidence when viewed in stereo of relief associated with bunds either side of the western access track. This air photo shows the bare area in the north of the quarry site which I can see in the July 1997 Sippel oblique photo, hence appearing to confirm the date written on Sippel's photo.

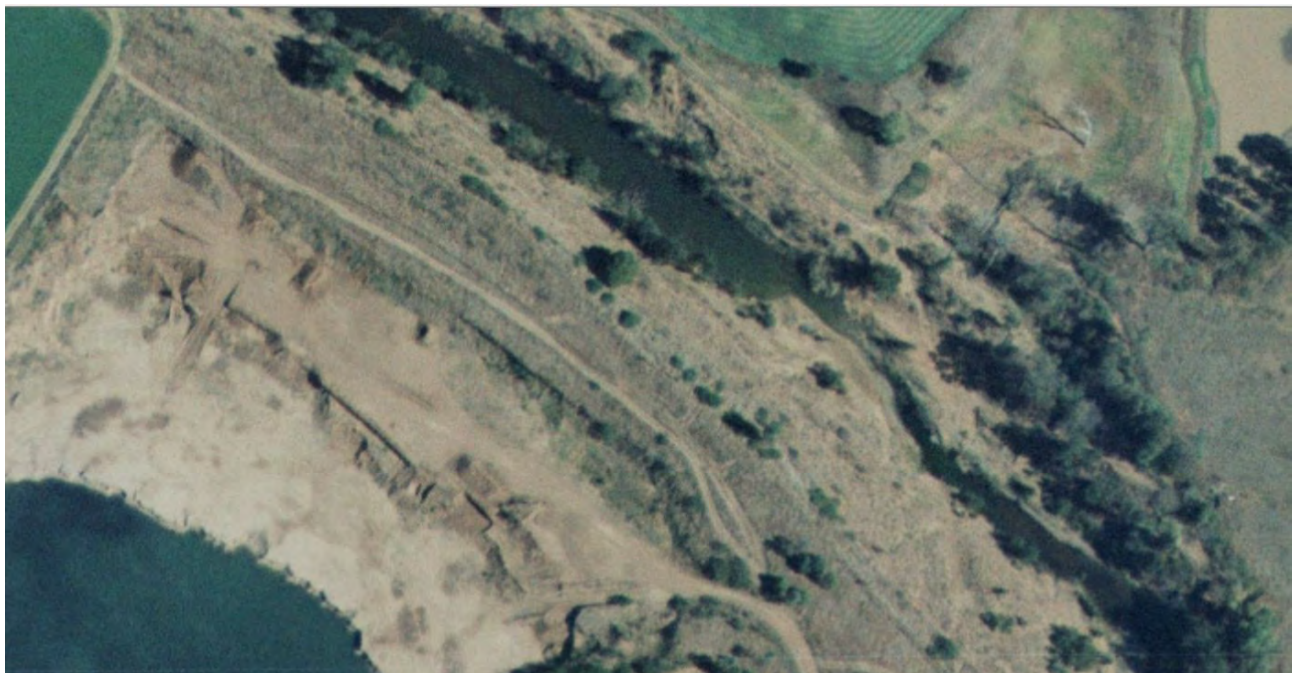
Plate 31b Enlargement of 1997 air photo showing western levee – note no bunds either side of access track

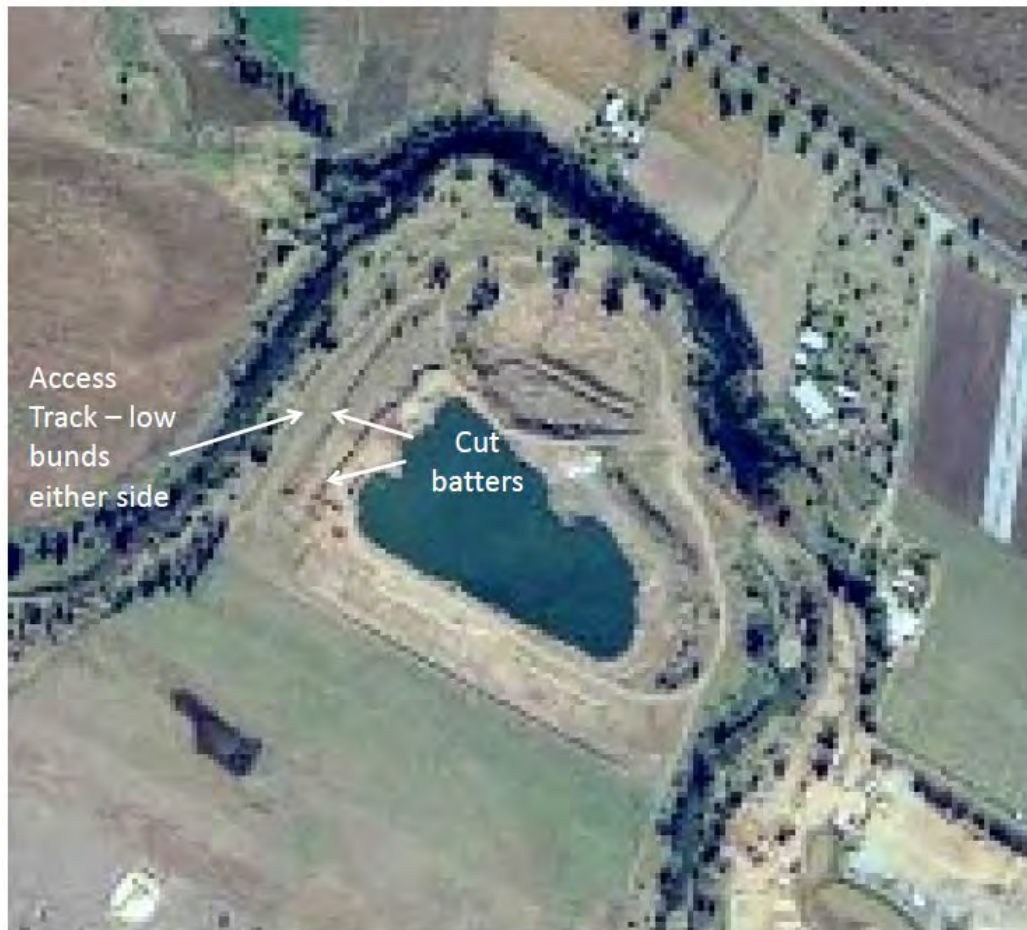
Plate 32a Air photo of Grantham Quarry, 2001

157. Plate 32a shows an annotated view of a section of the 2001 air photo (ref QAP 5903060) flown on 22 June 2001. When viewed in stereo, I can recognise features either side of the access track.

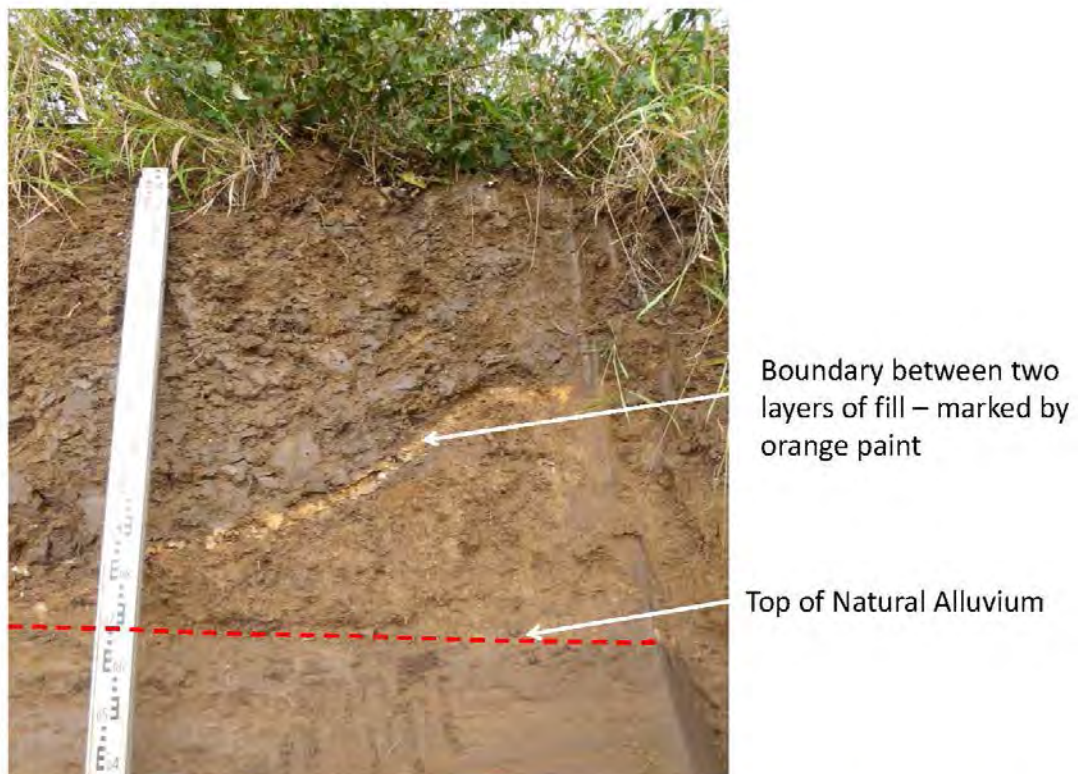
164. Some of the test pits along the western levee were excavated to reveal the contact between natural alluvium and remnant bunds. The face revealed in Test Pit 113 indicates that this section of bund was constructed in at least two stages, as illustrated in Plates 34 and 35.
165. I consider it likely that more extensive excavations would have found further evidence of stages of bund construction as revealed in TP 113, which was located at the northern end of a remnant bund on the western side of the track (see Plate 22, on page 31).
166. Based on the height and shape of the lower stage of bund construction revealed in Plate 34, it may be representative of the mounds observed in the 2001 air photo. I am not able to determine the time difference between the upper and lower portions.

Plate 34: Test Pit 113 – Western side of access track – viewed towards south – face excavated in remnant bund

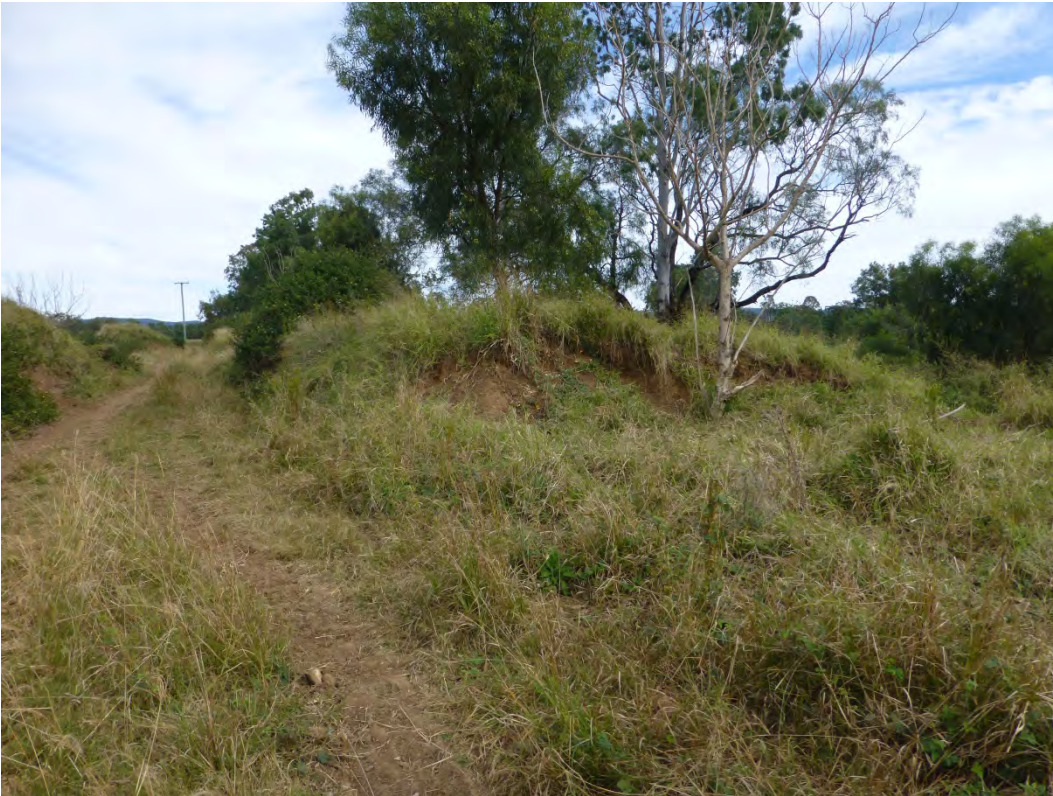
Photograph B5: Grantham Quarry – Remnants of bunds either side of track – Western levee.

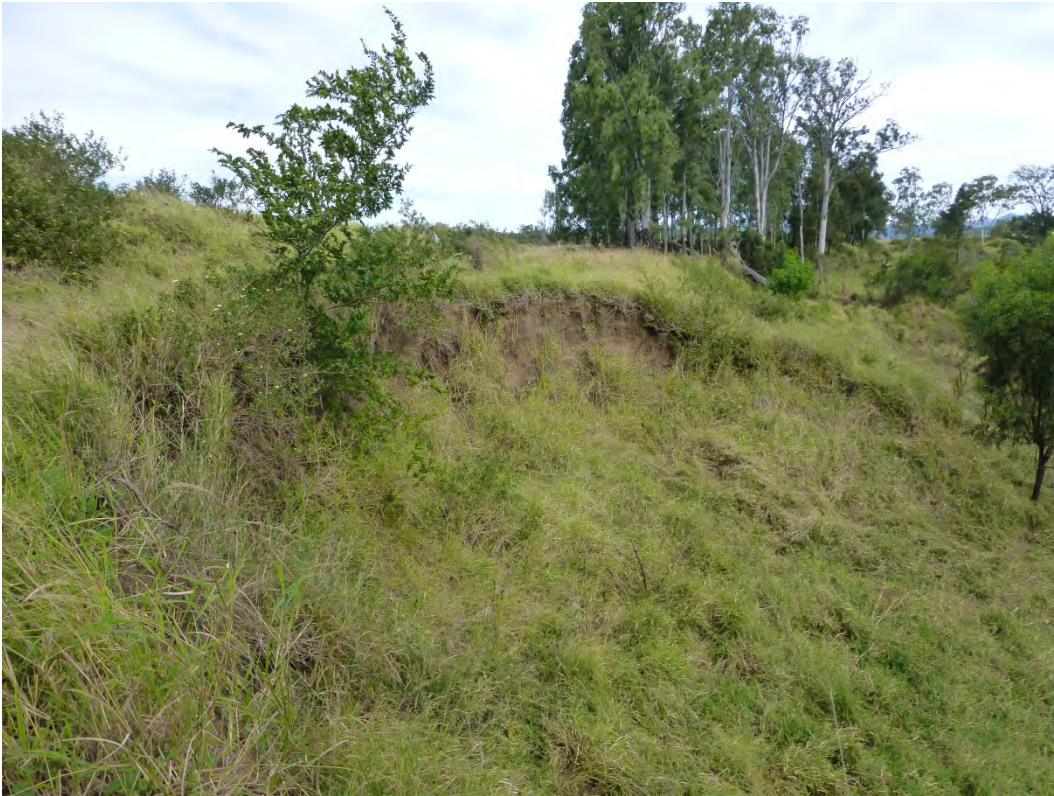
Photograph B7: Grantham Quarry – Erosion of Western side of levee from 2011 flood event.

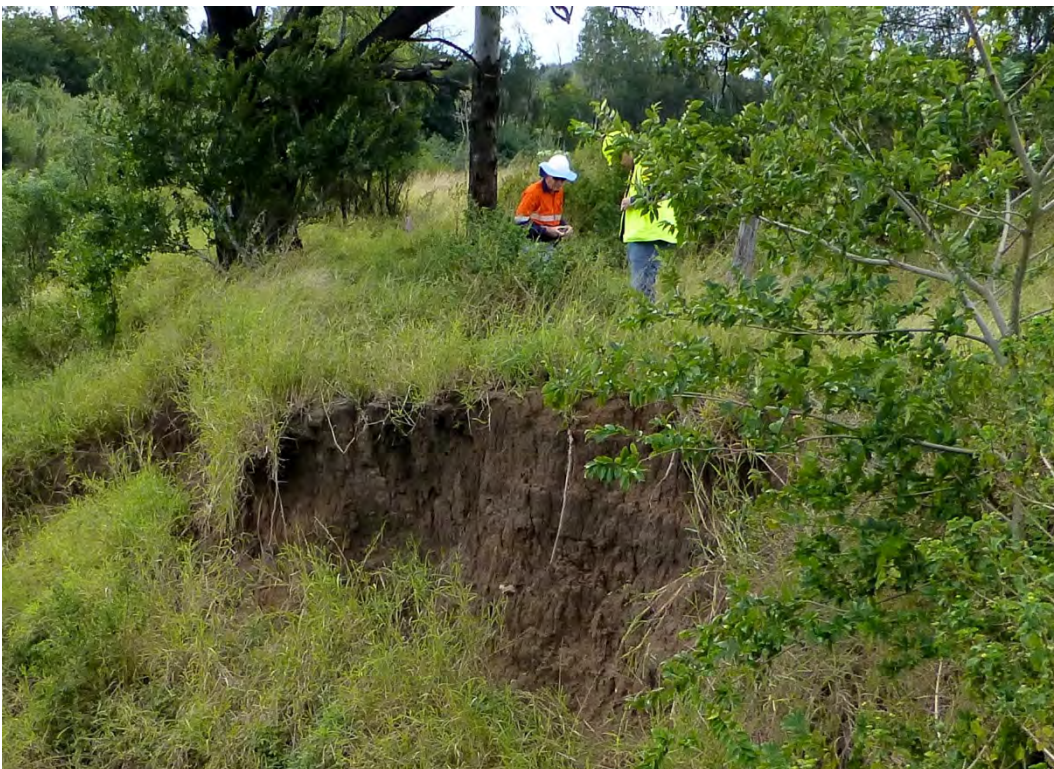
Photograph B8: Grantham Quarry – Close up of banded silt and sand in erosion scar.

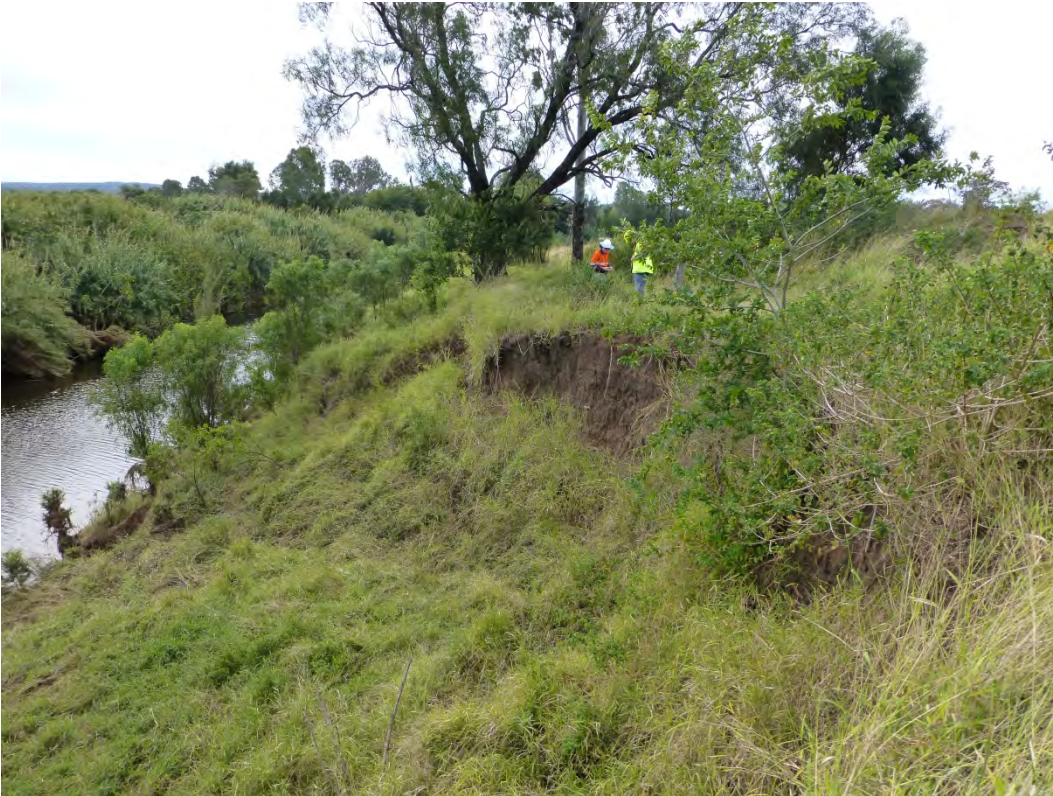
Photograph B9 Grantham Quarry – Erosion in terrace – Western bank.
