# GRANTHAM QUARRY - GEOTECHNICAL INVESTIGATIONS & EXPERT OPINION ON FORMATION OF EARTHWORKS - SUPPLEMENTARY REPORT CONCERNING LOCATION OF FAILED POWER POLE P182127

## Grantham Floods Commission of Inquiry

**Report Number.** 1532696-002-Rev1

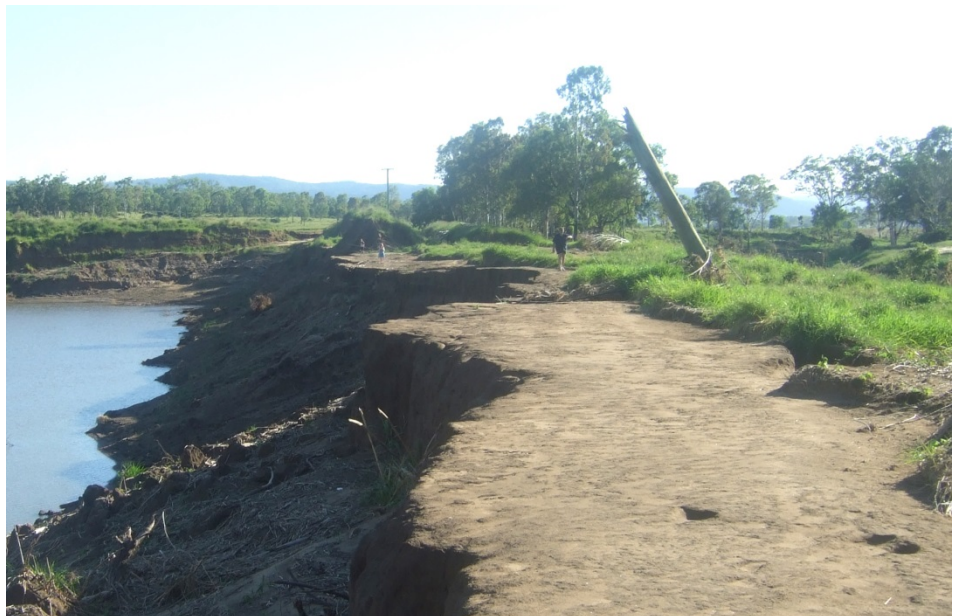
34. A photograph of the Broken Pole immediately after the flood is presented on the front cover of this report, based on image DSCF7666 provided by Anthony McIntosh taken on 12 February 2011. In my opinion, the bare surface in the foreground indicates where the eastern bund has been eroded by the flood. This photograph assists in determining that the Broken Pole was adjacent to the eastern bund.

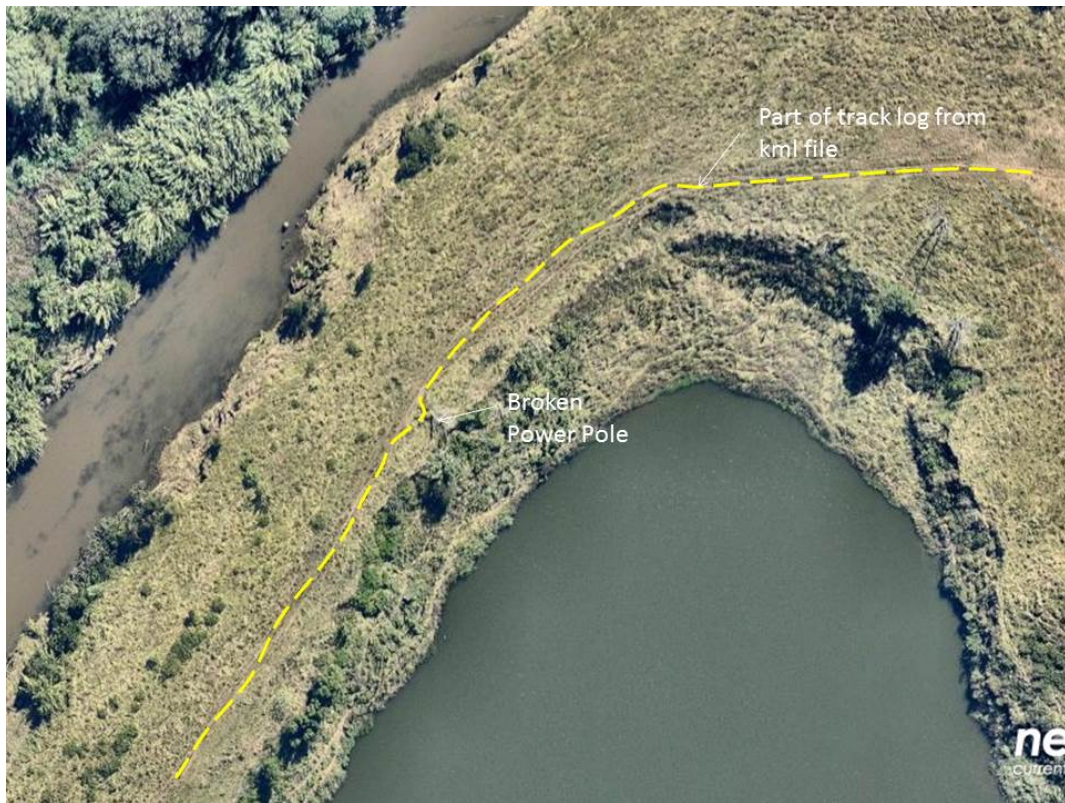
*Plate 1 Extract from Nearmap image dated 10 May 2015 showing path taken on 1 June 2015.*

26. I can see from examining the path taken during the site inspection that I passed by the location of the Broken Pole, which is at the northern end of the western levee. The location of the Broken Pole as I observed it is shown in Plate 1 below, which is based on a kml file superimposed on the 2015 Nearmap image of the Quarry.

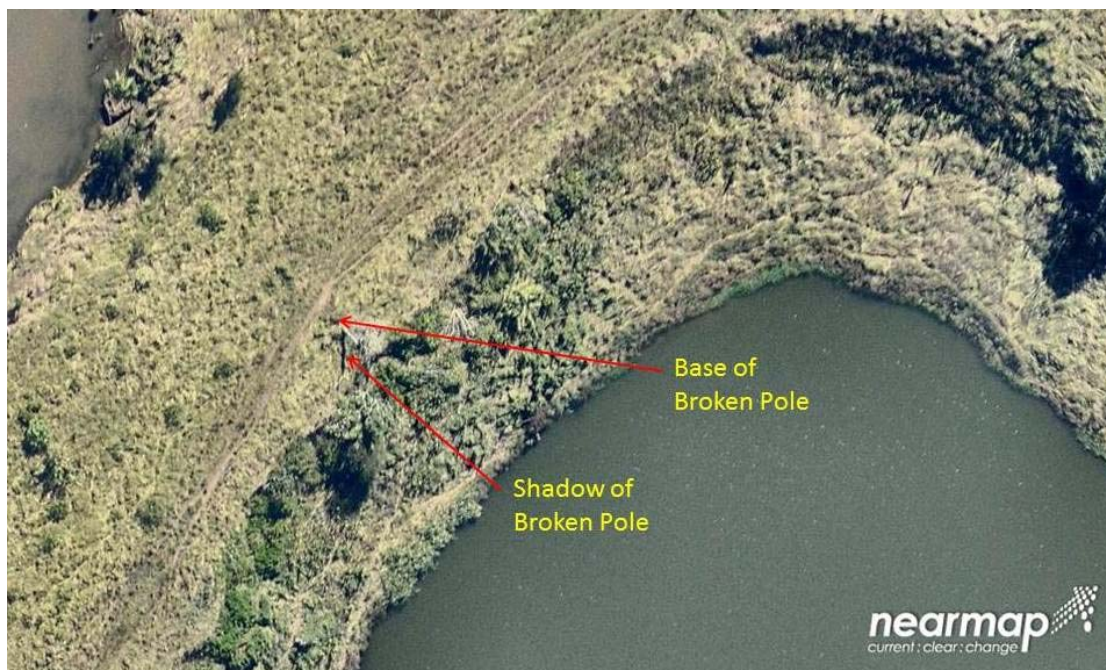
*Plate 2: Power Pole P182127 (the Broken Pole) on 10 May 2015*

27. Plate 2 shows the Broken Pole on a Nearmap image from 10 May 2015. Although dated two weeks before my site inspection of 1 June 2015, it is consistent with my recollection of the Broken Pole location.

29. The annotations on both Plates 2 and 3 indicate the base of the power pole and the shadow cast by the pole, depending on the location of the sun at the time the image was taken. I note that on 17 July 2010 (Plate 3), the shadow is almost in exact alignment with the pole, making it difficult to recognise the base location easily. However, I can see a slight bend in the shadow, where it passes over the adjacent section of bund, hence aiding identification of the base.
30. The Eastern Bund is labelled on Plates 4 and 5, and is also shown in cross sections in the Main Report as Plates 1 and 2.

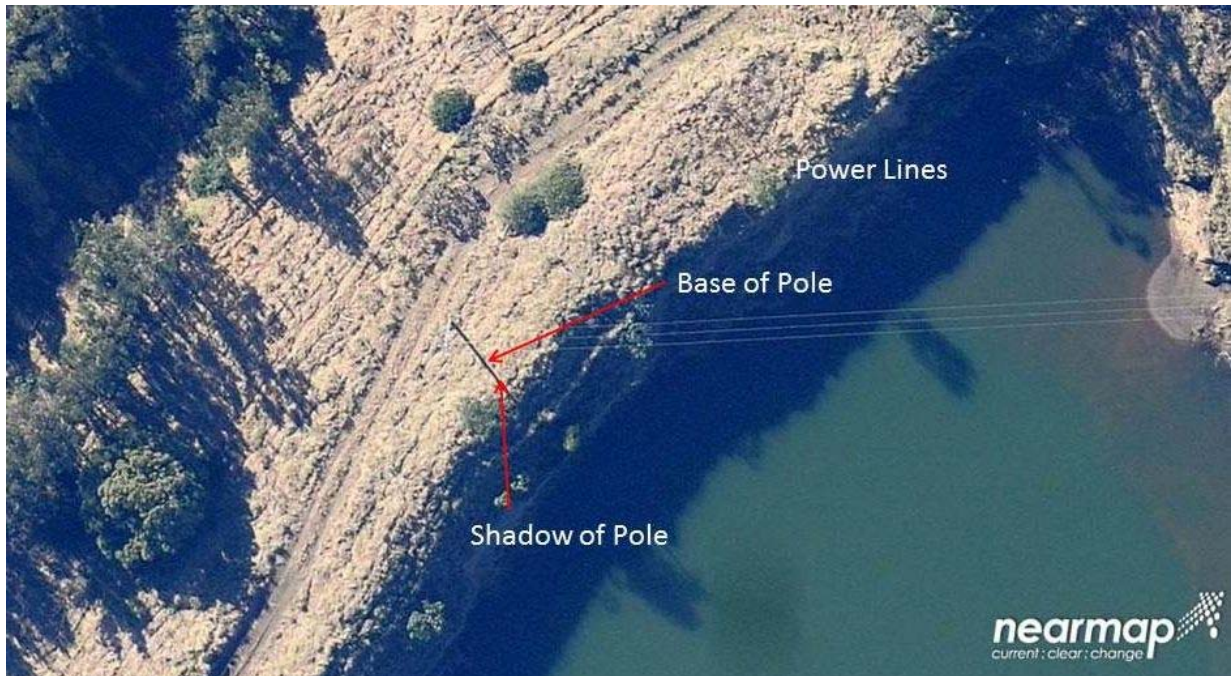
*Plate 3: Power Pole P182127 (the Broken Pole) on 17 July 2010*

28. Furthermore, I have also reviewed the same portion of the Quarry based on a pre-flood Nearmap image dated 17 July 2010, and note that it shows the Broken Pole in the same location (see Plate 3).

- a. The location of the Broken Pole is the same as shown in the 2010 aerial photograph (which is presented as Plate 3), and there was a slope located to the east of the Broken Pole on the eastern bund along the western side to the quarry;
- b. The surface level of the base of the Broken Pole was between 122.5m AHD and 123.5m AHD;
- c. The peak of the slope to the south east of the Broken Pole (on the Western embankment) was approximately 126.5m AHD;
- d. The distance between the base of the Broken Pole and the base of the embankment to the south east was between 1m to 2m;
- e. The horizontal distance from the Broken Pole to the top of the embankment to the south east of the Broken Pole was between 7m to 8m; and
- f. The embankment to the east of the Broken Pole had a slope which, on the side of the Broken Pole, was at an angle of 35 degrees.

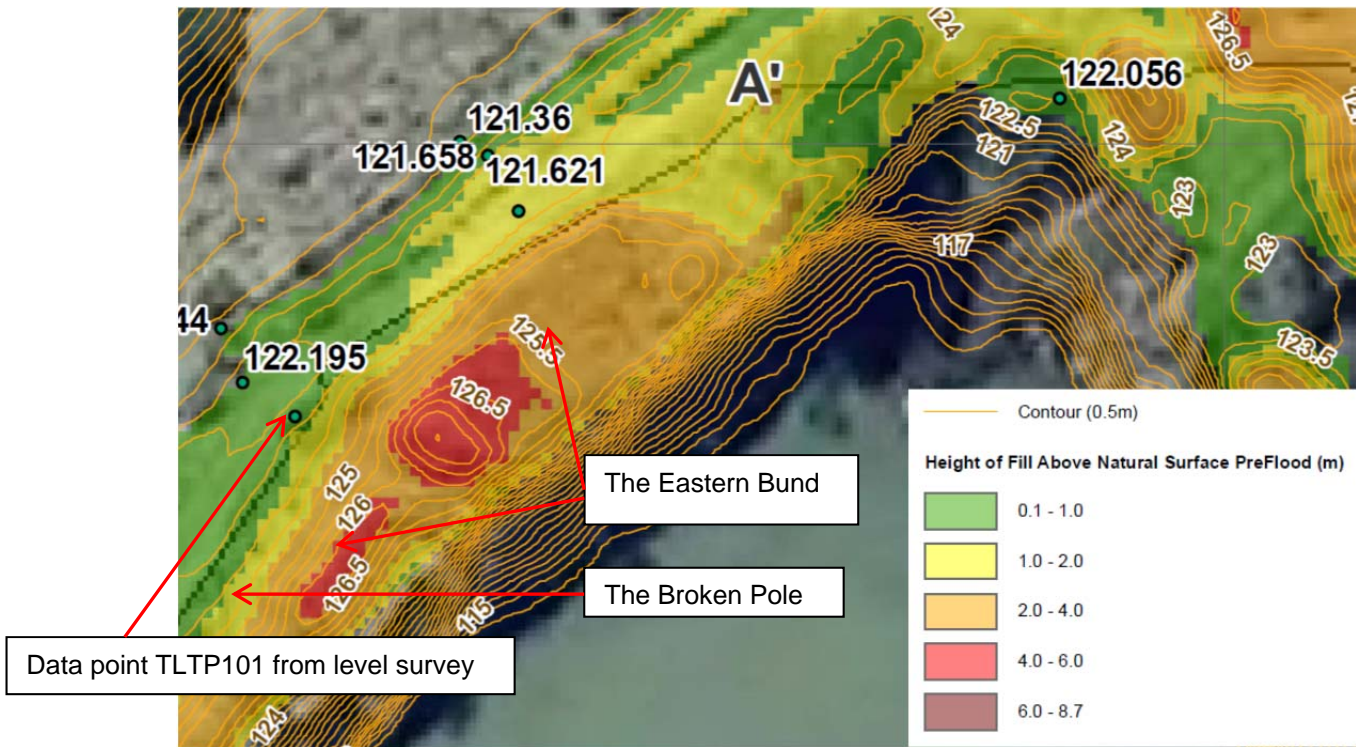
Plate 4: Extract from pre-flood 2010 LiDAR contour plan showing fill heights adjacent to Broken Pole

33. I note from Plates 4 and 5 that the pre-flood LiDAR contours indicate that the Broken Pole was at the toe of the northern section of the eastern bund, on the western side.

35. In reviewing the contour plans, I have identified a data point designated TLTP101 (Track Level near Test Pit 101), which is close to the base of the Broken Pole. This point is identified on Plate 4, and was surveyed as part of the geotechnical investigations. This data point has an RL of 122.849 AHD. (The survey data are tabulated on a figure in the front of Appendix D in my Main Report).

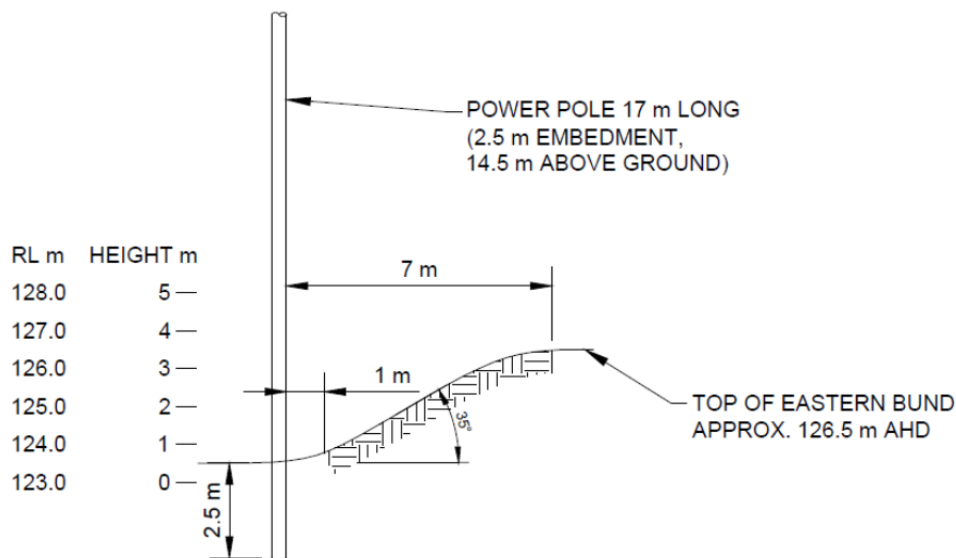
*Plate 6: Cross section through the section of eastern bund adjacent to the Broken Pole*

36. Based on the AHD contour values I have drawn a simplified cross section of the eastern bund adjacent to the Broken Pole. This is presented as Plate 6.

37. Based on Plate 6, I can make the following inferences:
- a The base of the Broken Pole pre-flood had an RL of between about 122.5 and 123.5 m AHD (depending on exact location of the pole in relation to the toe of the eastern bund).

- b I estimate that the level of the top section of bank adjacent to the Broken Pole immediately to the east was about 126.5 AHD.
  - c The embankment adjacent to the Broken Pole had a side slope of about 35 degrees on the western side of the eastern bund at this location.

- d The horizontal distance from the Broken Pole to the top of the bund is about 7 m.
