Report to: Grantham Commission of Inquiry- Investigation of timber utility pole failure

Re-issued on 4 Aug 2015

1.0 Executive Summary

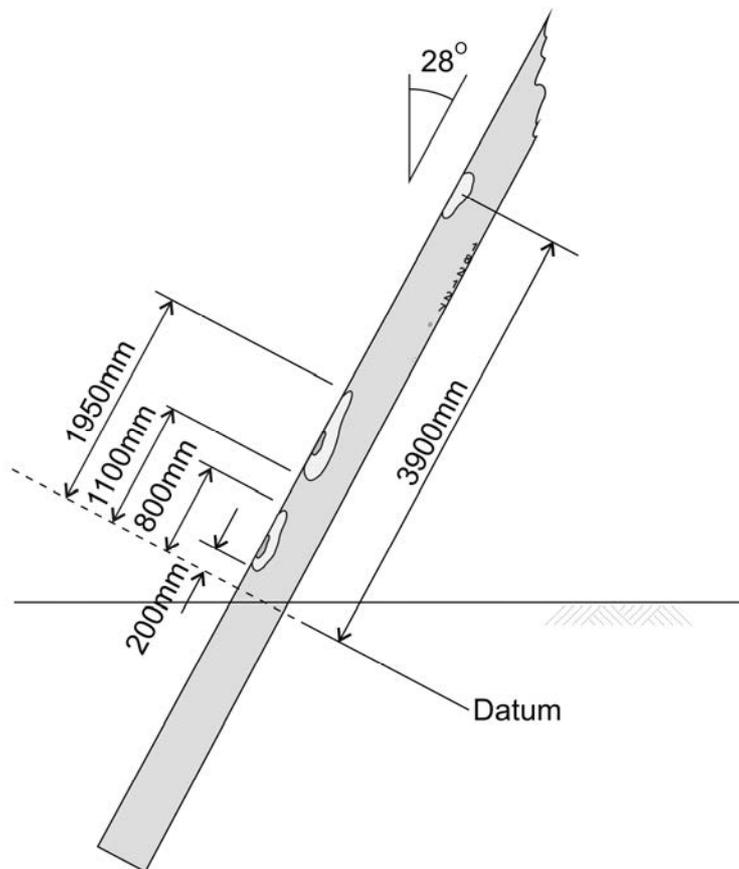
Figure 5 – Location of evidence of damage to pole (Approximate bruising locations indicated by darker shading)

6.6.1 I observed three damage locations on the outer surface of the pole towards the NW face. I did not observe any significant obvious damage on the SE face of the pole. These damage locations are indicated in Figure 5 below and shown in Photographs 13 to 17 in Appendix 3.

6.6.2 These damage locations were located below the pole failure location.

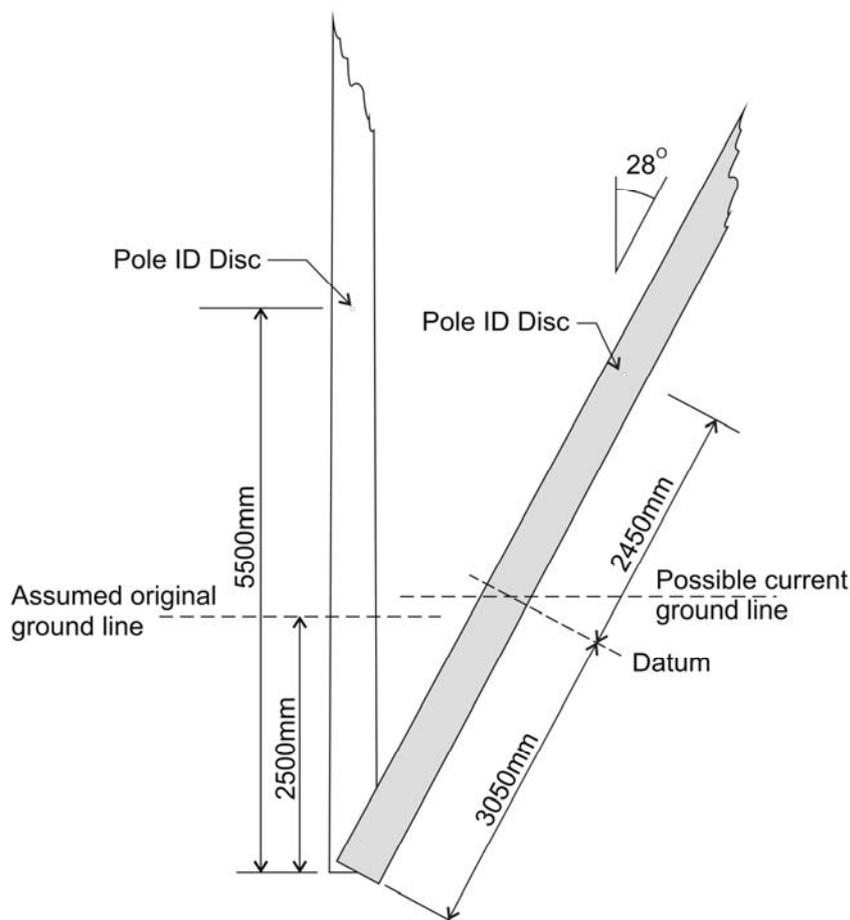
Figure 6 – Measurements of pole embedment versus ground level

- 6.7.4 Based on the above measurements and assumptions, I estimate that it is possible that the current ground line is higher than the assumed ground line at time of pole installation. See Figure 6 for measurements.

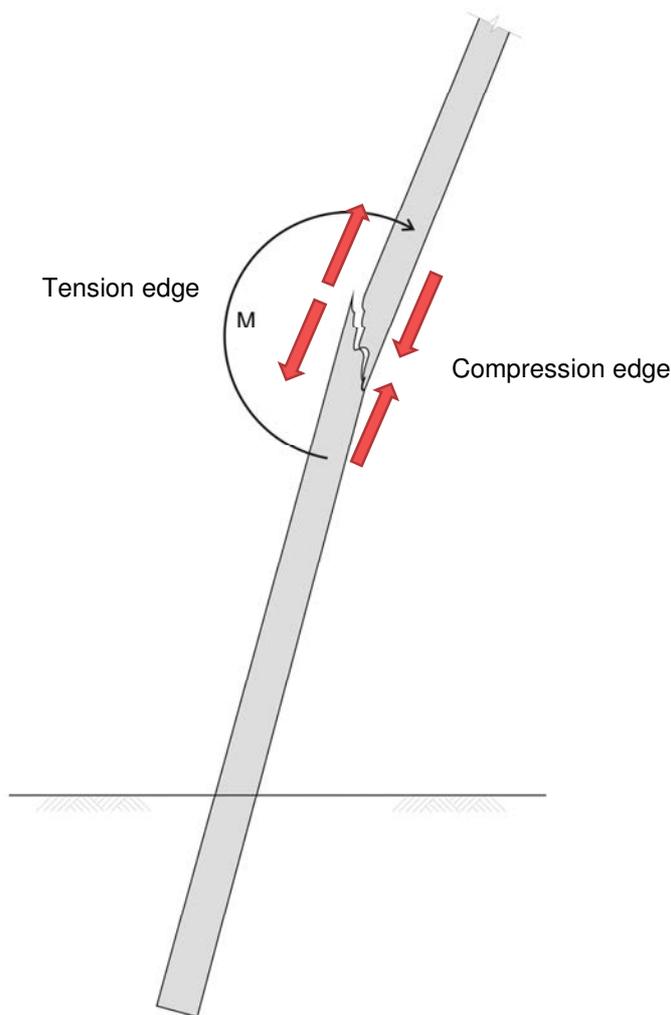
Figure 7 – Moment Direction on Pole viewed from the SW

- 6.8.2 I therefore conclude that the moment applied to the pole to induce the fracture was in a clockwise direction when viewed from the SW. See Figure 7. The implications of this are that either:

- a. A load was applied above the fracture in a SE direction or
 - b. A load was applied above and or below the fracture in a NW direction.

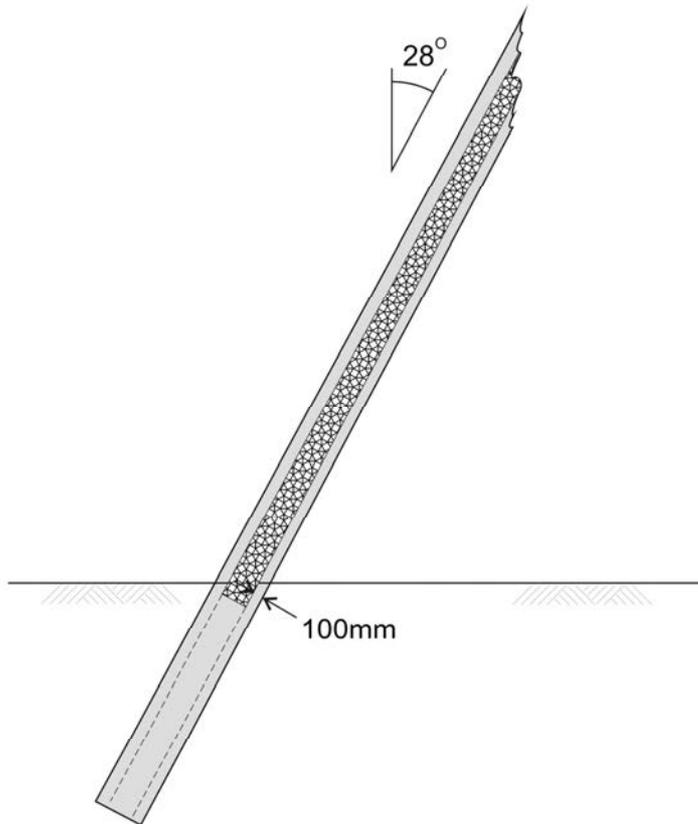
Figure 9 – Sound/Unsound timber (Unsound brittle heart timber indicated by dark hatching)

- 7.3.1 Under my direction, Mr Somerville undertook drill probing of the Failed Pole from the base to close to the top fracture location. This revealed unsound timber approximately 100 mm in from the outer surface. See Figure 9 for an indication of the location of the unsound timber.

- 7.3.4 I have estimated from pole measurements and from Appendix 3, Photo 20 that the brittle heart has a diameter of approximately 190 mm at the fracture or slightly greater at the ground line.

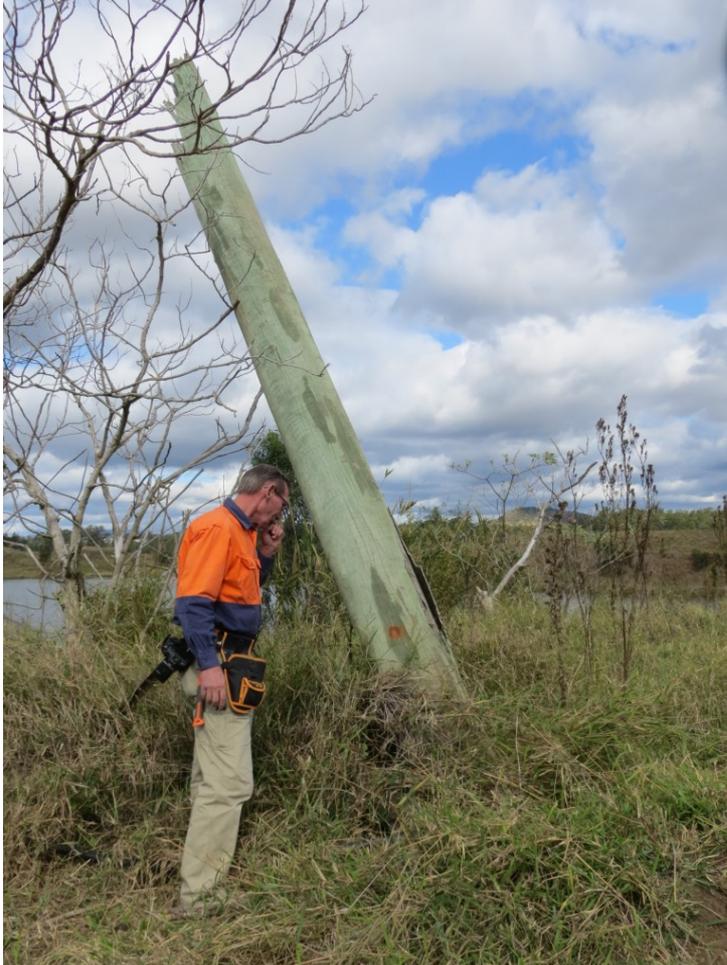
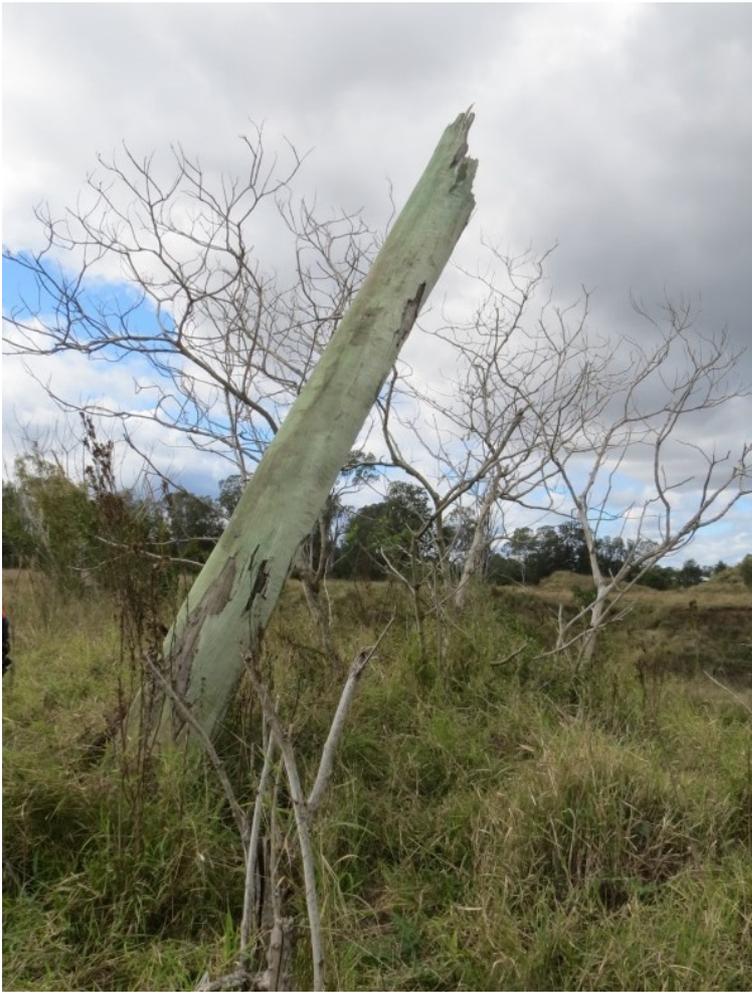
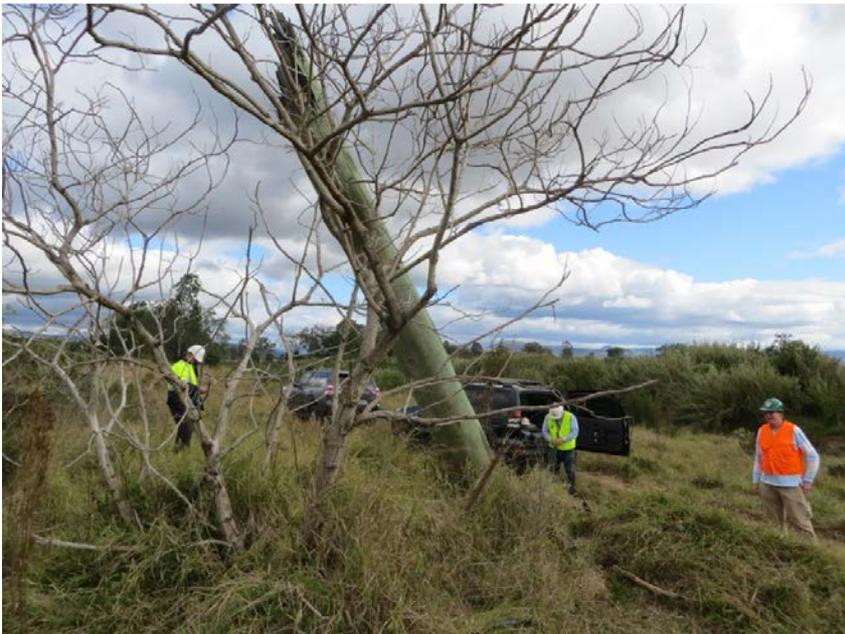
- 5.3.3 From base to tip, I identified the pole was leaning in an approximate south-east direction towards the water body. Refer to Appendix 3, Photo's 1 to 3 for a general view of the failed pole and the direction of lean.

Photo 1 – View of pole from the North. Note paint dot indicating North.

Photo 2 – View of pole from the West

Photo 3 – View of pole from the East

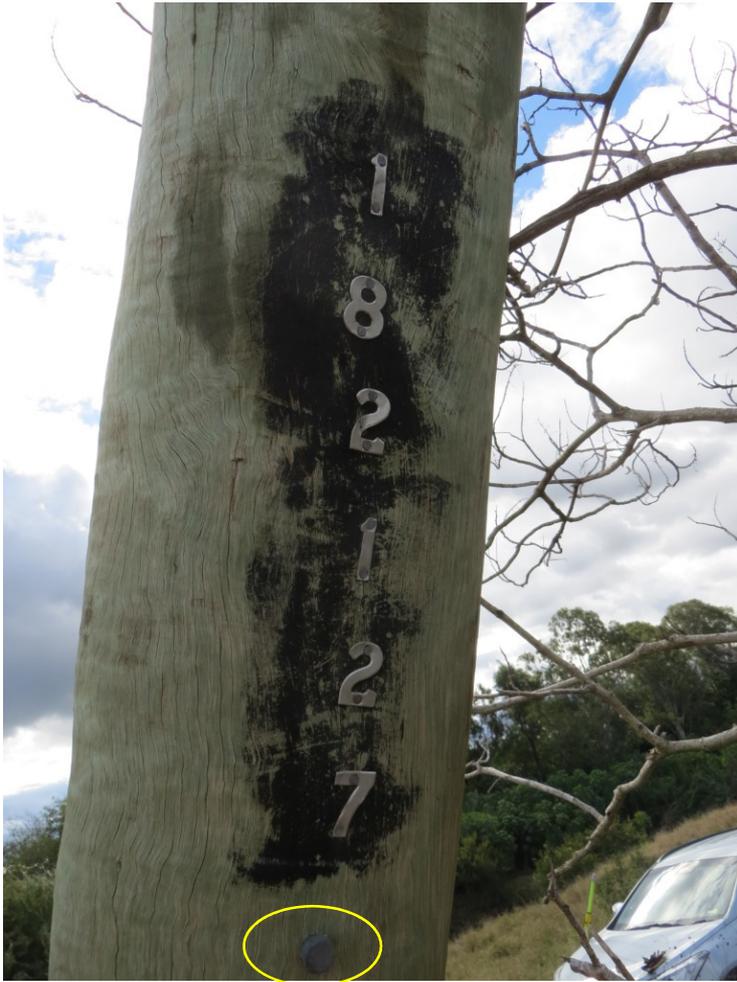
- 5.3.4 I found the original pole identification disc, pole number and current leakage test point (coach screw) still to be intact on the remaining section of the pole. Refer to Appendix 3, Photo 4 and 5 that show the disc, identification number and test point.

Photo 4 – Pole Identification # and Current leakage test point (highlighted)

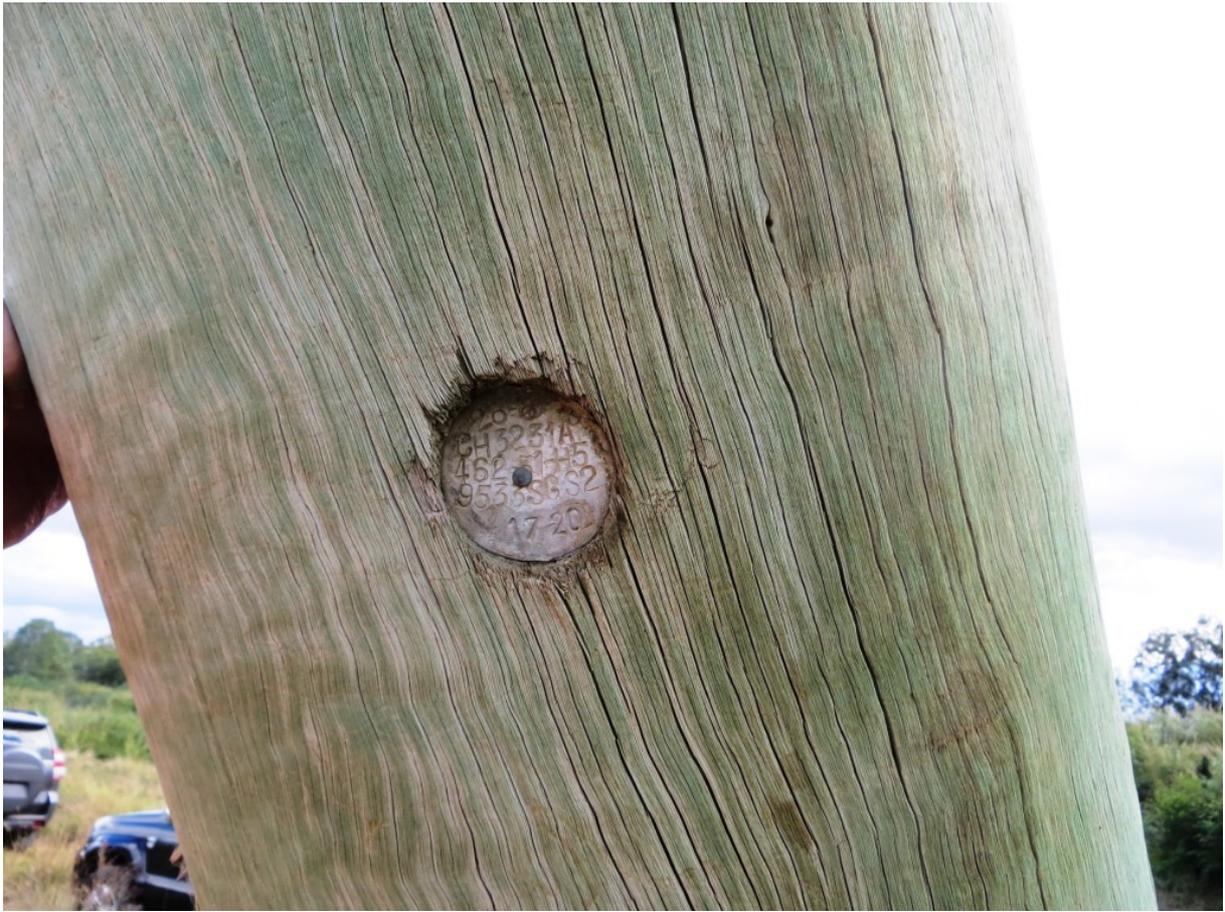
Photo 5 – Pole Identification Disc.

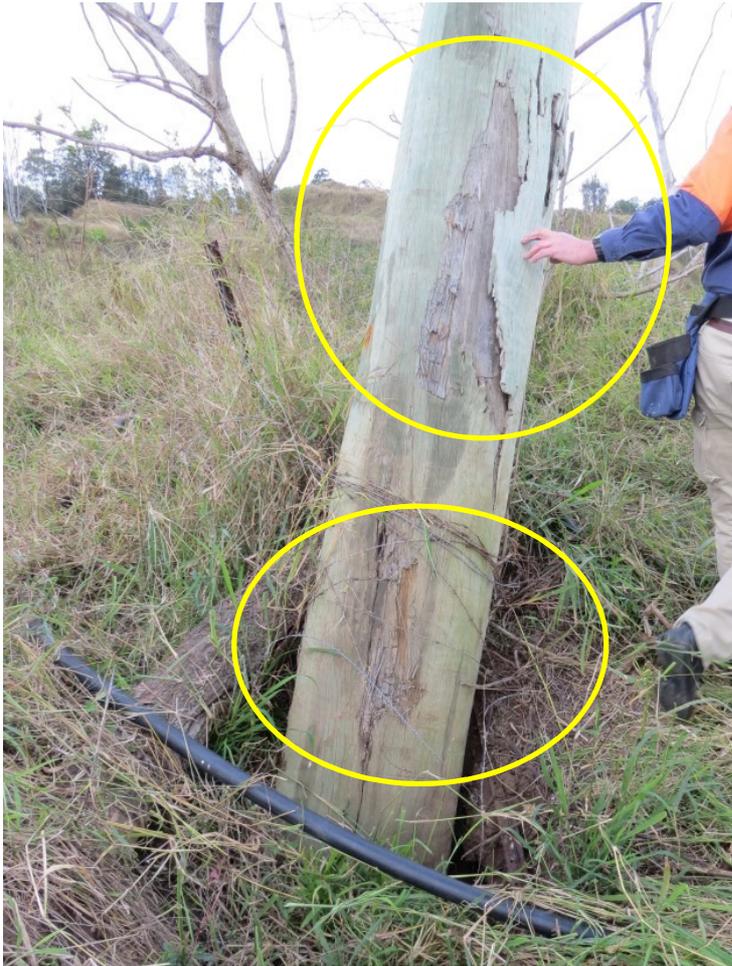
- 5.3.5 I identified visible bruising/scarring/damage at a number of locations on the remaining section of the pole. Refer Appendix 3, Photo's 6 and 7 that show these damage points.

Photo 6 – Bruising/damage to pole on NW face highlighted

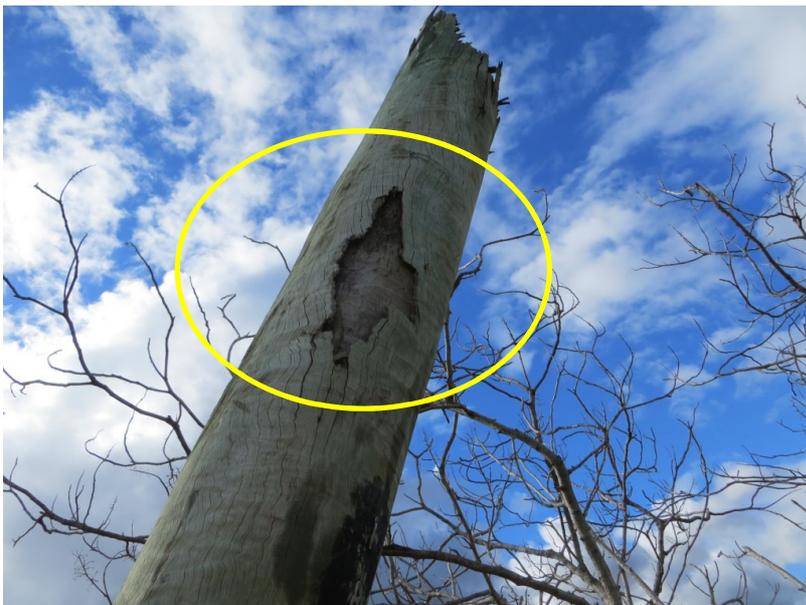
Photo 7 – Damage (possible shelling) to pole on West face highlighted

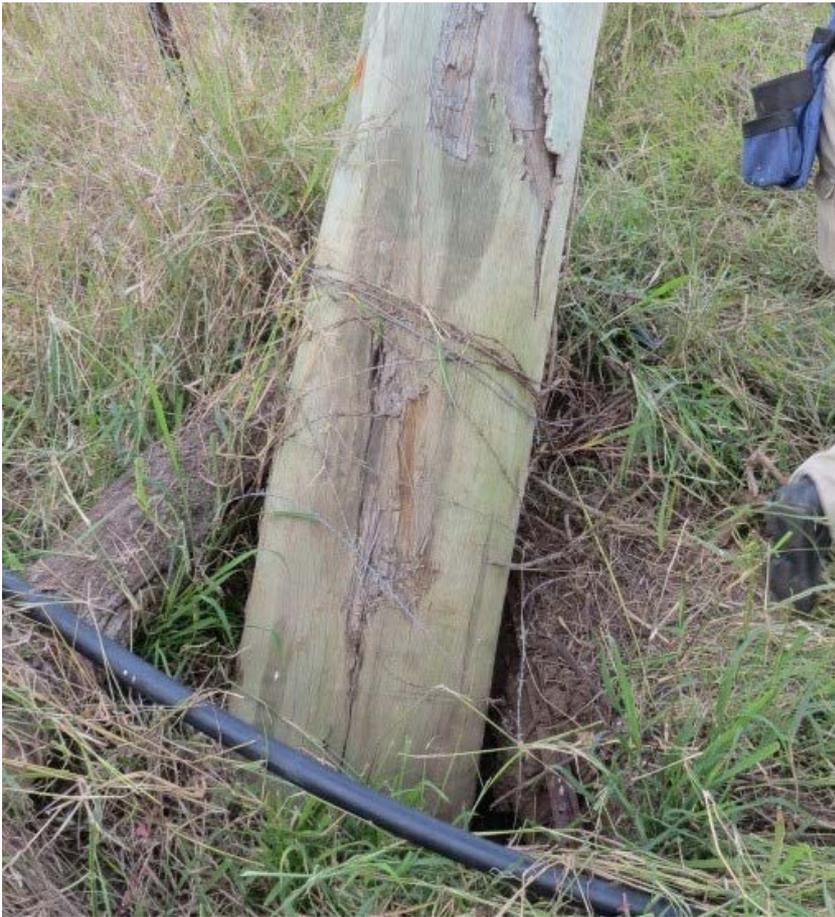
Photo 8 – Debris around base of pole

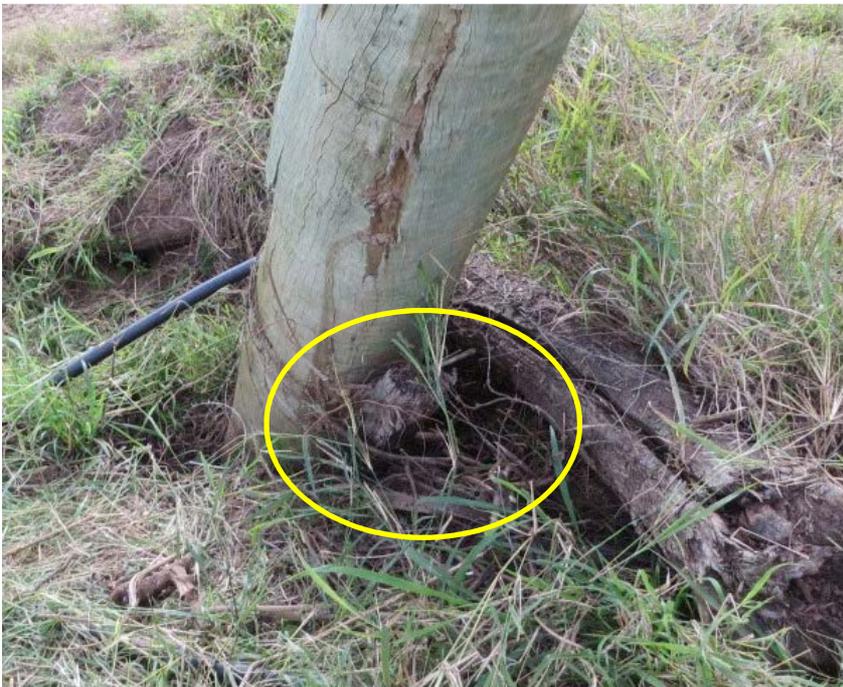
Photo 9 – Evidence of possible top of old fence post adjacent to post

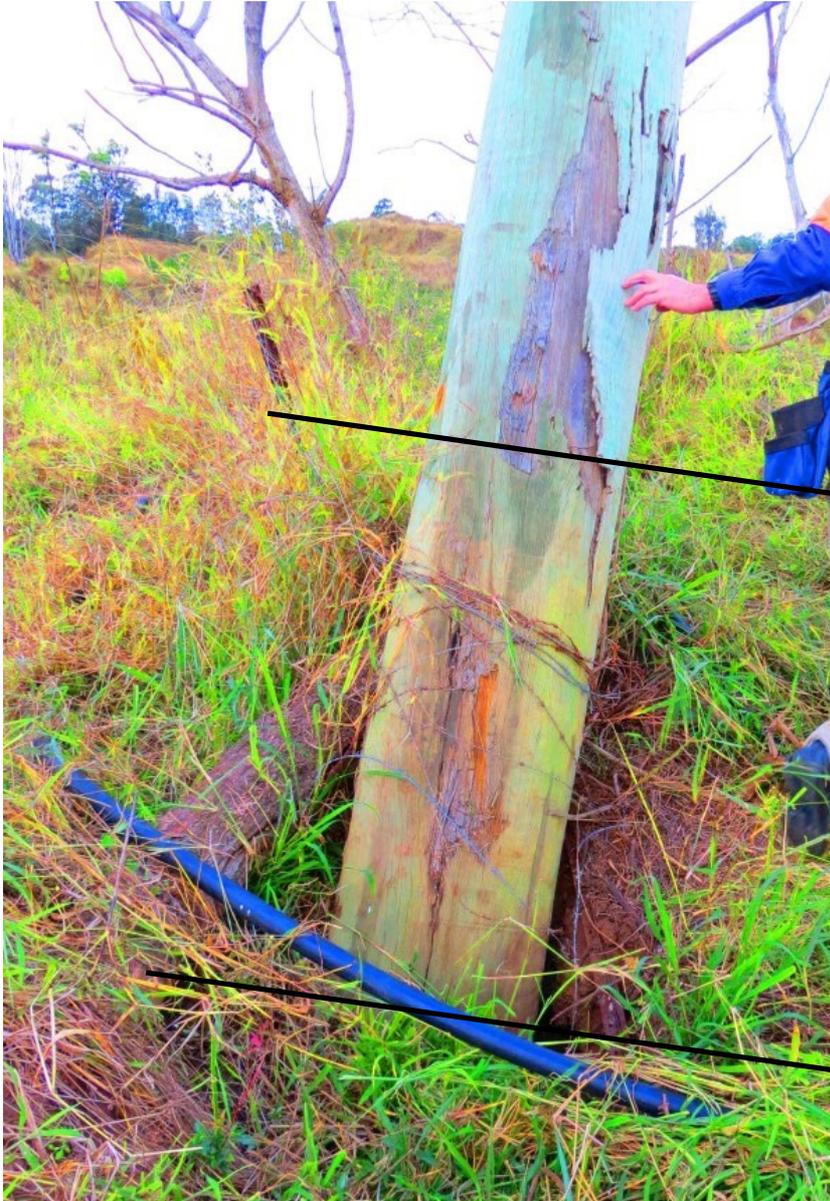
- 5.3.8 I observed a slight colour variation on the surface of the pole for a distance of approximately 1100 mm from ground line. Refer Appendix 3, Photo 10 which has been digitally enhanced to show this slight colour variation. Note: For comparison, a non-enhanced photo of the same section of pole is shown in Photo 6, Appendix 3.

Photo 10 – Digitally enhanced picture of base of pole indicating height of slight colour variation against pole approximately 1100 mm up from ground line.

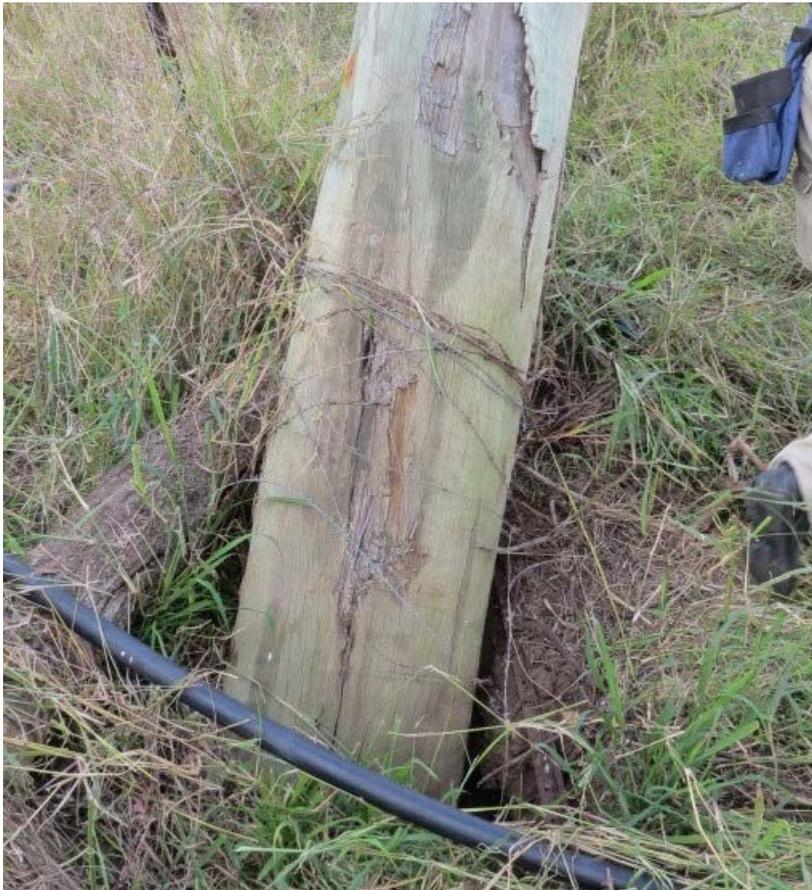
Under my direction, Mr Somerville, using a steel tape measured the depth of scouring to the pole, apparent at the time of inspection. To the SE side of the pole (presumably the downstream side) this was found to be approximately 800 mm from the ground surface on that side of the pole however, there was a lot of debris in the hole so this probably does not represent actual scour depth. Similarly, on the NW (again presumed upstream side of pole) the depth of scouring was found to be approximately 250 mm from the actual ground surface. Refer Appendix 3, Photo's 11 and 12 that show the apparent scouring to the NW side and SE side respectively.

Photo 11 – Scouring at front of post to a depth of approx. 250 mm from actual ground. Note also wire and log debris etc.

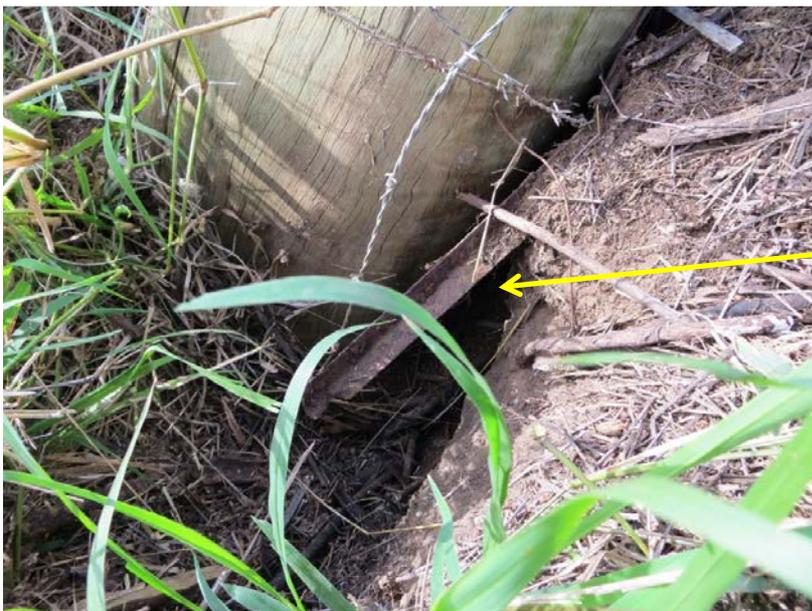
Photo 12 – Scouring to rear (SE) of post to approximately 800 mm from actual ground

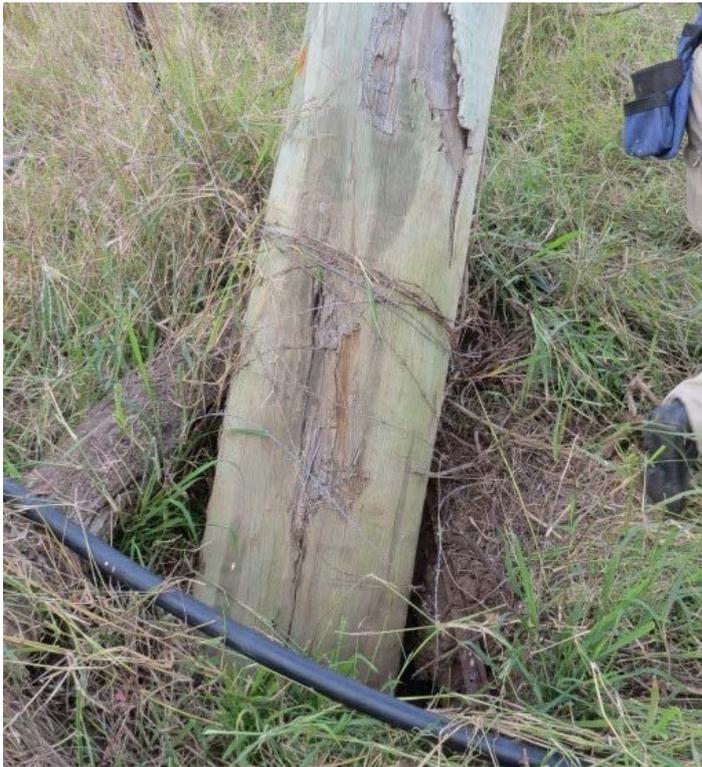
Photo 13 – Damage to lower portion of pole

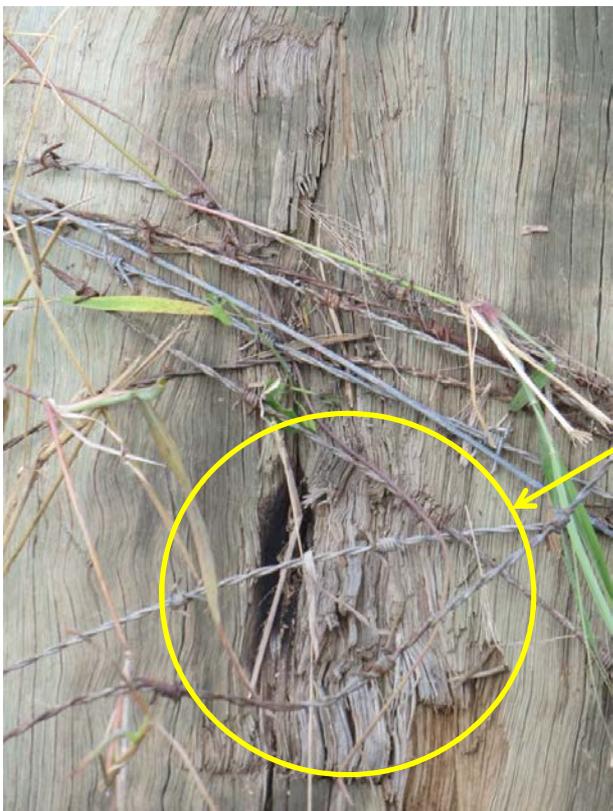
- 6.6.3 The damage appears to be the result of either/or a combination of abrasion, bruising and shelling. Shelling can occur in timber where there is a line of circumferential weakness that follows the growth rings. It may be due to the presence of gum veins or some other ‘weakness’ that has arisen such as onset of decay to the inner portion of the sapwood in the pole.
- 6.6.4 At both the lower damage location and the middle damage location, there is evidence of a bruising depression that is likely to have resulted from some type of impact. This is highlighted in Photo’s 14 and 16 in Appendix 3.

Bruise

Photo 14 – Close up of damage to lower portion showing bruising

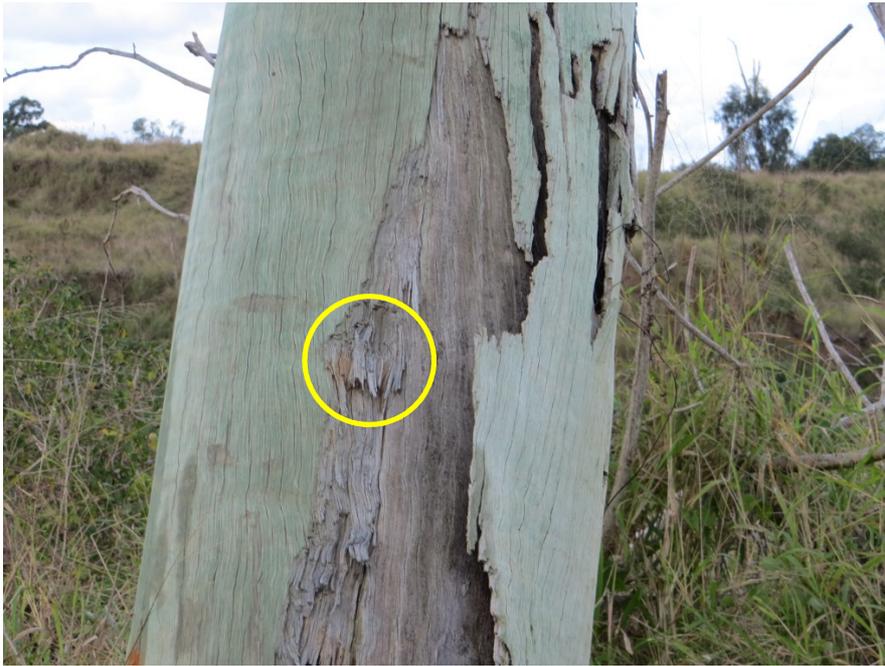
Photo 15 – Damage to middle section of pole

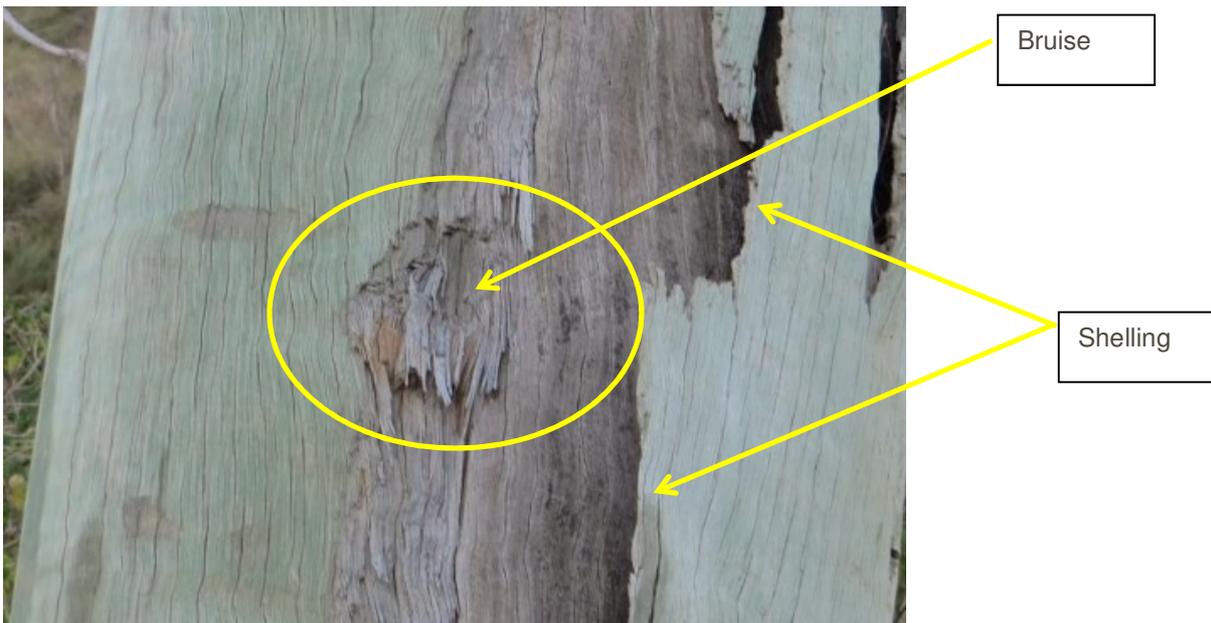
Photo 16 – Close up of bruising damaged middle section of pole and typical shelling

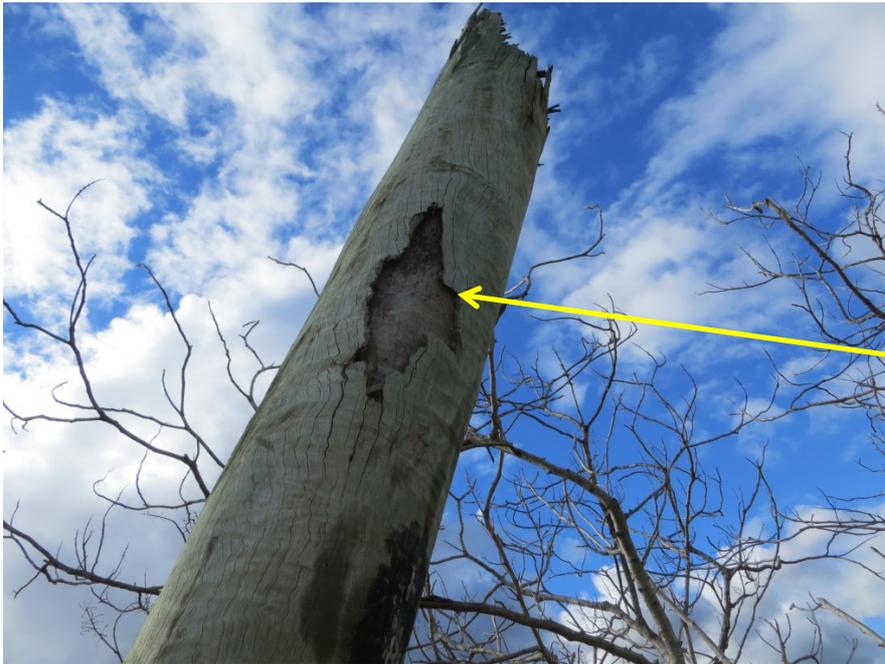
Photo 17 – Damage to upper section of remaining pole. Appears to be shelling

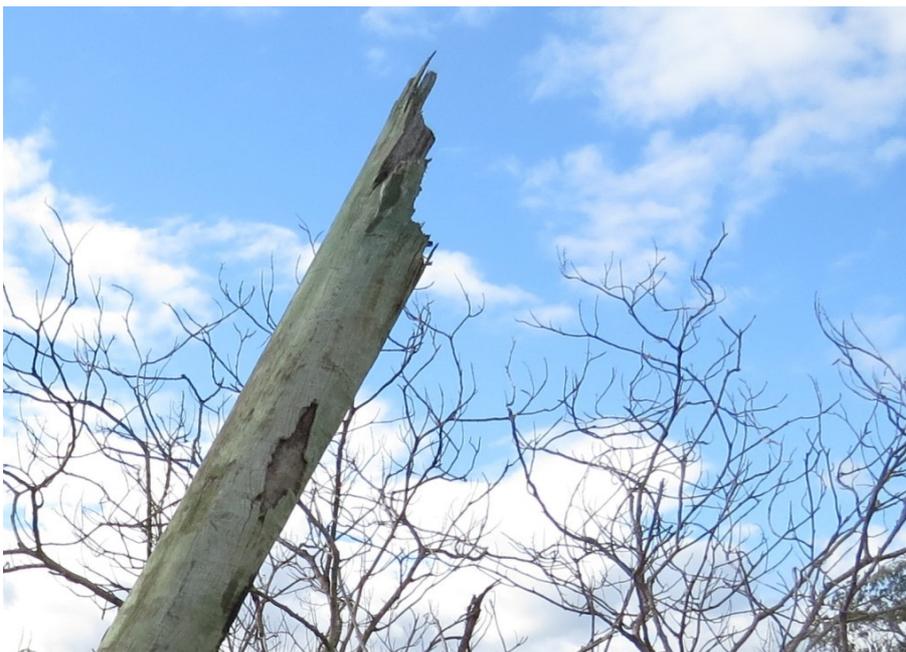
- i. The direction and the angle of broken fibres at both the top and bottom of the fracture. Refer Appendix 3, Photo's 18 and 19 that indicate these directions.

Photo 18 – Pole fracture viewed from the SW

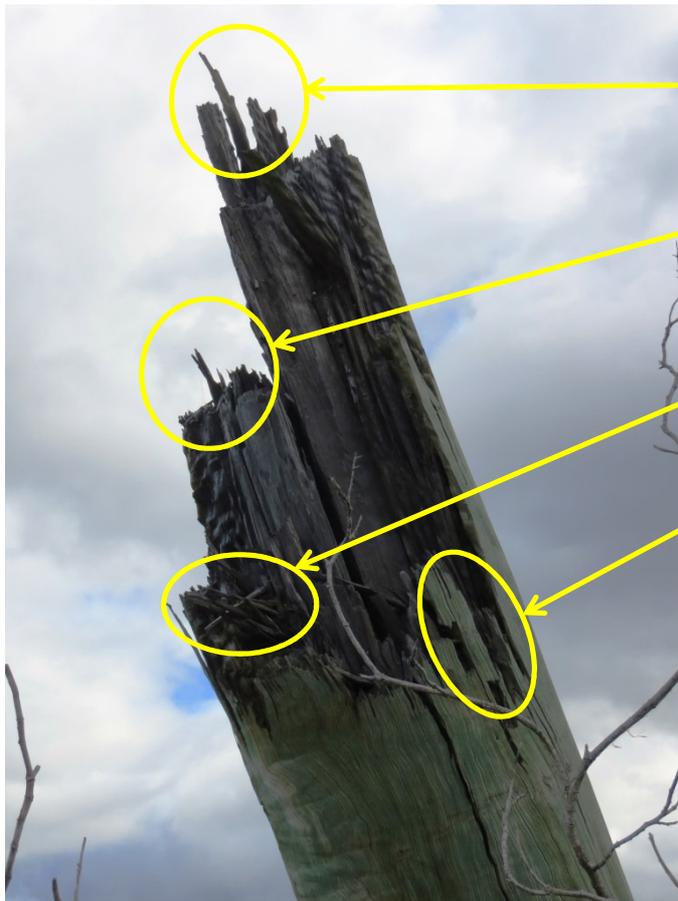
- b. Elongated fibres bent towards the SE at both top and bottom of the fracture. Refer Photo 19, Appendix 3, that highlights these points.
 - c. That the tension side of the fracture is on the high side (NW) of the fracture and the compression on the low side of the fracture. My reasons for forming this opinion are:

- v. Rotation to the left about the compression edge at failure which has pulled the fibres at the lower edge to the left. The tension side and compression side are shown in Figure 7 below and in Appendix 3, Photo 19.

Fibres on tension side of fracture leaning to the SE

Tension edge moving up and to left side of fracture and fibres leaning to left

Plug of timber pulled on fracture above neutral axis of failure indicating tension side of failure

Photo 19 – Pole fracture from the NE

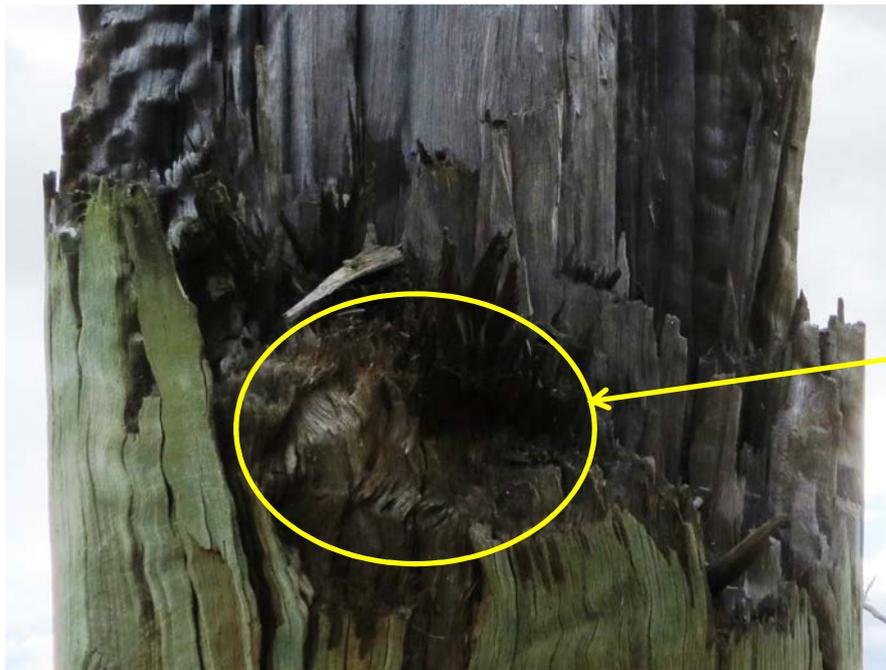
- ii. Signs of compression damage, such as fibres that have buckled, which can be seen in some layers of fibres just in from the face near the lower edge. Refer Appendix 3, Photo 20 that shows this compression damage.

- 7.3.2 Based on a closer review of the pole fracture location and visual assessment of the nature of the fracture, I concluded that a significant proportion of the center of the pole had 'brittle heart'. See Appendix 3, Photo 20 that identifies the location of the brittle heart.

Compression failures on lower side of fracture

Photo 20 – Close up of pole fracture from the east showing signs of compression of fibres.

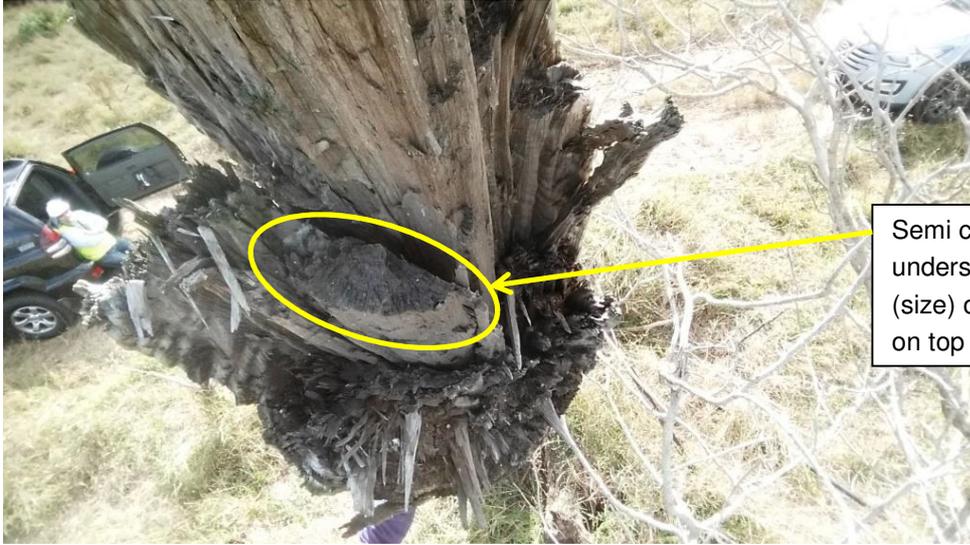
- 6.8.1 A close examination of the fracture location I conducted (refer Photographs 18 to 21 Appendix 3) indicates:
- a. The presence of brittle heart with a brash fracture in the central portion of the pole. Refer Photo 21, Appendix 3 which highlights brittle fracture zone on the compression side of the fracture. Refer also to Paragraph 7.3 which considers the effects of brittle heart in more detail.

Semi circular shape of brittle heart on underside of fracture. A similar amount (size) of brittle heart would be located on top side of fracture.

Photo 21 – Indication of brittle heart
