**GRANTHAM FLOODS COMMISSION OF INQUIRY**

**EXPERT HYDROLOGY REPORT  
10 JANUARY 2011 FLOOD**

**CIRCUMSTANCES AND CONTRIBUTING  
FACTORS**

**SUPPLEMENTARY MATERIAL No. 2**

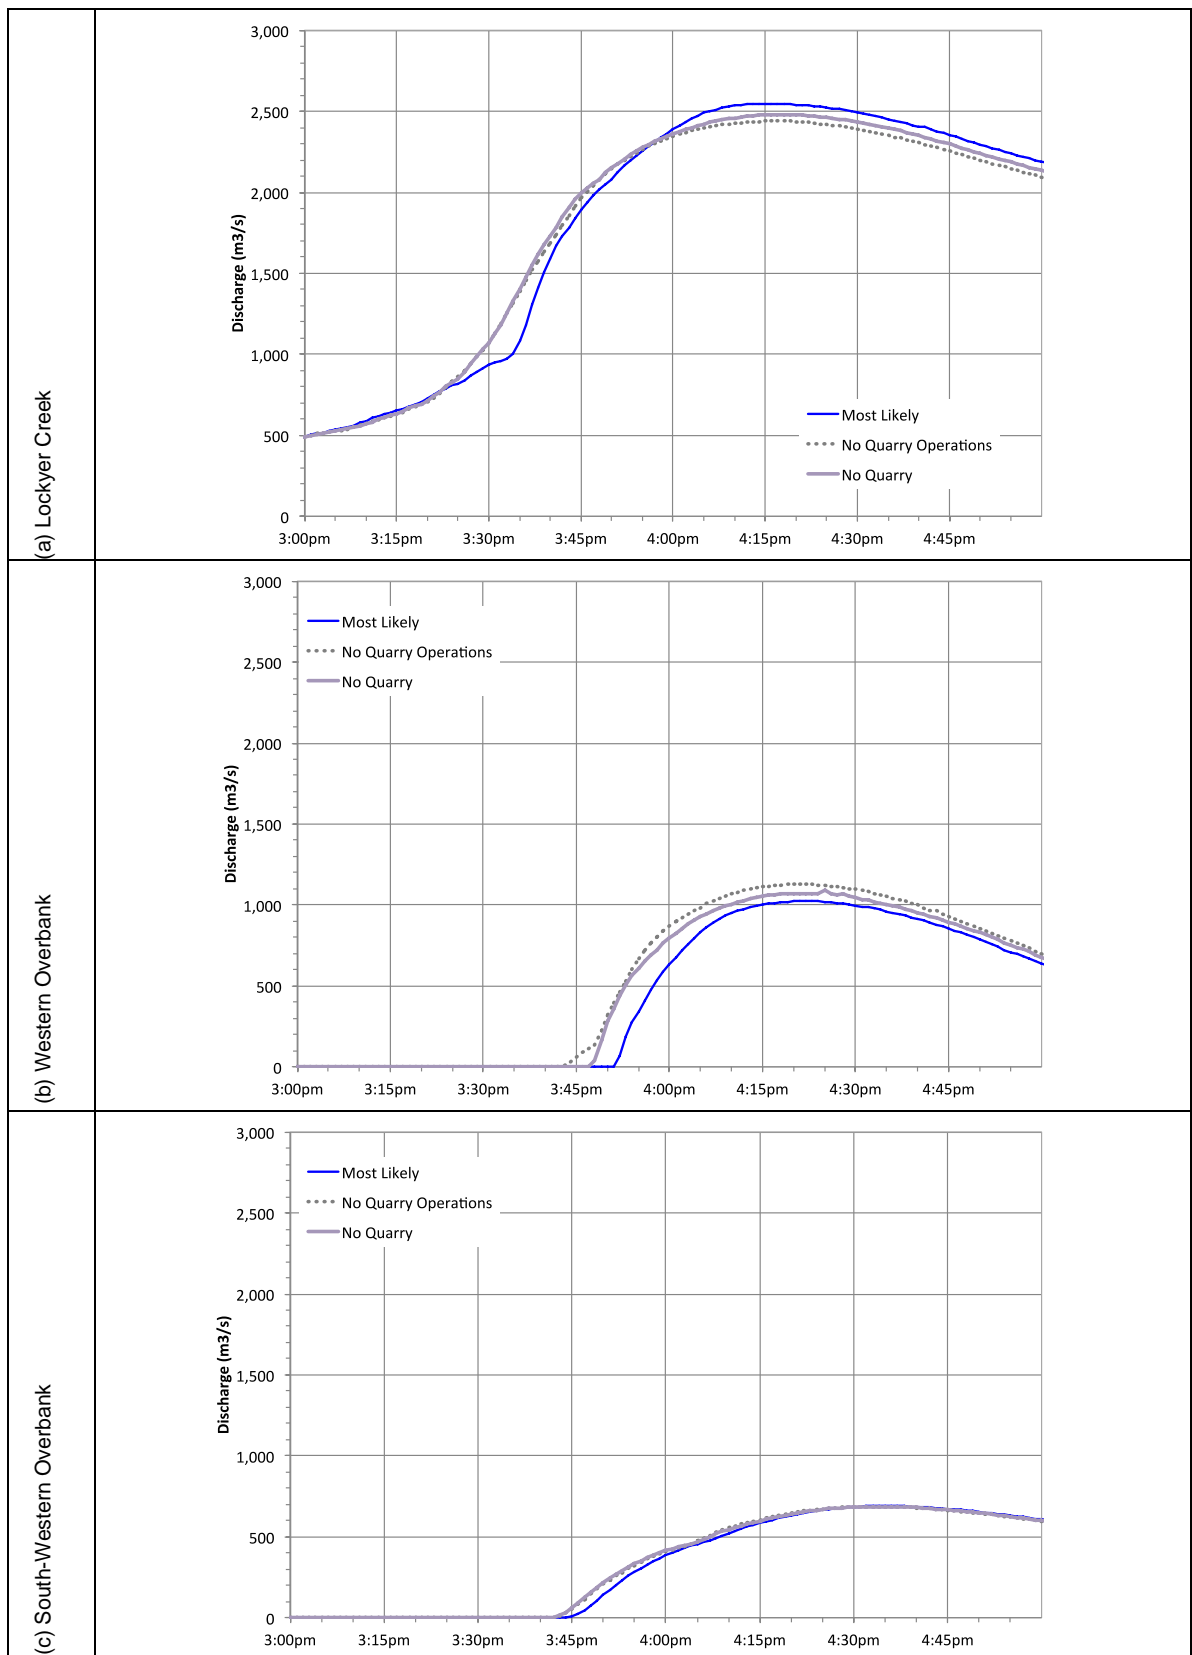
**Figure 3.3 – Effect of No Quarry Operations on Downstream Flow**

- no change to delay times to the Most Likely scenario case;
  - a slight reduction in the peak flow rate in Lockyer Creek of about  $60\text{m}^3/\text{s}$  (2%);

- a small increase in the peak flow rate in the Western Overbank of about  $110\text{m}^3/\text{s}$  (10%);
  - no apparent change in the peak flow rate in the South Western Overbank;

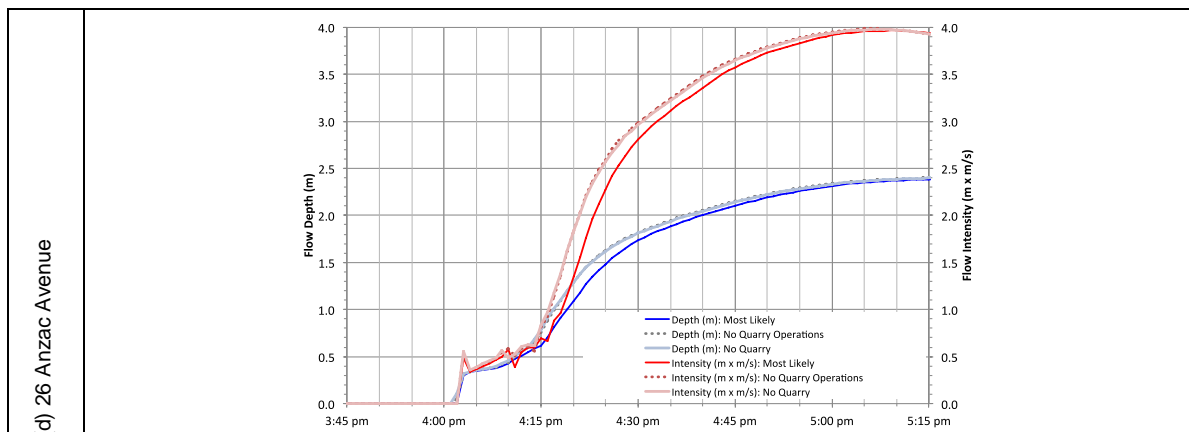
Figure 3.4 – Effect of Quarry Operations on Flow Depth and Intensity

- a reduction in peak flow depth and flow intensity at near 25 Quarry Access Road of about 0.2m (15%) and  $0.6\text{m}^2/\text{s}$  (20%) respectively, compared to the No Quarry case;

- no apparent change to depth or flow intensity at the other reference locations.
25. As indicated above, I consider that the removal of the surface features associated with quarrying operations in the Plant area with the No Quarry Operations scenario resulted in the direction of slightly more overbank flow into the Western Overbank in preference to Lockyer Creek compared with both the No Quarry and Most Likely scenarios. This had an impact in the No Quarry Operations scenario at near 25 Quarry Access Road because the flow path at this location is wider than simulated under No Quarry scenario conditions. In my opinion the wider flow path resulted in a reduction in flow depth and intensity at this location as indicated in Figure 3.4(a).

26. The observed reduction in flow depth and intensity at near 25 Quarry Access Road is the largest change across the reporting locations. This location is closest to the Grantham Quarry and I therefore considered it necessary to review the effect of the No Quarry Operations scenario at the 7 additional reference points (shown as red dots in Figure 1.2). I have produced plots of flow depth and intensity at these locations for the cases of No Quarry, No Quarry Operations and Most Likely for comparison, Figures 3.5 to 3.11.

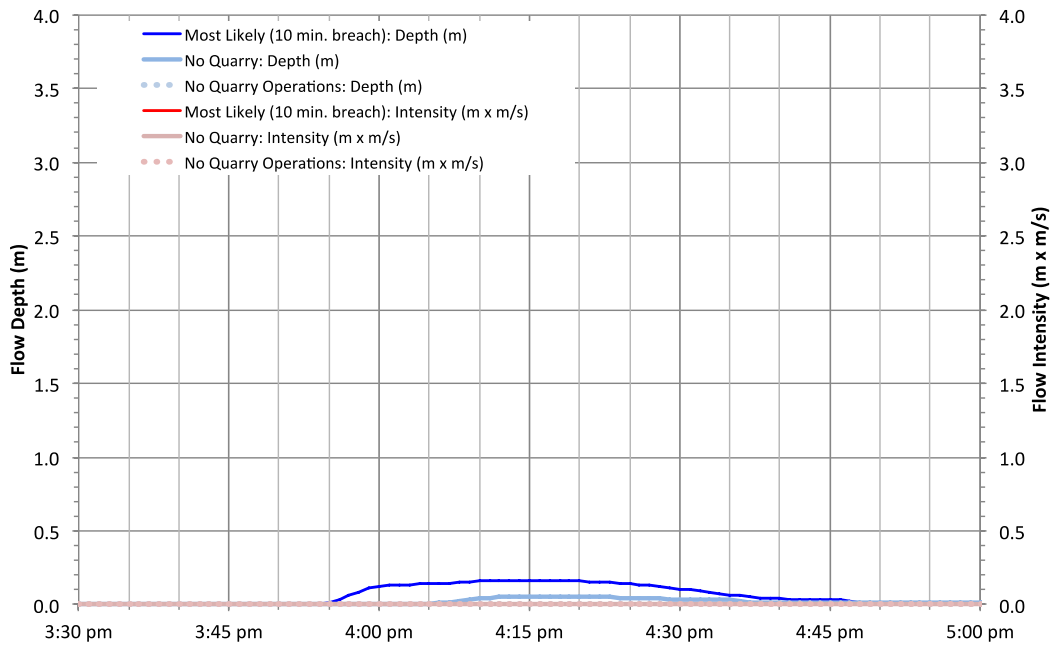
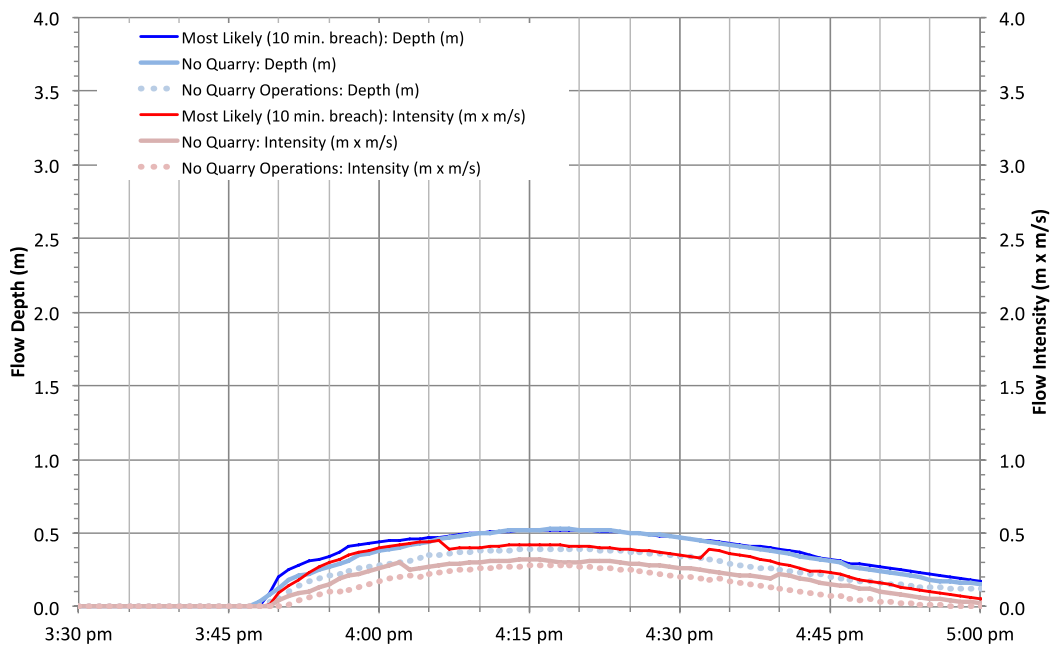
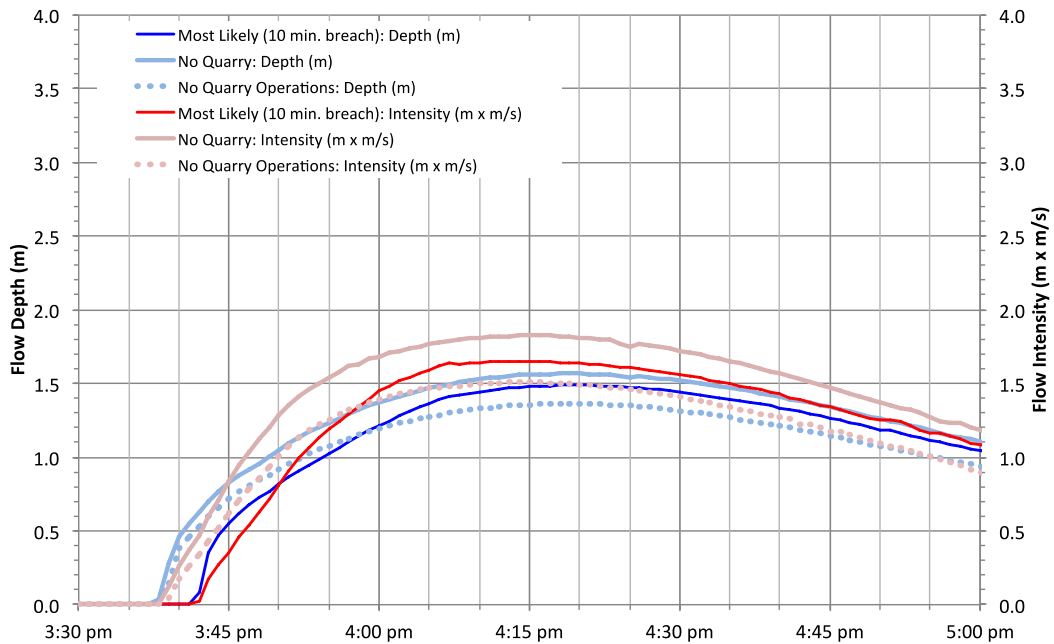
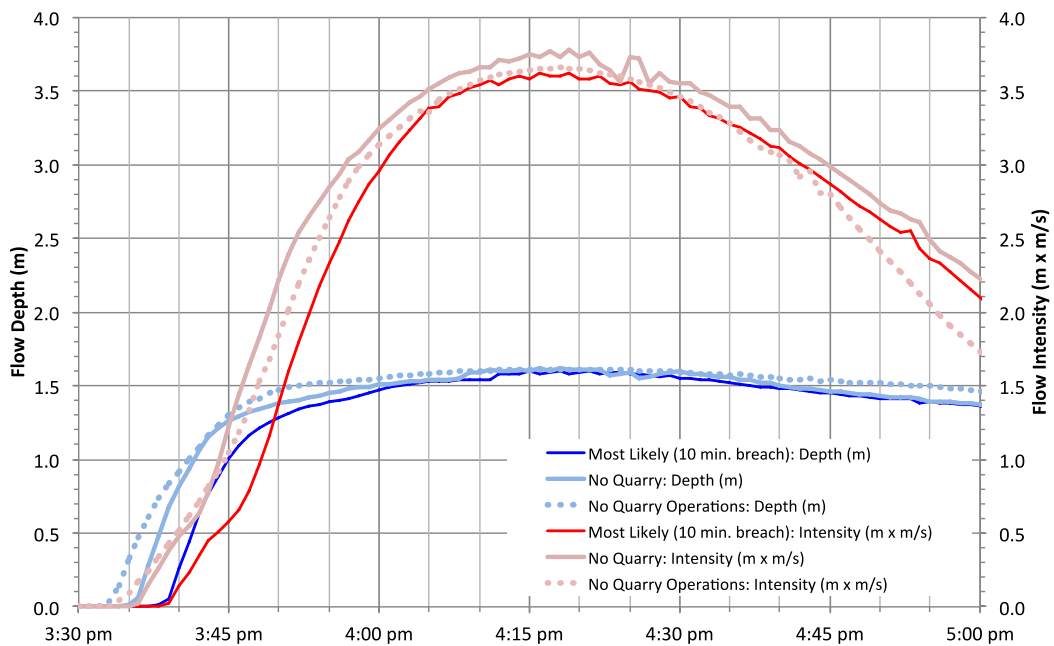
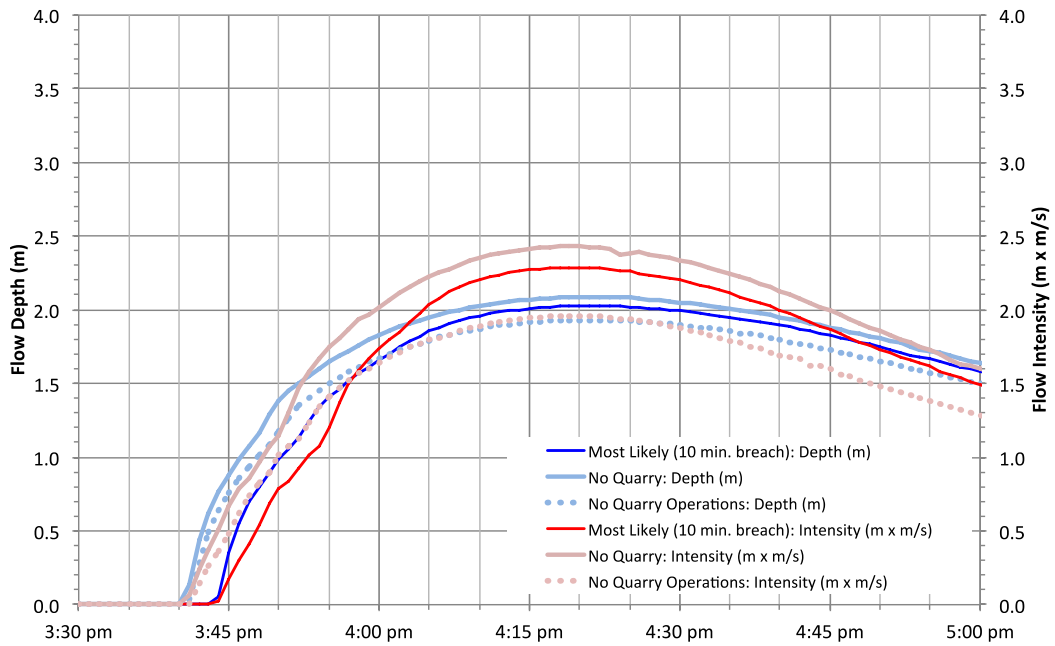
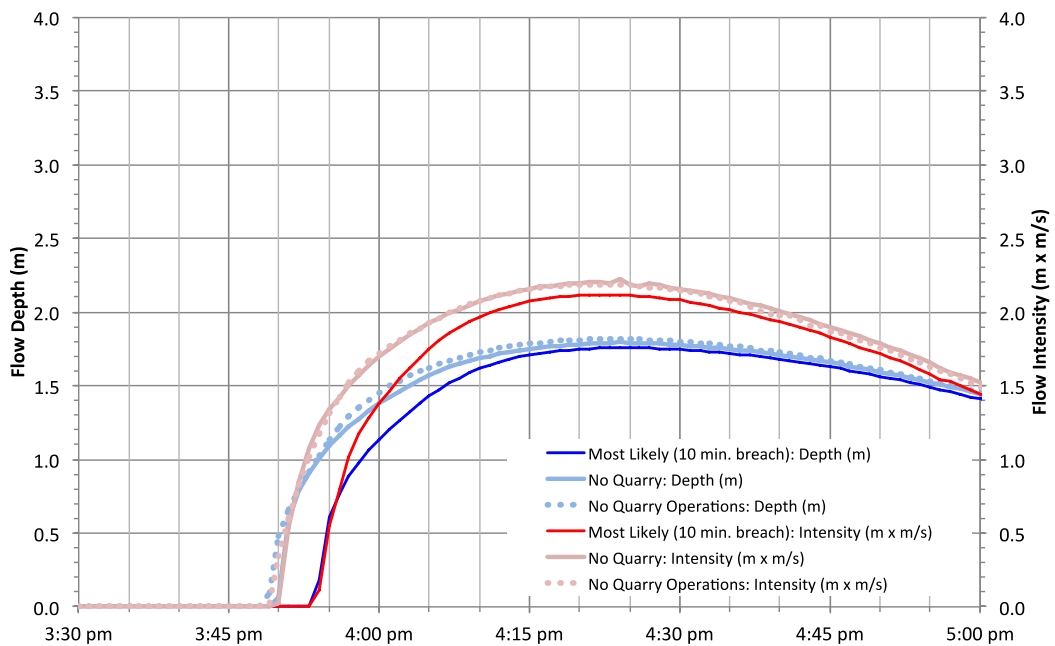
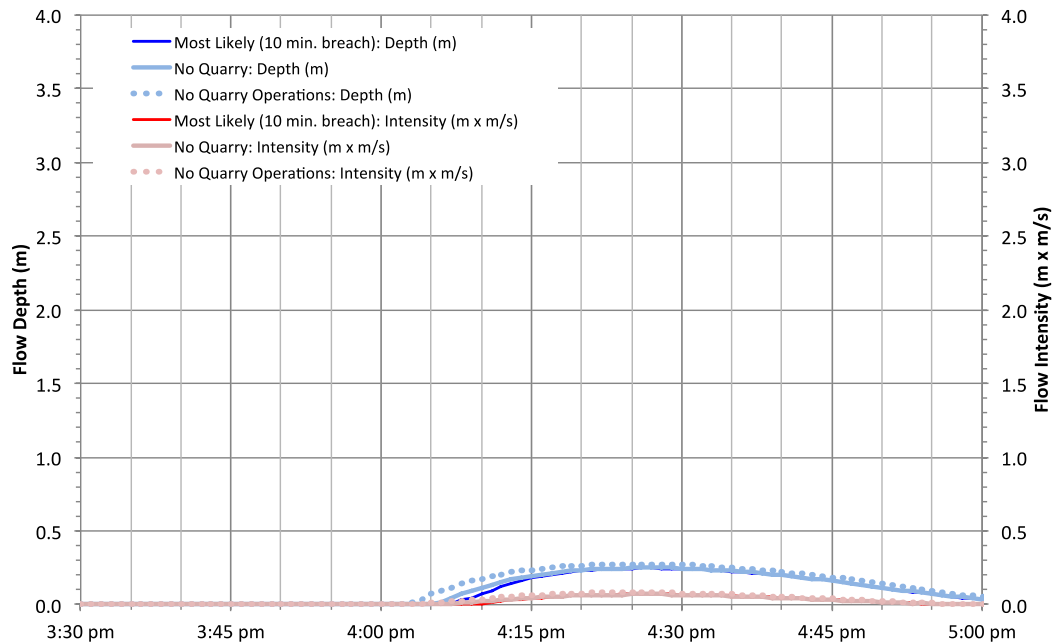
- there is no apparent change to flow depth and intensity at the locations of Ryman, Gallagher and Produce Paddock;
  - at the Mallon reporting location, there is a reduction in depth of less than about 0.1m and a reduction in intensity of less than about 0.1m<sup>2</sup>/s;

- at the Sippel reporting location, there is a reduction in depth of less than about 0.2m and a reduction in intensity of less than about 0.2m<sup>2</sup>/s;

- at the Besley reporting location, there is a reduction in depth of up to about 0.3m and a reduction in intensity of up to about 0.3m<sup>2</sup>/s, with the greatest reduction being on the rising limb of the hydrographs; and

- at the Gillespie reporting location, there is a reduction in depth of less than about 0.2m and a reduction in intensity of less than about 0.5m<sup>2</sup>/s;

27. I have interpreted the information presented in the above plots by making comparison between No Quarry and No Quarry Operations scenarios. My views are summarized as follows:

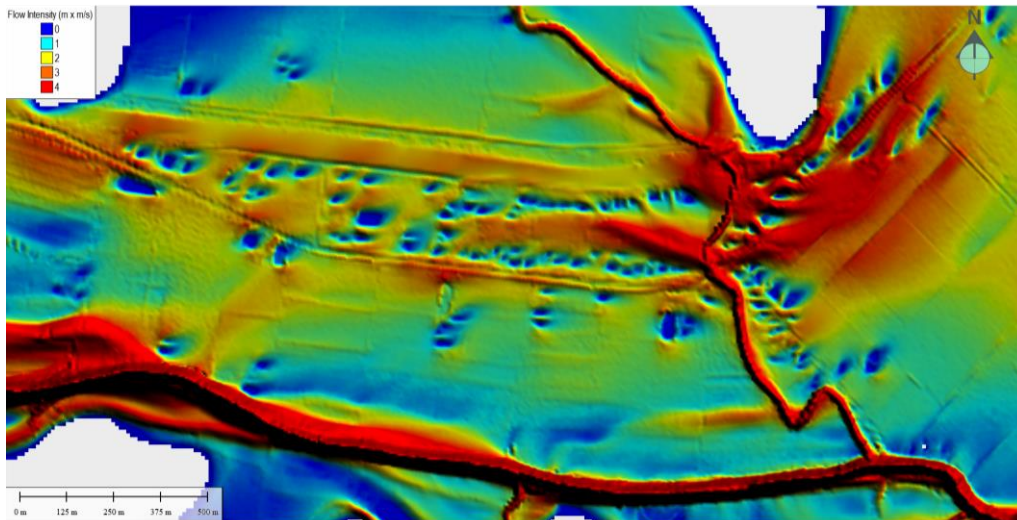
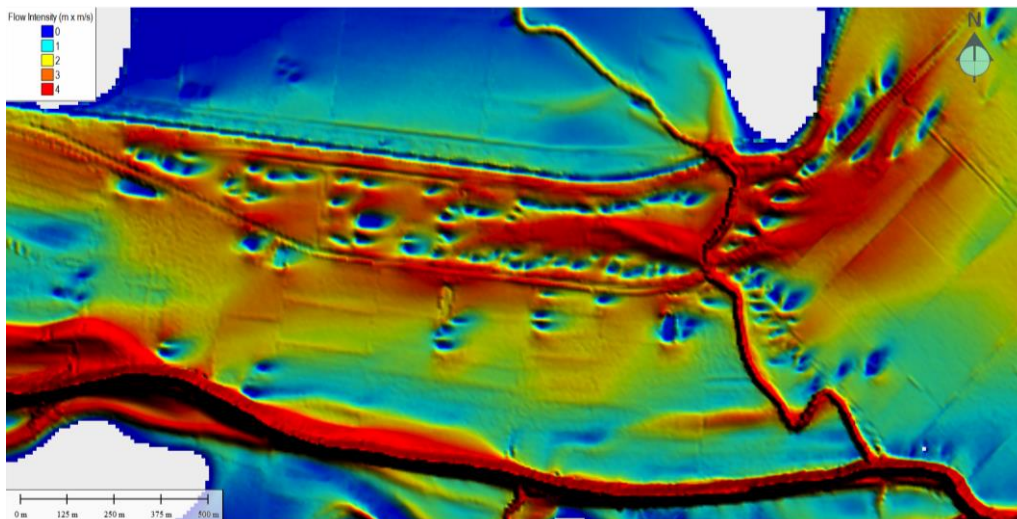
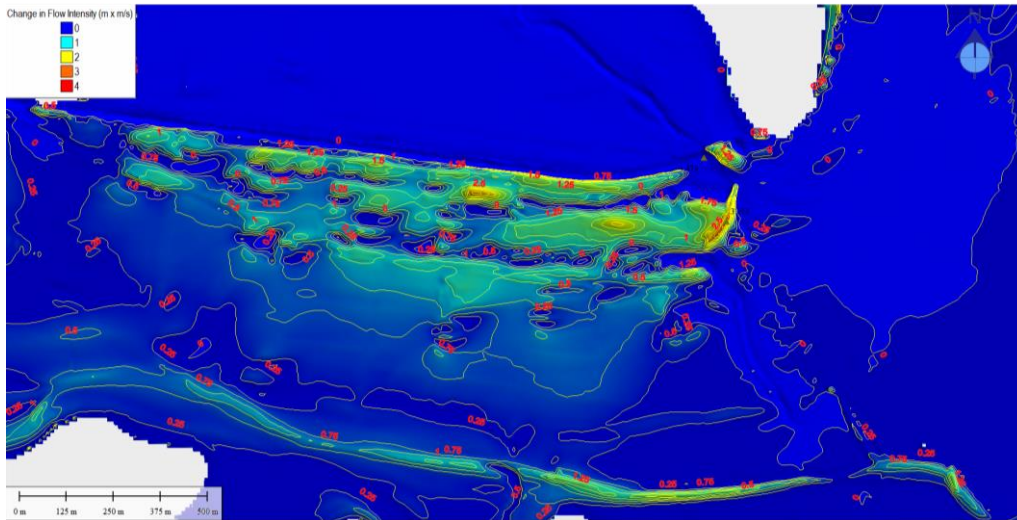
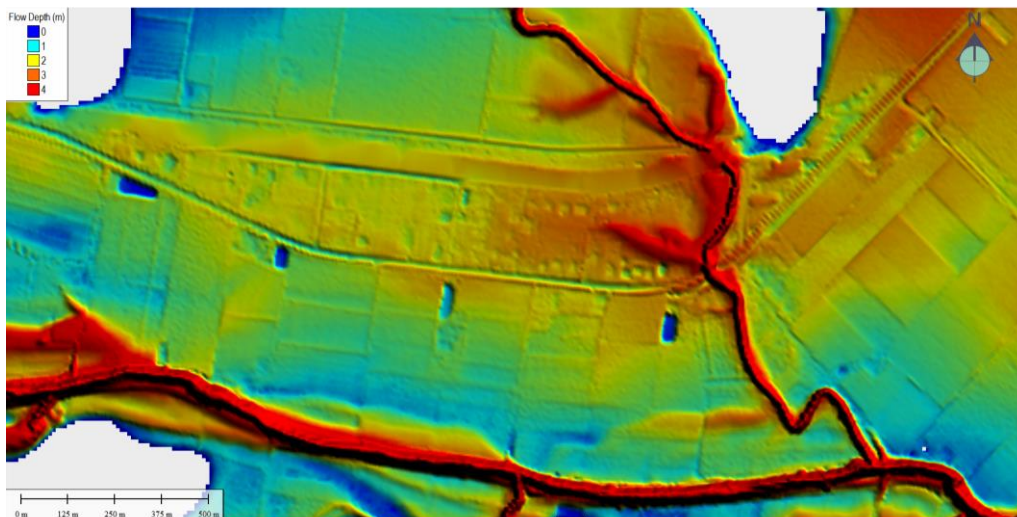
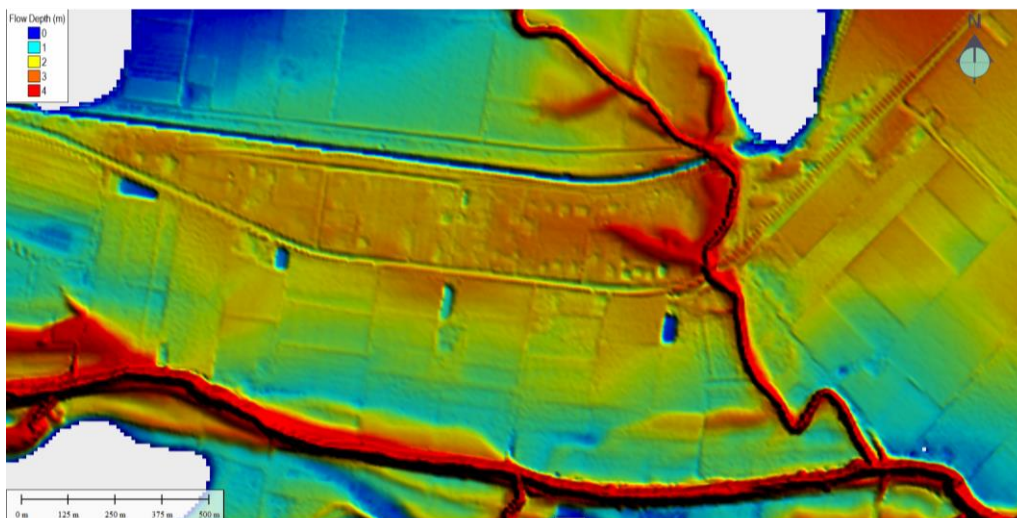
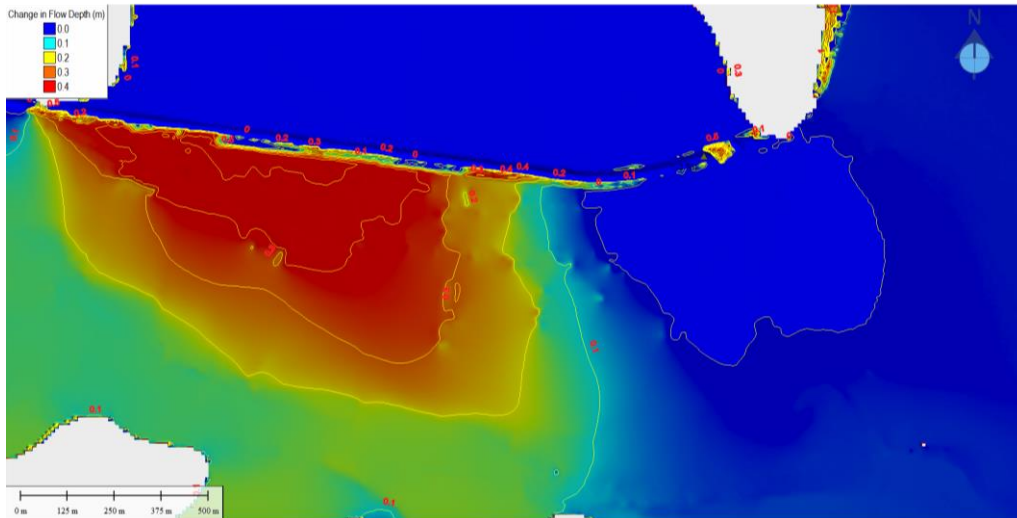
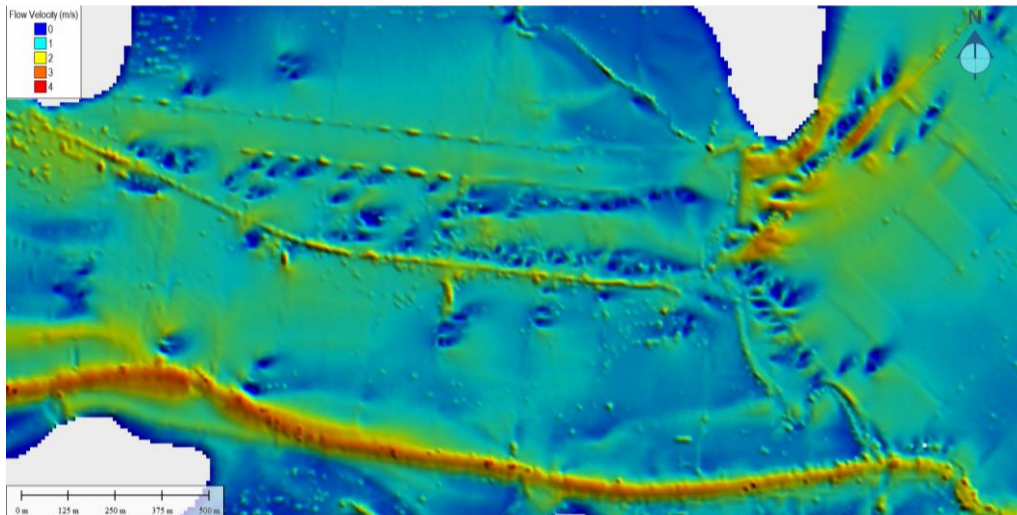
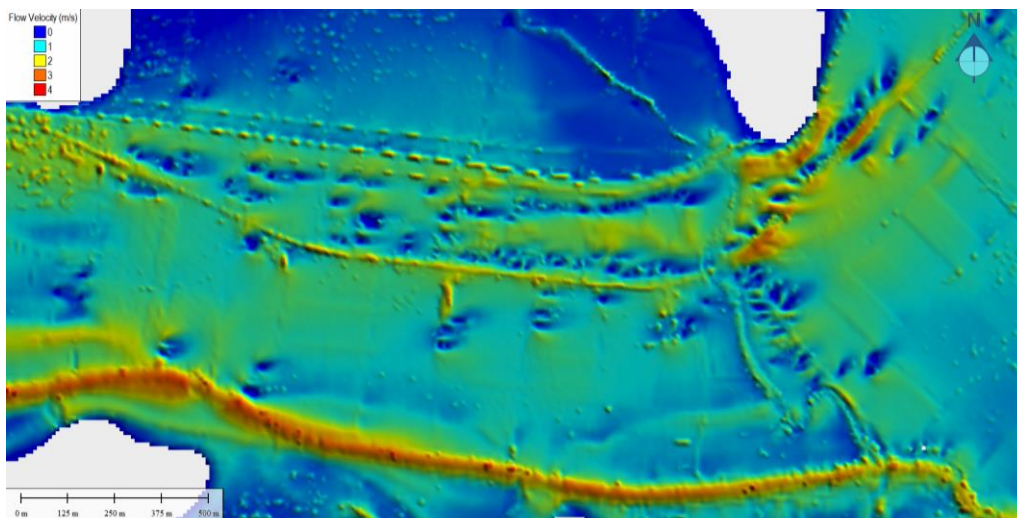
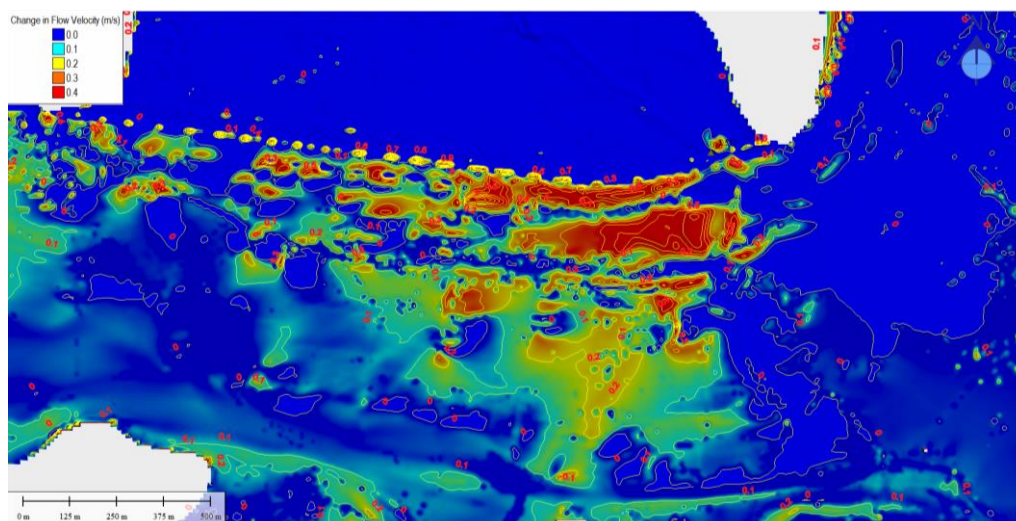
35. Based on my comparison between the Extended Railway Scenario and the Most Likely scenario, as shown in the above Figures 4.2 to 4.10, I consider that the effect of the Extended Railway Embankment is the same as the No Railway Embankment scenario as described in paragraph 409 of my main report.
36. I have listed the average of the plotted flow parameters through Western Grantham and Central Grantham to the West of Sandy Creek in Table 4.1. For ease of reference I have also included parameters for the No Railway Embankment case presented in my main report.

37. I have considered the outcomes listed in Table 4.1 and conclude that the presence of the entire railway embankment has resulted in increased maximum flood depths, velocities and flow intensity within Western Grantham and Central Grantham. I have also concluded that the Extended Railway Embankment case produces an additional increase of 0.1m<sup>2</sup>/s in average intensity and 0.1m/s in average velocity, but no significant increase in average depth, compared to the No Railway scenario.
38. I further consider that the underlying flood hazard (as depicted by the average intensity parameter) remains relatively high under both no embankment cases considered.

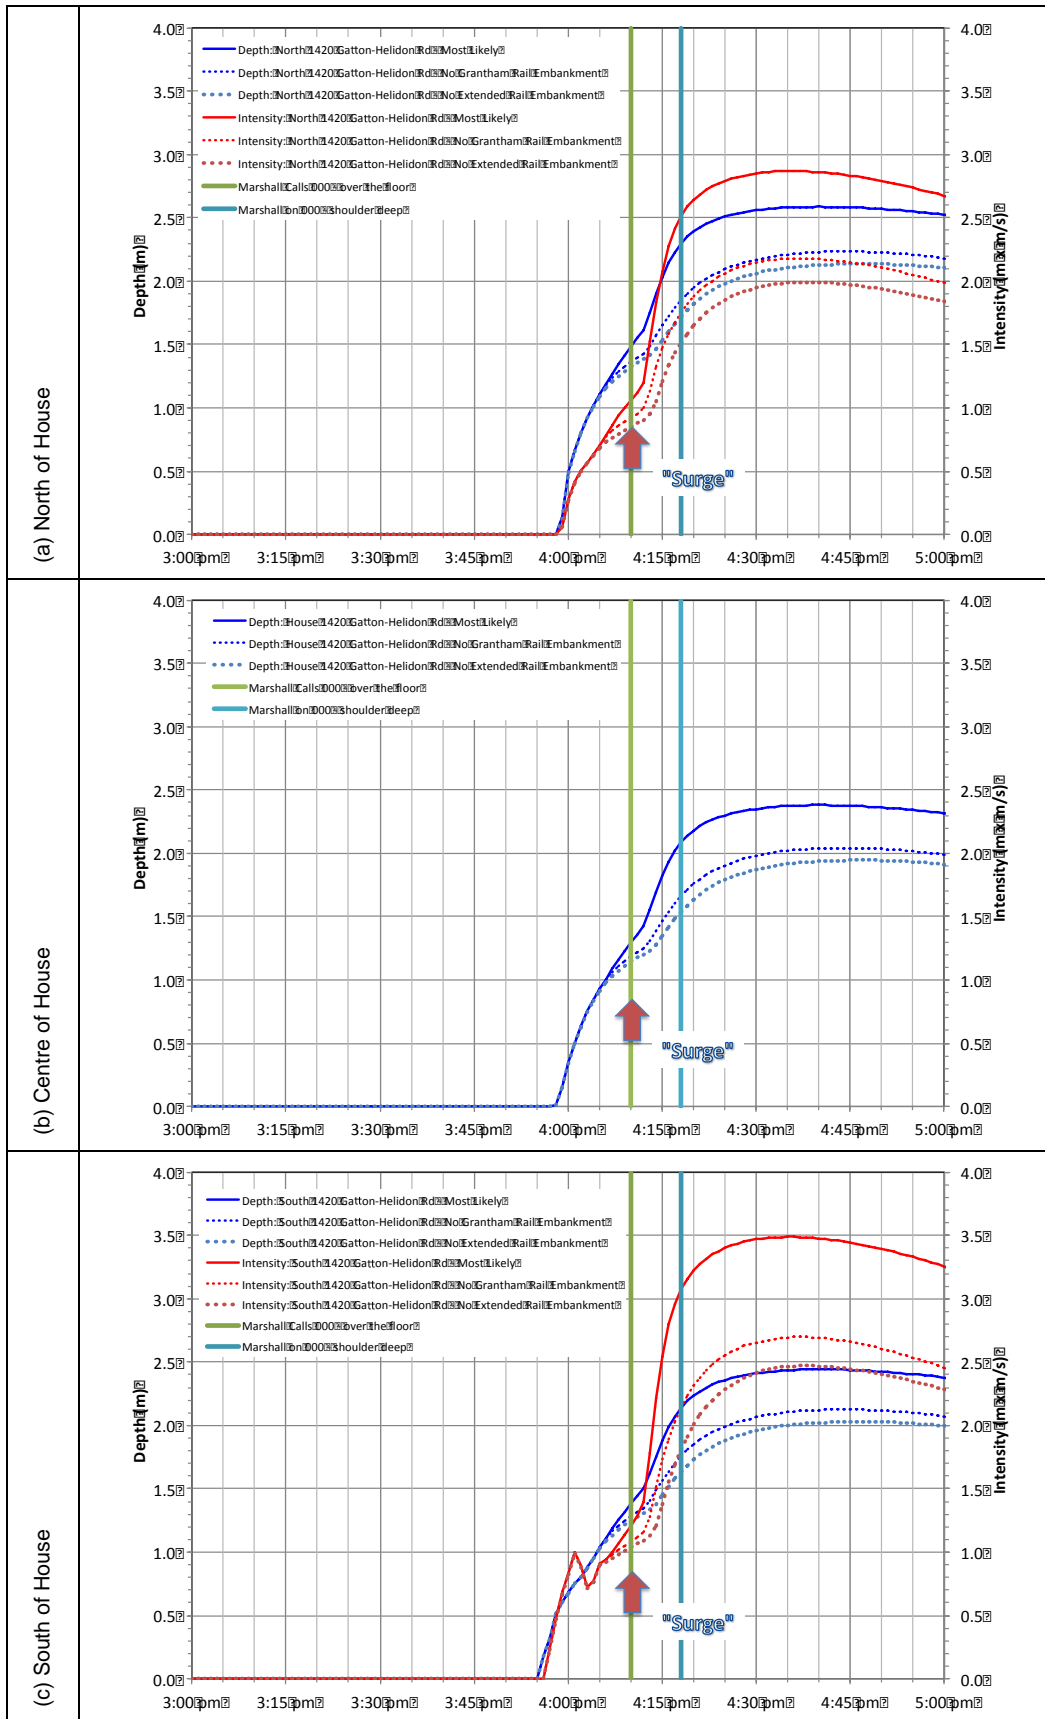
**Figure 4.11 – Flow Depth and Intensity at the Location of 1420 Gatton-Helidon Road**

41. I have observed from the information plotted in Figure 4.11 that the Extended Railway Embankment case produces a small lowering in flow depth and intensity compared to the No Railway Embankment case. This is consistent with the simulation outcomes presented in Figures 4.4 and 4.7 above.

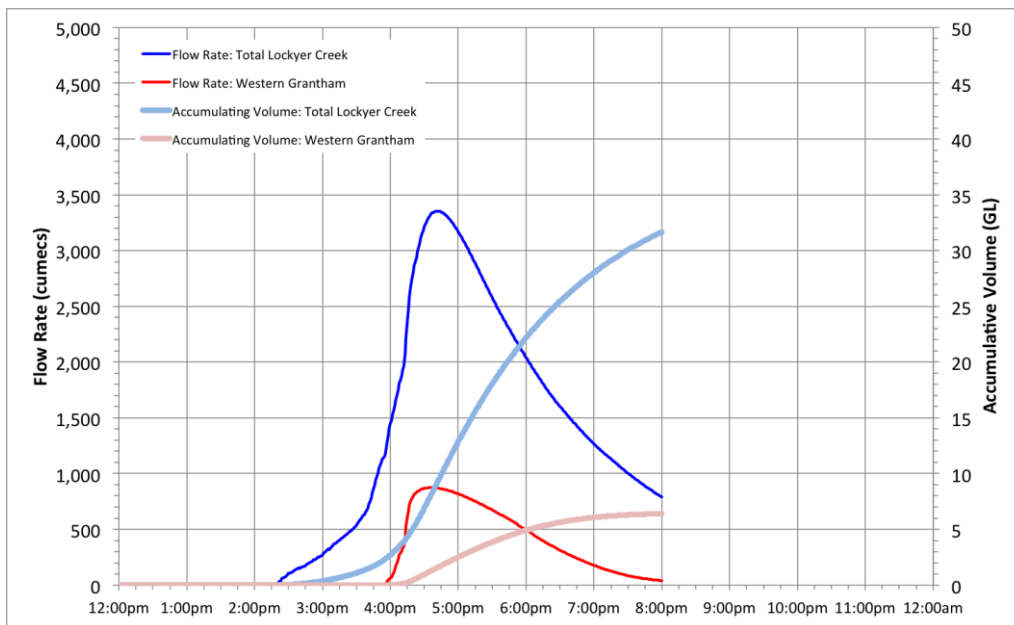
Figure 5.5 – 2011 Lockyer Creek and Overbank Flow Hydrograph and Volume at Near Grantham

47. I observe from Figure 5.5 that the data for the 2011 event is truncated at 8:00pm. This is because the GFCOI model that I used to produce this flow estimate was set to stop the simulation at this time.

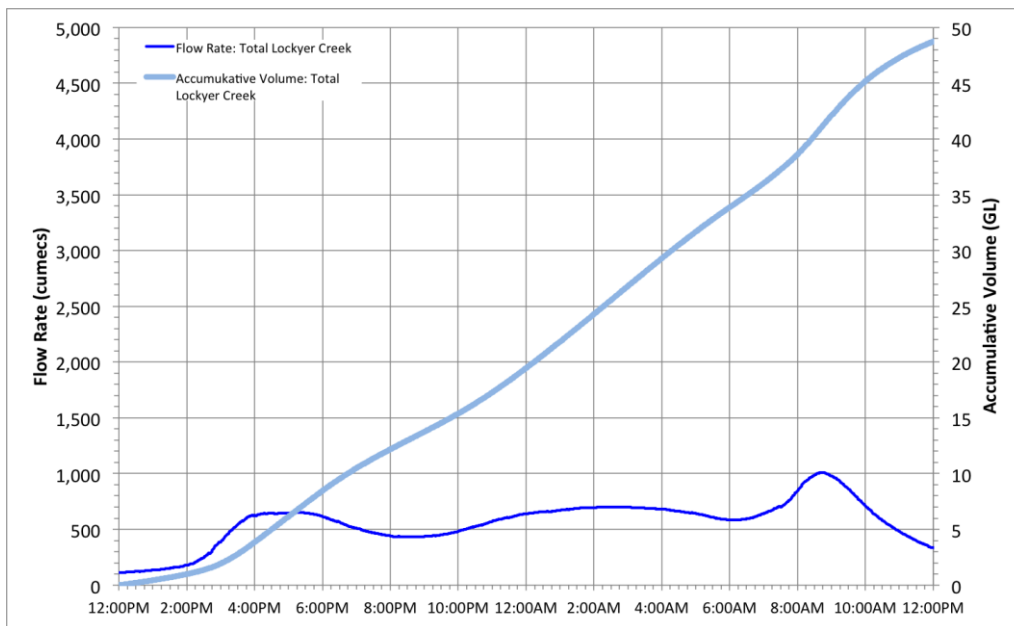
**Figure 5.6 – 1996 Lockyer Creek Hydrograph and Volume at Near Grantham**

49. I observe in Figure 5.6 that the rate of increase in accumulating flow volume for the 1996 flood event appears relatively linear at approximately 50GL over a period of 24 hours, or about 2GL/hr. Therefore, over a 6 hour period 12GL would typically have flown past Grantham under these conditions. I consider that this outcome satisfactorily addresses Item (ii).

46. Furthermore, although some of the 1996 flood hydrograph shown in Figure 5.6 entered Grantham, I consider that the proportion was relatively small. I consider that the 1996 flood event is a reasonable representation of flow for the purposes of item (ii) above.

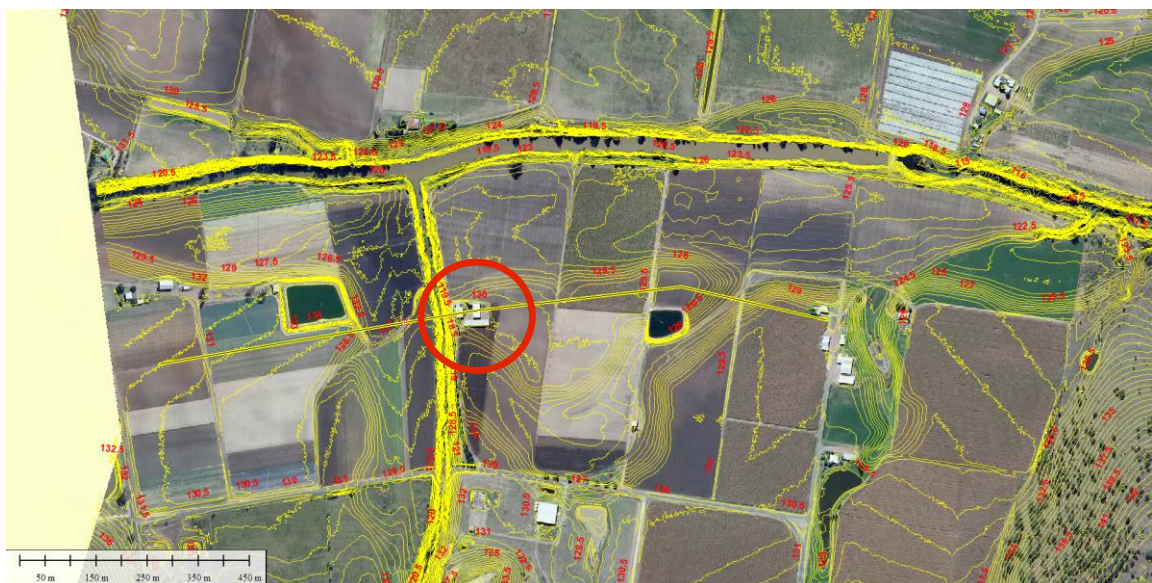
Figure 6.1 – House on the Property of [REDACTED]

59. I have prepared a contour plan that has a house on this property circled in red, Figure 6.1. A yellow line is also marked horizontally which crosses through the circle depicting the line of a cross-section that is shown plotted in Figure 6.2.

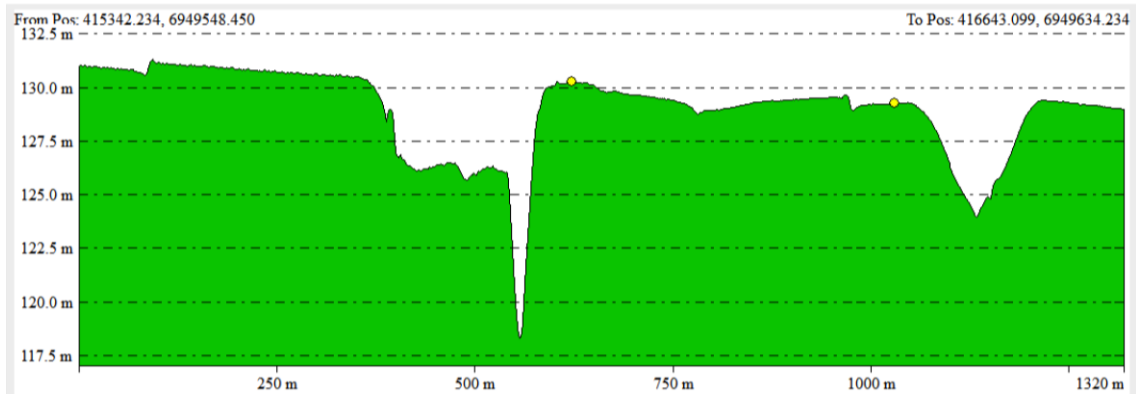
Figure 6.2 – Cross-section through House on the Property of [REDACTED]

60. I observe that the house sits on a ridge line running east-west between two drainage paths and about 2m higher than the edges of the fields immediately to the north and south. The ground level at the location of the house is shown at around 130.0mAHD.
61. Simulation outcomes from the GFCOI model for the 10<sup>th</sup> January 2011 flood produce a maximum flood level at the location of the house of about 130.4mAHD, or 0.4m above ground level.
62. I have extracted aerial images of the area around [REDACTED] from the August 2010 and January 2011 aerial survey data provide to me by LVRC. These are shown on Figures 6.3 and 6.4 respectively.

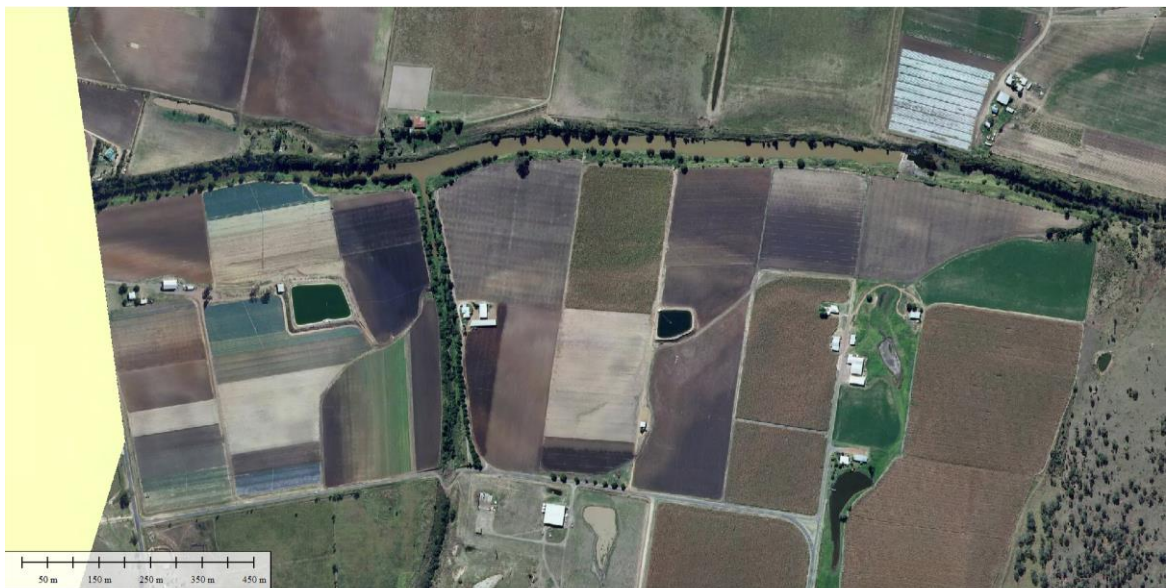
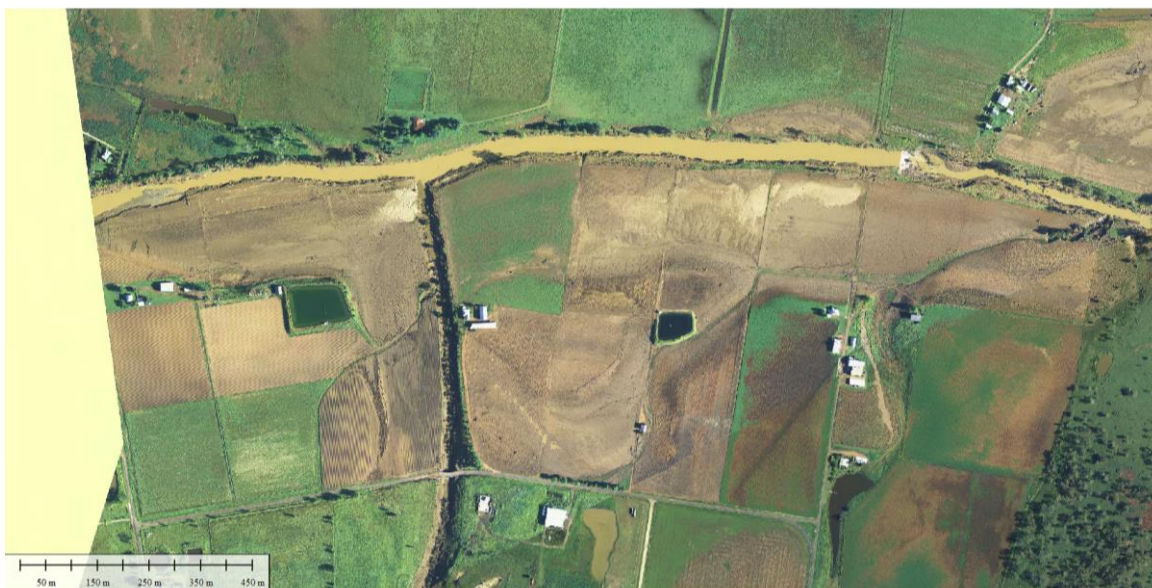
Figure 6.3 – Aerial Image of [REDACTED], Pre Flood August 2010

**Figure 6.4 – Aerial Image of [REDACTED], Post Flood January 2011**

63. On the basis of my comparison of these two images I observe that portions of 67 Carpendale Road were inundated by the flood as indicated by flood flow marks and sediment deposits covering previously ploughed fields.
64. I am unable to discern from the aerial image if floodwaters (simulated to be around 0.4m deep, as I have noted above) covered the area of land on which the house is located.
65. Further, I refer to peak flood height data provided to me by LVRC as I have discussed in Section 12.4 of my main report. In Figure 12.8b of that report I have presented a comparison between simulated peak flood heights for the 10<sup>th</sup> January 2011 flood and those peak heights provided to me by LVRC. I observe from this figure that the simulated level at [REDACTED] is 0.9m higher than the peak height provided to me by LVRC.

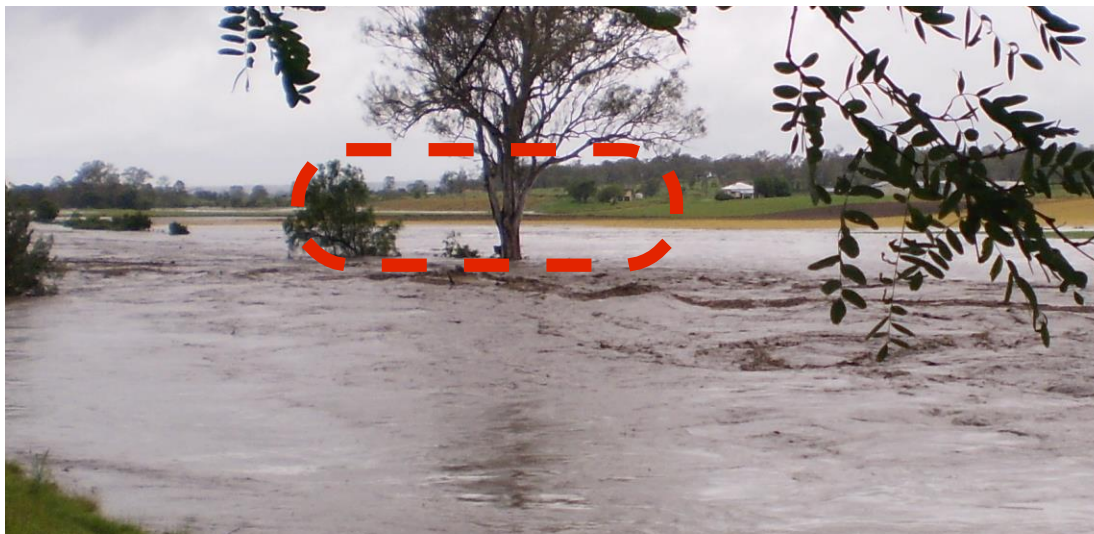
Figure 6.6 – Photograph P2060259 by Mr Castle (cropped enlargement)

68. I have reproduced a cropped enlargement from photograph P2060259 shown on Figure 6.6 (below). I note Mr McIntosh's residence in centre-field background that I have identified with a red dashed line oval shape.

69. I observe from Figure 6.6 that floodwater had broken the northern bank of Lockyer Creek at Mr Castle's location, and is just on the brink of a full breakout adjacent to Mr McIntosh. I have indicated (with the overlaid red dotted oval shape) the paddock area on Figure 6.6 that separates Mr McIntosh's residence from Lockyer Creek. I also observe within this paddock an area of backwater within a depressed local drainage path that lies between Mr McIntosh's residence and the creek.
70. I also observe a photograph labelled IMG\_0229.jpg contained in material provided by Mr McIntosh taken at 3:15pm on 10<sup>th</sup> January 2011 that contains the same vista shown in Mr Castle's image (Figure 6.6), but from the location of Mr McIntosh. I have reproduced a cropped enlargement from Mr McIntosh's photograph shown on Figure 6.7.

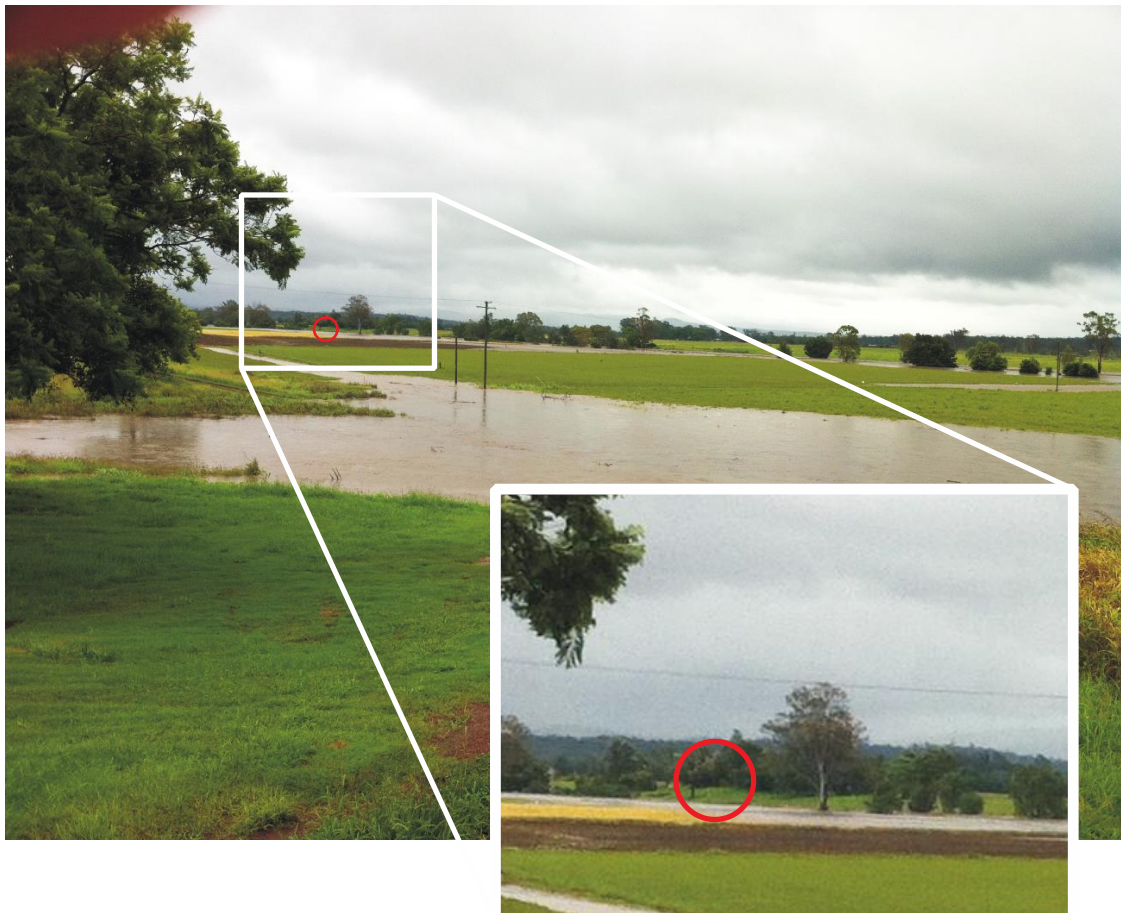
**Figure 6.7 – Photograph IMG\_0229 by Mr McIntosh (cropped enlargement)**

72. I observe from Figure 6.7 that flooding conditions at the location adjacent to Mr McIntosh's residence appears similar to those shown in Figure 6.6. That is, Lockyer Creek is just starting to break its banks, and the existence of backwater inundation of a drainage path in the middle-ground of the figure.

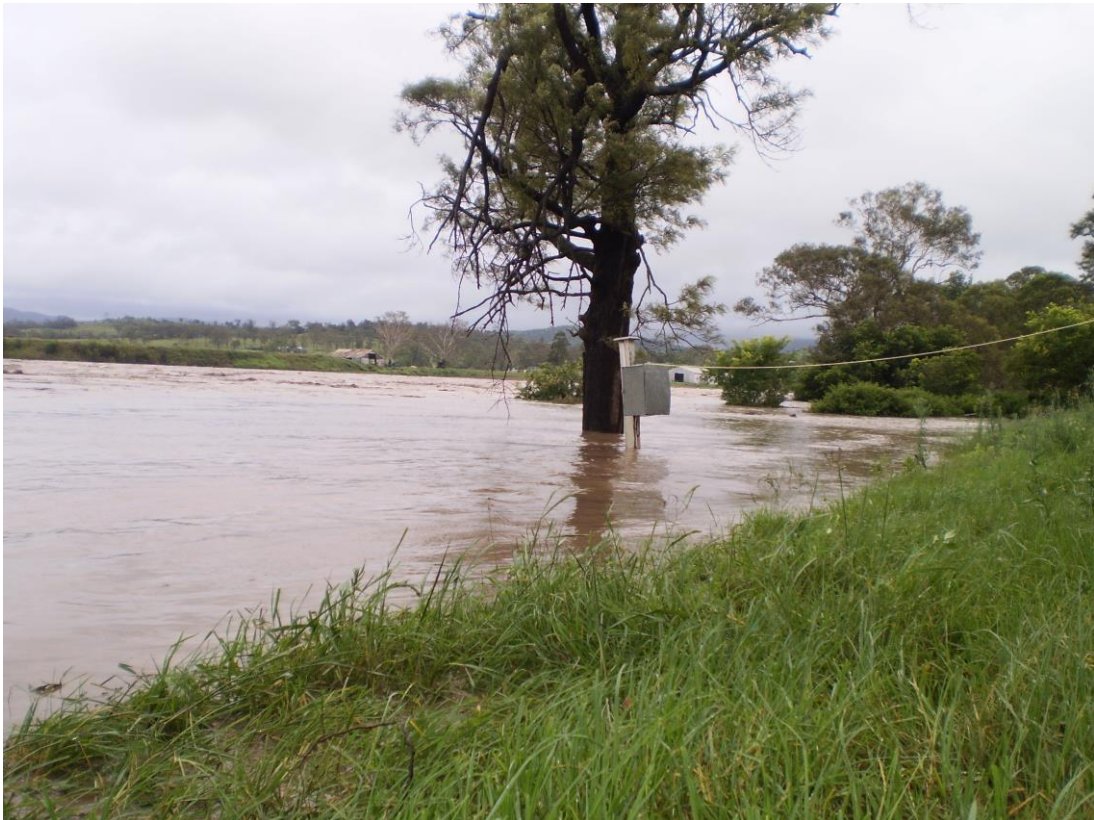
**Figure 6.8 – View South-West Over Lockyer Creek from the Southern Side of Mr Castle's Residence (Photograph P2060273)**

76. I have reproduced a copy of Mr Castle's photograph P2060273 that I observe was taken at a time close to the peak of the flood. This photograph is Figure 6.8 below.

77. From the location of objects shown on Figure 6.8 it is my view that this image was taken at a location approximately 20m directly south of Mr Castle's residence. I observe that the extent of flood inundation shown in this image is well within a distance of 120m from Mr Castle's residence.
78. In consideration of the above, it is my view that although Mr Castle did not indicate any particular direction when he referred to the closest proximity of flood inundation to his residence, he clearly could not have meant it to apply to the south of his residence.
79. I have produced an aerial image, Figure 6.9, showing the region surrounding Mr Castle's residence and plotted on contours of peak flood depth from the Most Likely scenario simulation outcomes. I have further drawn a white circle with a radius of 120m from Mr Castle's residence.
