**GRANTHAM FLOODS COMMISSION OF INQUIRY**

**EXPERT HYDROLOGY REPORT  
10 JANUARY 2011 FLOOD**

**CIRCUMSTANCES AND CONTRIBUTING  
FACTORS**

**SUPPLEMENTARY MATERIAL No. 2**

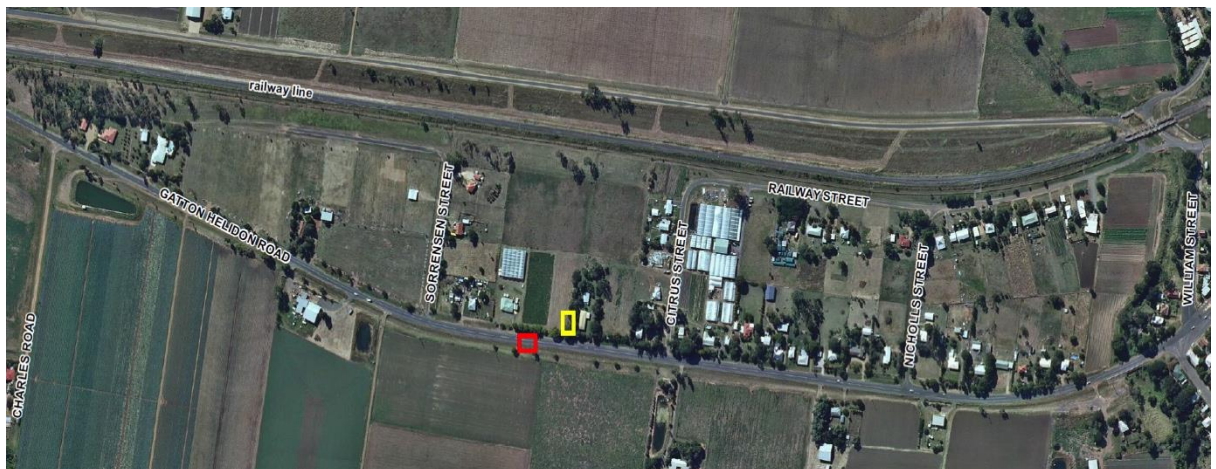
**Figure 10.1 – Arndt's Vehicle Location**

109. I have identified the location of the tree that I understand Mr and Mrs Arndt refer to as indicated by a yellow rectangle in an aerial photograph contained in Mrs Arndt's statement dated 1<sup>st</sup> July 2015. I have reproduced a copy of this image in Figure 10.1.

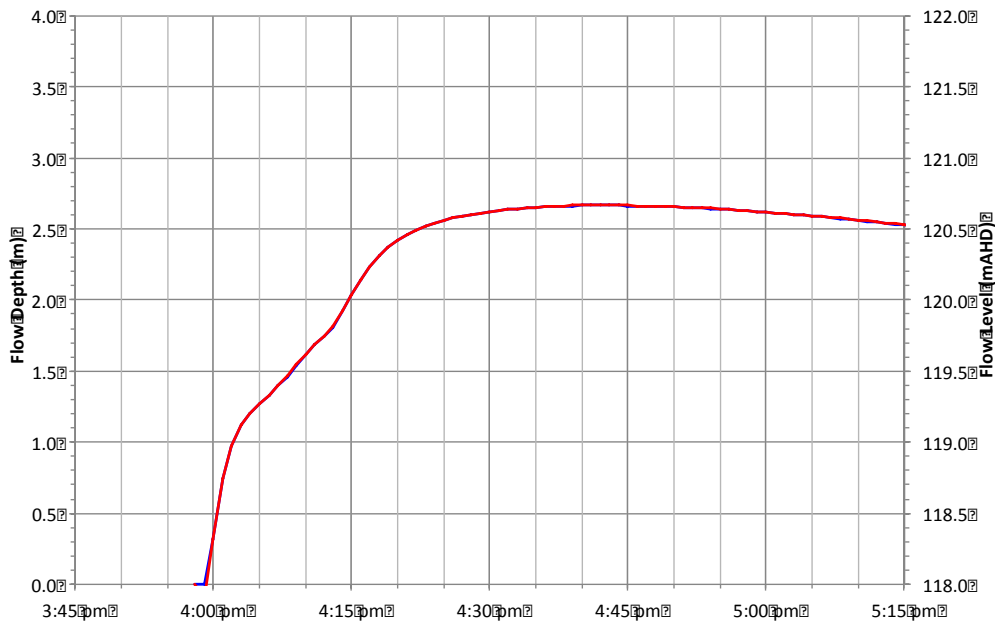
**Figure 10.1 – Simulated Flood Depth and Level Hydrograph at the Arndt Tree**

110. I have produced a flood depth hydrograph from simulation output from the GFCOI model for the Most Likely case and show this in Figure 10.2.

111. I observe from Figure 10.1 that the ground level at the tree is close to 118.0m AHD.
112. This level is approximately 0.5m lower than the level of the adjacent Gatton-Helidon Road that is close to 118.5m AHD, from the August 2010 LIDAR aerial survey.
