12 Testing Model Performance

12.1 Overview

13 Corroboration by Eye-witness Accounts

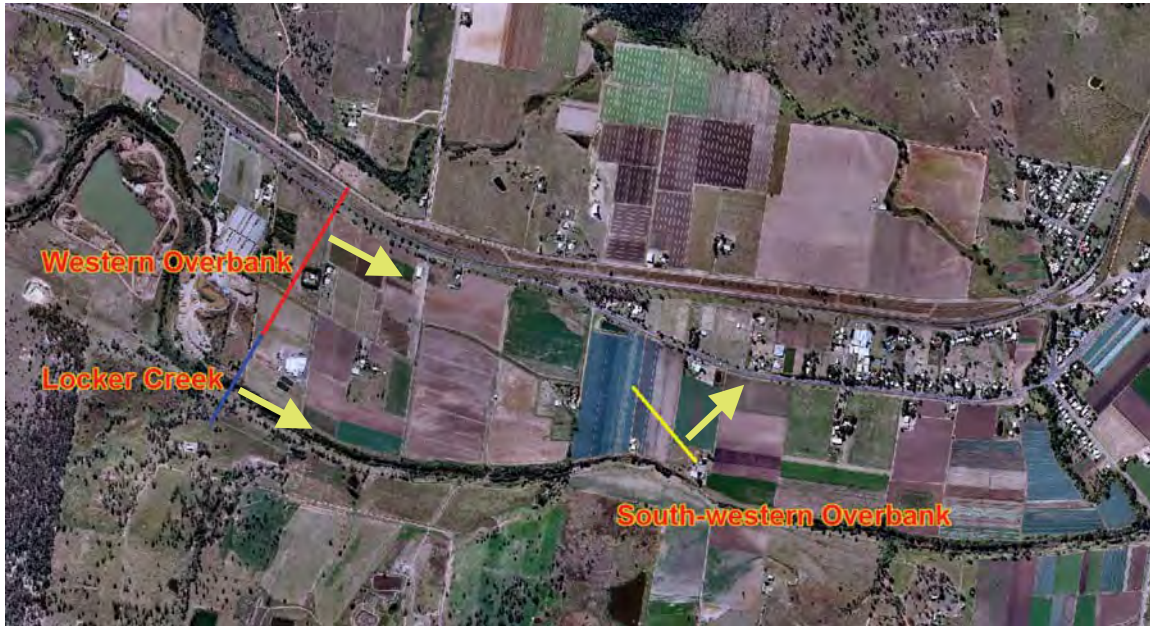
Figure 12.1 – Downstream Reporting Locations

- Lockyer Creek – flows past this location affect all flooding that emanates from the downstream Lockyer Creek, including the South-Western Overbank flow and Sandy Creek back flows;

- Western Overbank – flows past this location lead directly to Grantham from the west;
 - South-Western Overbank – flows past this location represent the initial breakout front that first reach West Grantham from the south-west.

395. I have undertaken a number of tests and quantified summaries of their outcomes using the following information:
- flow hydrographs at the downstream locations marked in Figure 12.1;

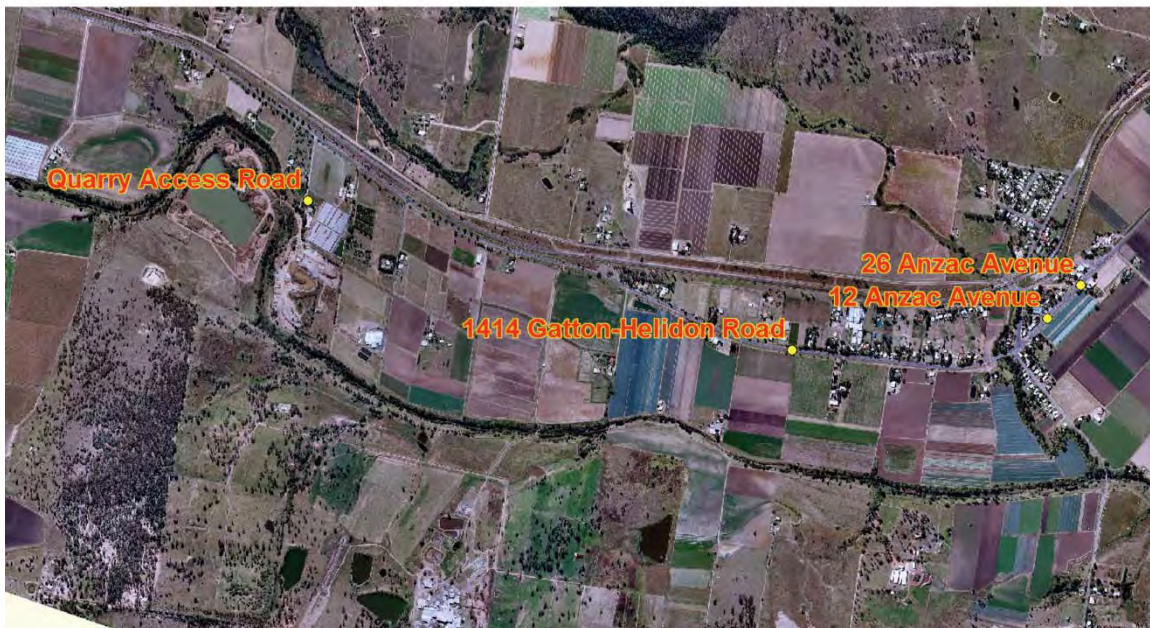
Figure 12.2 – Flow Depth and Intensity Locations

- depth and flow intensity hydrographs at the locations marked in Figure 12.2; and
 - metrics tabulations at selected locations in and around Grantham and the Quarry, Figure 12.3.

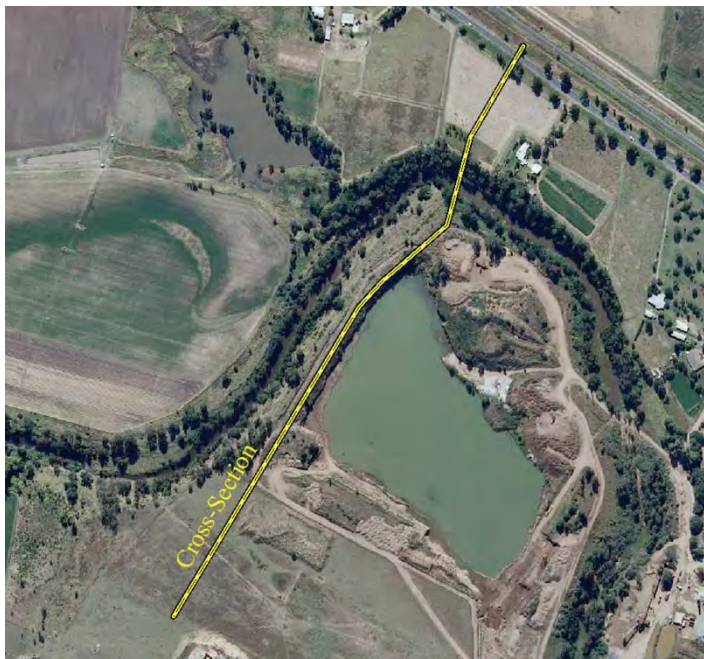
Figure 12.9 – Locality of Western Levee Waterway Cross-section

423. I have constructed a cross-section through the Lockyer Creek waterway at the location of the Western Levee of the quarry. The cross-section starts at the Gatton-Helidon Road and runs south for approximately 900m as indicated in Figure 12.9. The cross-section is also plotted in Figure 12.10.

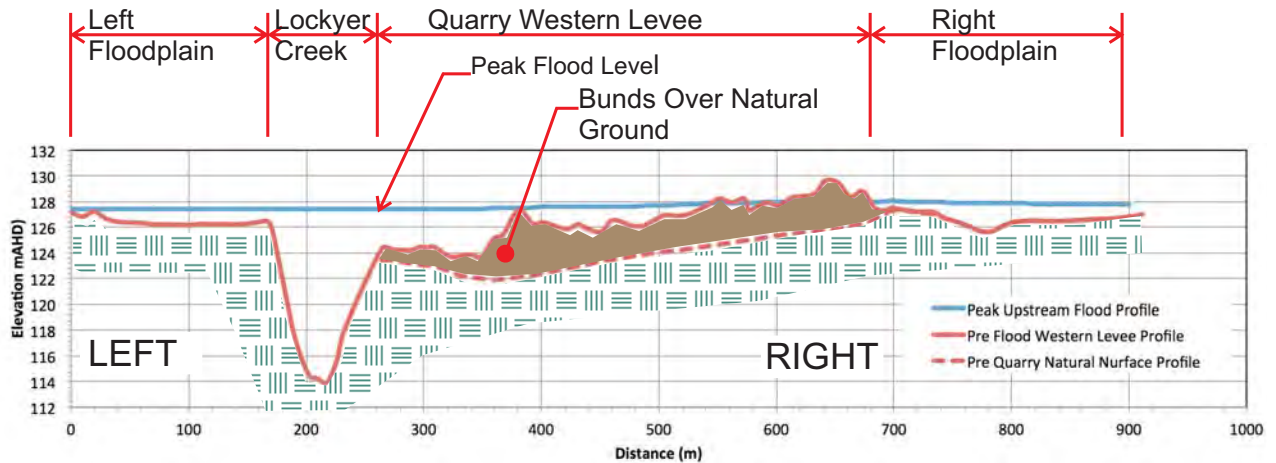
Figure 12.10 – Western Levee Waterway Cross-section

424. The cross-section is orientated looking down-stream from upstream of the Western Levee. The cross-section shows the high-level left overbank area, the creek (on the northern side of the quarry), the Western Levee, and the right overland flow path (to the south of the quarry).

427. I have calculated the area of fill material shown in Figure 12.10 (brown infill) as well as the area of the cross-section that lies between the blue water surface line, and the line beneath it which represents the ground level for pre-quarry conditions (i.e. the line under the brown infill section). This second area calculation is representative of the flow area under pre-quarry conditions. I have listed this information in Table 12.4 including my calculated flow area for Pre-flood (August 2010) conditions (equal to the pre-quarry flow area minus the area of bund fill).

429. Assuming the levee remains intact, then from Table 12.4 it can be inferred that the presence of the Bunds would reduce the flow area by approximately 40%. That is, it would reduce the flow area to only approximately 60% of what it would have been under pre-quarry conditions. Hence I expect that water levels upstream of this constriction would rise in order to compensate.

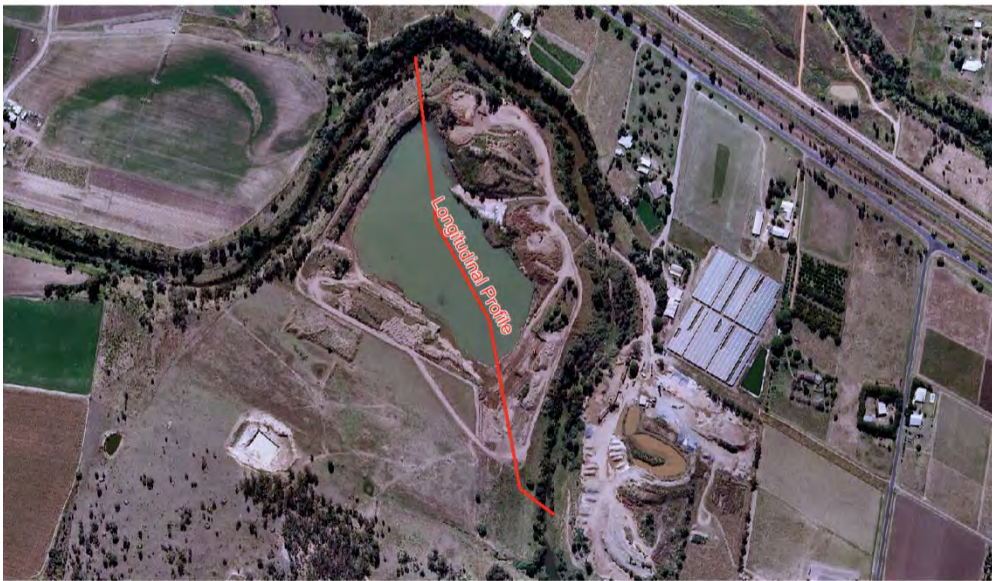
Figure 12.13 – Quarry Cross-section Locations

- 446. The hydraulics of overtopping of the Western Levee and subsequent rapid erosion of the Main Breach is one involving rapid changes over relatively short distances and time frames. With this in mind the possibility that model grid resolution might affect model performance was considered. I have tested it by reconfiguring the GFCOI model to have a 5m grid resolution.
- 447. Both the 5m grid model and the base GFCOI model (10m grid) were then used to simulate the breaching and subsequent filling of the Quarry and a comparison was made between the outcomes.
- 448. Figure 12.13 presents a plan view of the Quarry showing the location of a longitudinal profile through the middle of the pit.

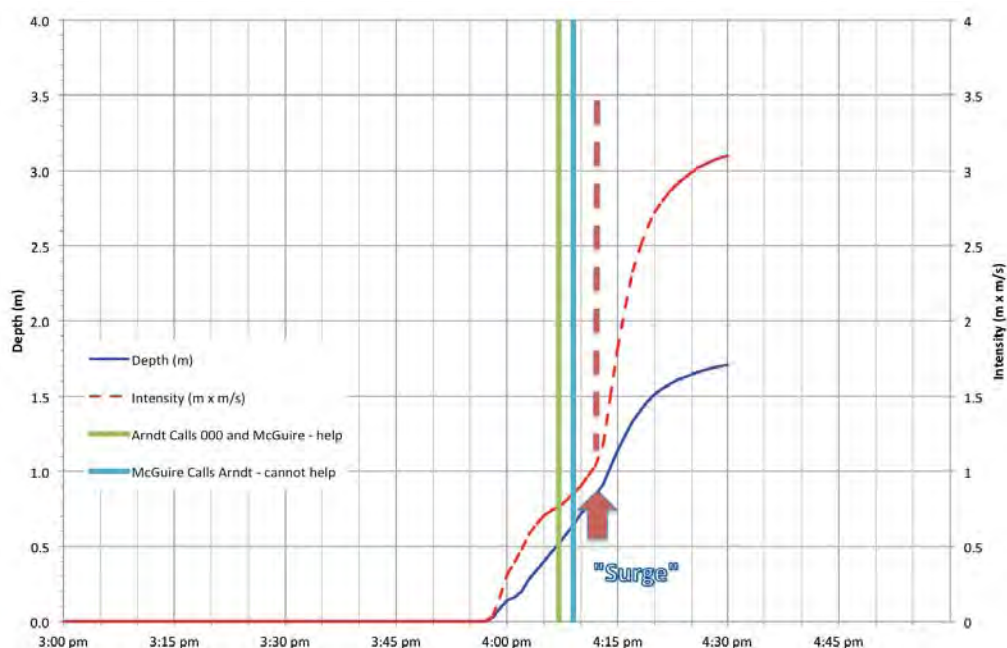
Figure 13.5 – Simulated Flow Characteristics at Mr and Mrs Arndt Location B

456. As shown by the simulation graphics, the information given by Mrs Arndt corroborates the model simulation. In particular it shows the following:
- a) 4:00pm – floodwater is approaching Grantham from Lockyer Creek to the south, as described by Mrs Arndt at location A.
 - b) 4:07pm – Mrs Arndt is at location B in her car with her husband and calls both 000 and Mr McGuire (at close to location C) for help.
 - c) 4:09pm – Mrs Arndt’s car is losing traction on the road due to the flood flows and receives a call from Mr McGuire apologising that he cannot help. Mrs Arndt observes that Mr McGuire’s fire truck (near to location C) is being forced backwards by the flow of water.
457. I also extracted simulation outcomes at Location B (on the Gatton-Helidon Road) to produce a plot of simulated flow depth and intensity (the product of flow depth and velocity), Figure 13.5.

- 458. Flow intensity, is often used to establish the likely stability of an object in the path of flood flows, in this case, the likely stability of the Arndts' vehicle. Typically, flow intensities greater than 0.5m²/s are capable of creating conditions that are unsafe for a vehicle.
- 459. I consider that the information shown in Figure 13.5 is consistent with the rise and timing of floodwaters as described by Mrs Arndt, including the occurrence of what I consider to be a surge in flow at 4:12pm.

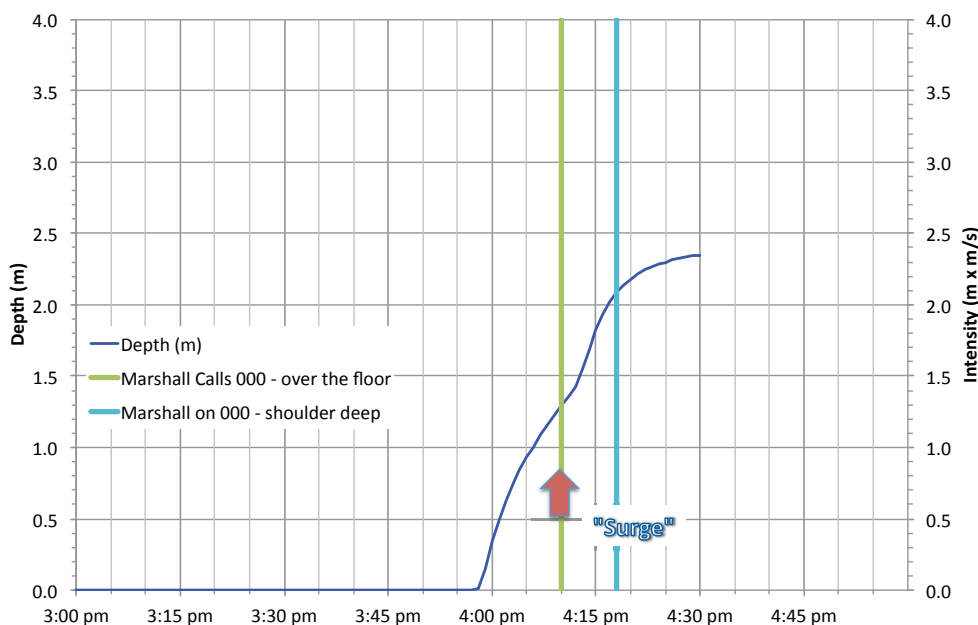
Figure 13.7 – Simulated Flow Characteristics at Mr Marshall’s House (Location D)

- 461. I have extracted simulation outcomes at Location D to produce a plot of simulated flow depth, Figure 13.7.

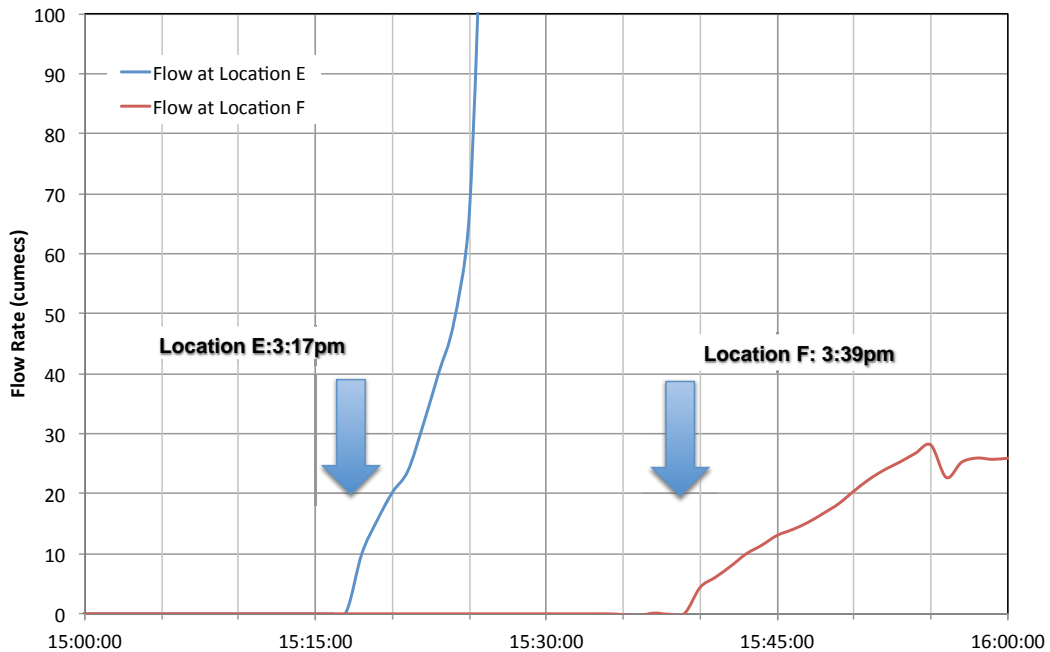
Figure 13.11 – Simulated Flow History at Locations E and F

the flow rate into the pit at Location E exceeds 100 m³/s. This situation is also consistent with the simulated time of the initiation of the Main Breach at 3:25pm – that is, as at 3:17pm the breach had not initiated (although water was already overflowing the Western Levee into the pit) and by 3:35pm the inflows from the breach were well established. The simulated inflow occurrence at Location E is corroborated by Mr Mallon’s observations whether made at 3:19pm or 3:35pm.

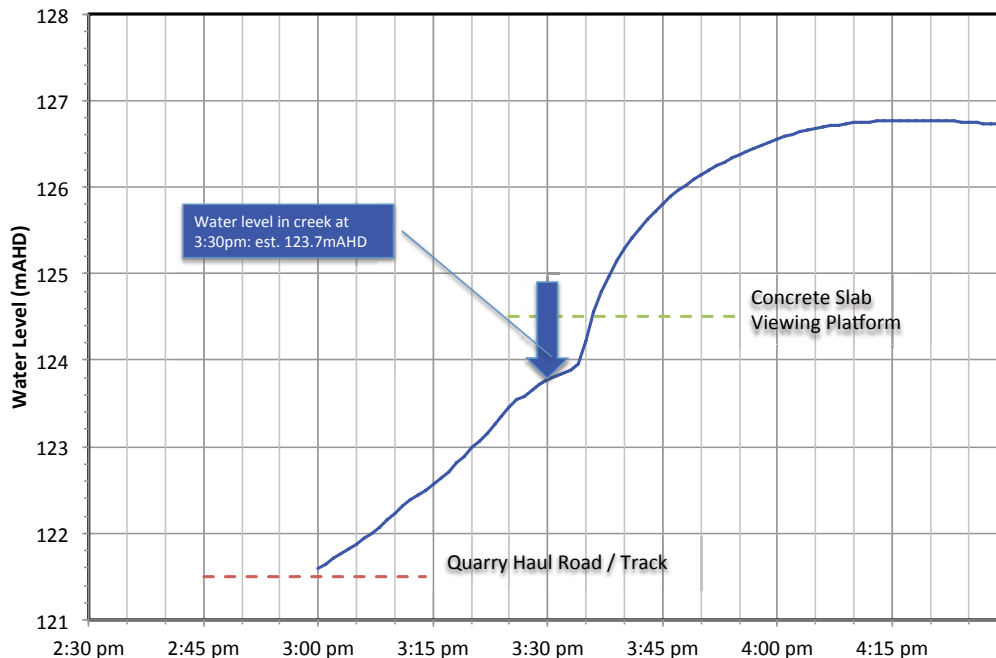
Figure 13.15 – Simulated Stage Hydrograph in Lockyer Creek Adjacent Location H

475. I have plotted in Figure 13.1 what I understand is the location of the concrete slab from which Mrs Besley viewed the flood flows within Lockyer Creek before it broke its banks, near Location H. I have extracted a stage hydrograph from the GFCOI model from the centreline of Lockyer Creek immediately adjacent to this viewing platform as indicated in Figure 13.15.

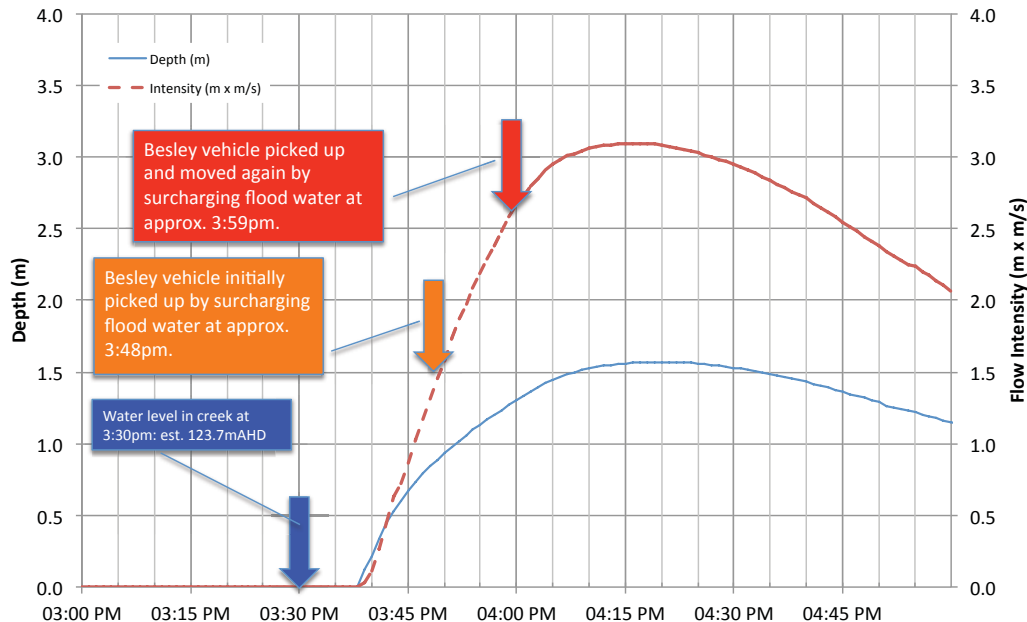
Figure 13.19 – Simulated Flow Characteristics at Mrs Besley's Location I

483. In Figure 13.19, I have plotted additional data that I have extracted from simulation modelling which shows flow depth and flow intensity (the product of flow depth and velocity) at close to Location I. As I have noted previously, in my opinion, flow intensities greater than $0.5 \text{ m}^2/\text{s}$ are typically capable of creating conditions that are unsafe for a vehicle. I observe in Figure 13.19 that flow intensities at around the location of the Besleys' vehicle are simulated to rapidly increase to a value of greater than $2 \text{ m}^2/\text{s}$ over a period of less than 30 minutes. In my opinion, the water depths indicated in Figure 13.19 are also consistent with Mrs Besleys' account of her situation that has her vehicle grounded sufficiently at 3:48pm to give opportunity for her and Mr Besley to escape the vehicle through the windows and to perch on their window sills. The subsequent

increase in flow depth and intensity I observe in Figure 13.19, in my opinion, is consistent with the 000 transcript that indicates the time of the Besleys being washed from the vehicle.

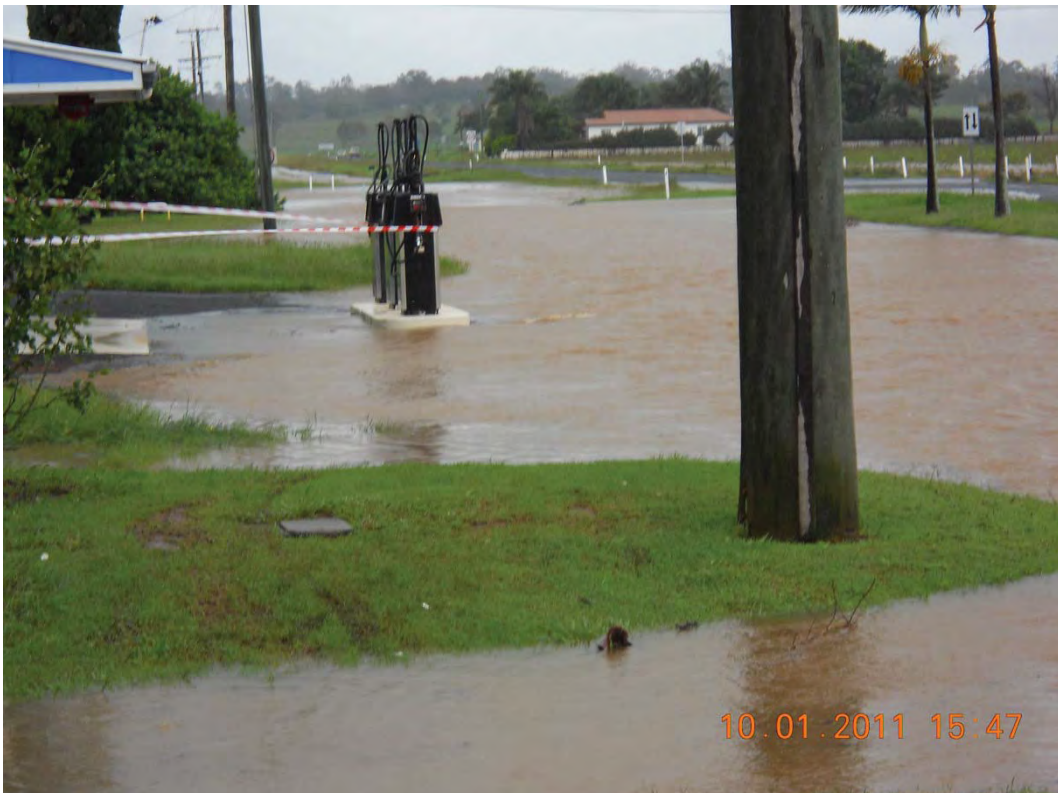
**Figure 13.21 – Mr Lack’s Photograph showing water around base of the fuel bowser slab
(Picture 002.jpg)**

485. Mr Lack’s photographs between 3:47pm and 4:09pm are reproduced in Figures 13.21 to 13.23, below.

- The water shown in Picture 002 taken at 3:47pm is at a level close to ground level at this location (115.1mAHD). In my view, this is the reason why there is no simulated water showing at this point in time, because the model cannot differentiate between ground level and water level at the onset of inundation when the water is at the depth indicated;
- There is a small variation between the water level shown in Picture 010 taken at 4:05pm with that simulated, with simulated being about 0.1m lower than that shown in Picture 010; and
- There appears to be a match between the water level shown in Picture 020 taken at 4:09pm with that simulated.

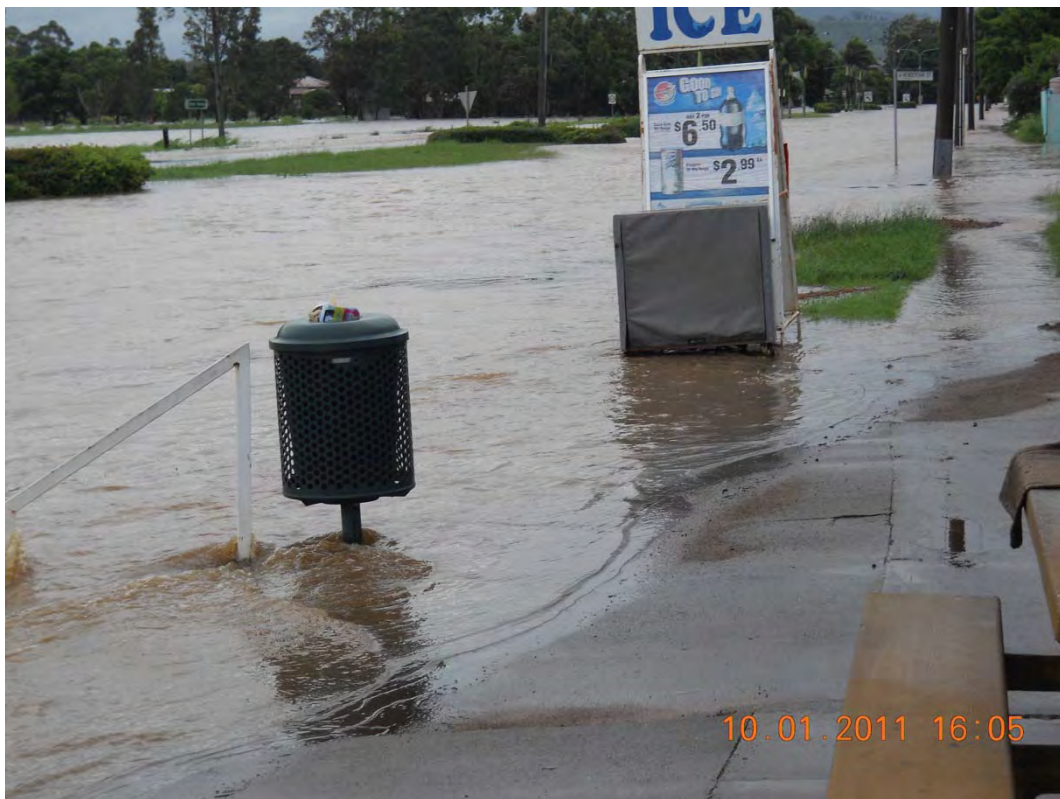
Figure 13.22 – Mr Lack’s Photograph showing water around base of bin (Picture 010.jpg)

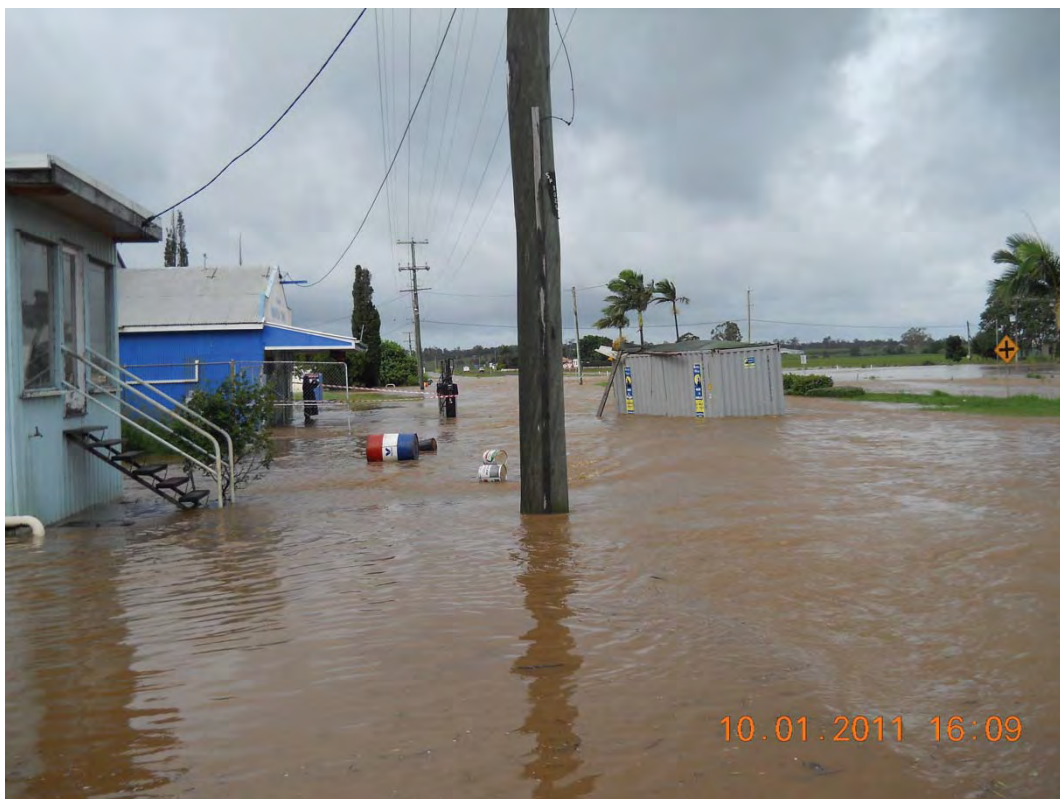
Figure 13.23 – Mr Lack’s Photograph showing water over base of the fuel bowser slab (Picture 020.jpg)

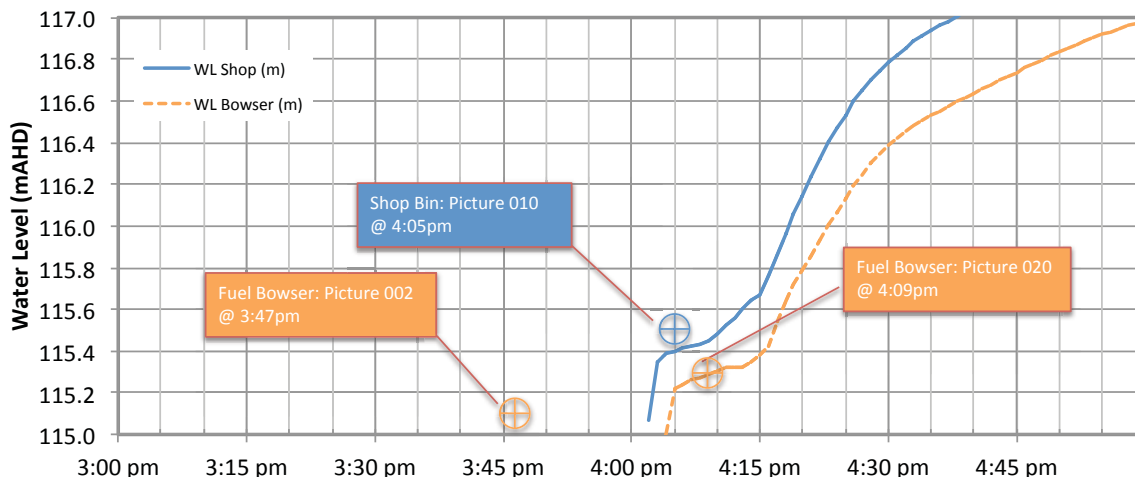
Figure 13.24 – Simulated Flow Characteristics Location J

486. I have extracted simulated levels at Location J and at 28 Anzac Avenue (Marnell Fuels, approximately 50 east along Anzac Avenue from Location J), from the GFCOI model and plotted them in Figure 13.24.

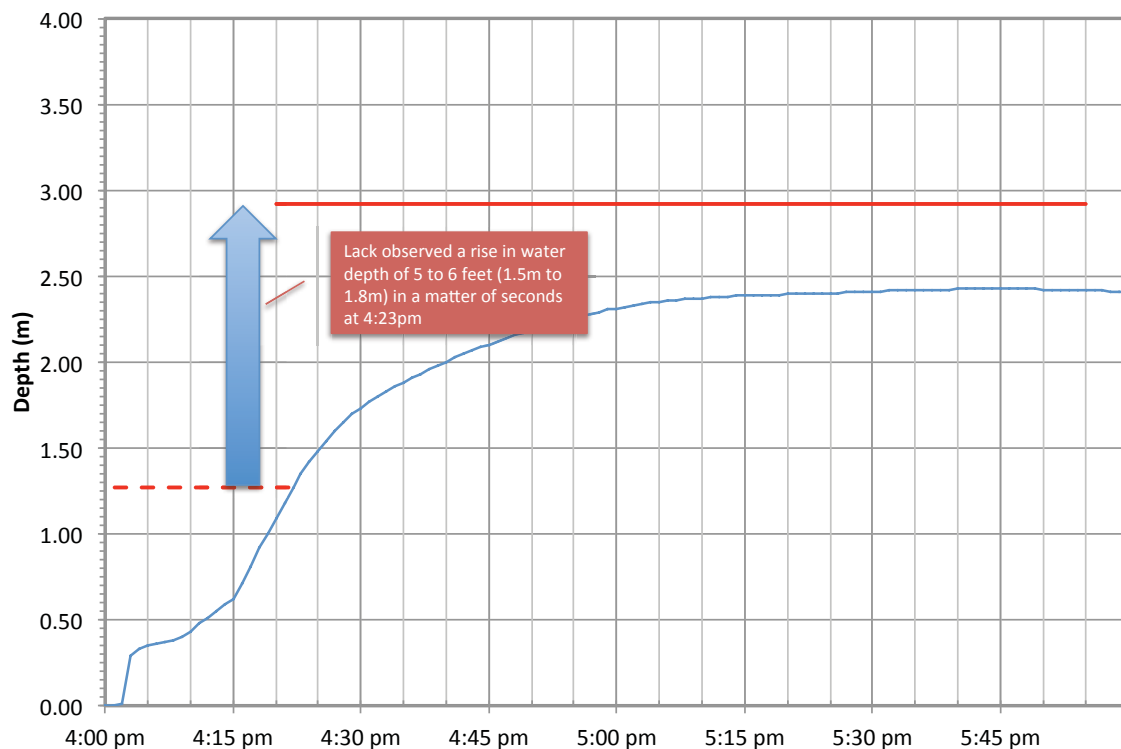
Figure 13.25 – Simulated Water Depth at Location K

488. I have plotted simulated water depths at the Lack’s location (Location K) in Figure 13.25. Mr Lack’s observations are also overlaid on the plot. Comparison shows that although a marked increase in rate of rise is simulated between around 4:15pm and 4:25pm, the maximum rate is around 0.5m over 10 minutes, which is different from Mr Lack’s description of 1.5m to 1.8m over a matter of seconds. However, in my opinion Mr Lack’s description is consistent with a rapid increase in water levels over a relatively short period of time.

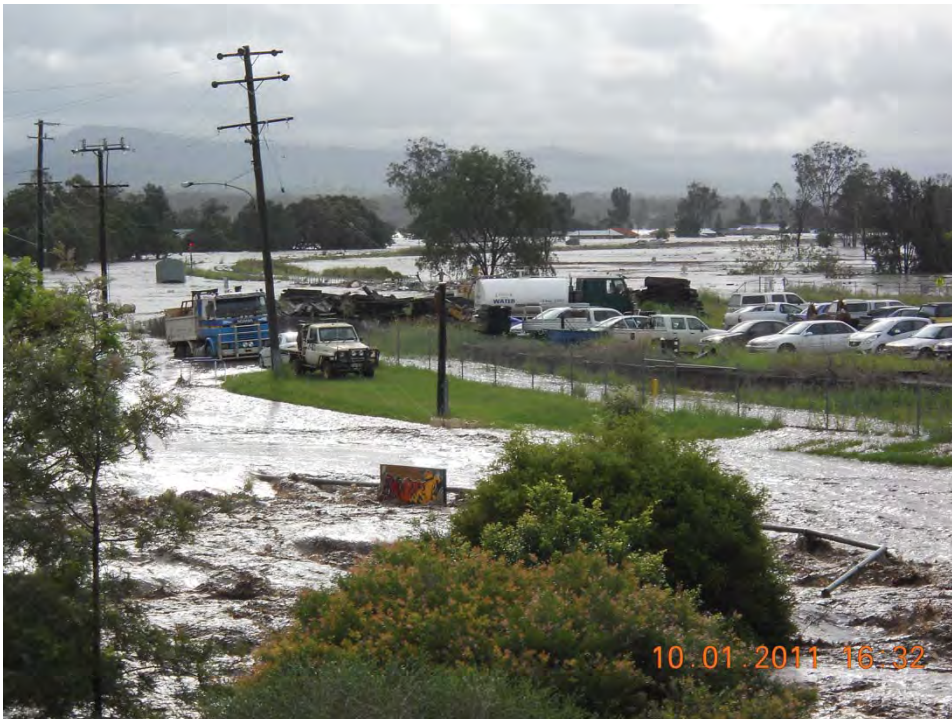
Figure 13.26 – Mr Lack’s photograph showing floodwater at the base of the stay pole
(Picture 028.jpg)

489. Mr Lack's photographs taken at 4:32pm and 5:00pm are reproduced in Figures 13.26 and 13.27, below for Location L.

490. I have plotted the simulated water level at location L in Figure 13.28. Mr Lack’s observations are also overlaid on the plot. I observe a small variation between the time and / or level of Mr Lack’s observations and those simulated. I observe that the 4:32pm photographic record appears close

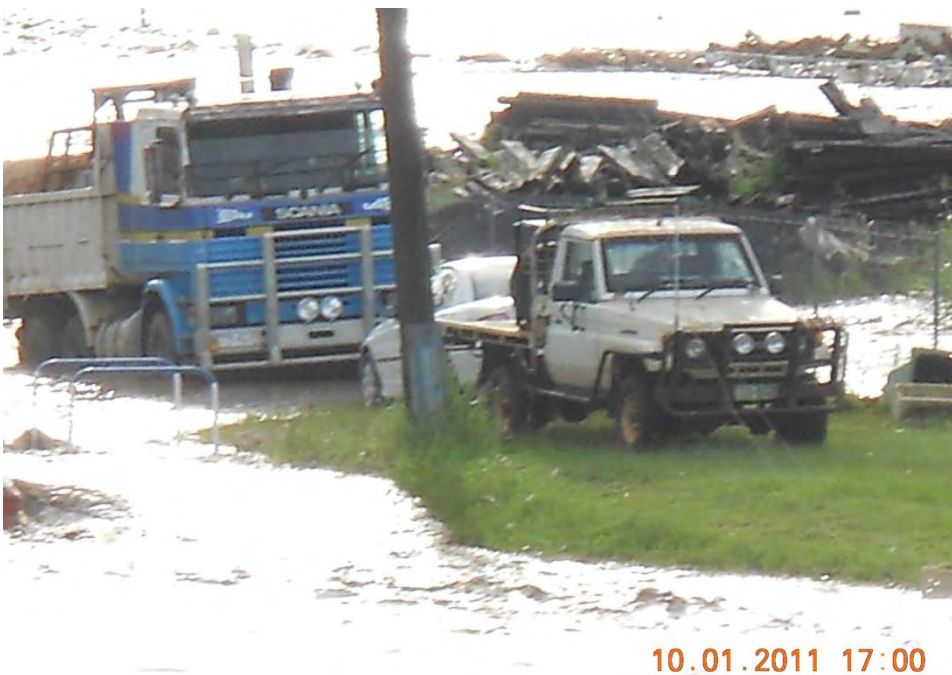
Figure 13.27 – Mr Lack’s photograph showing floodwater at the base of the power pole
(Picture 040.jpg)

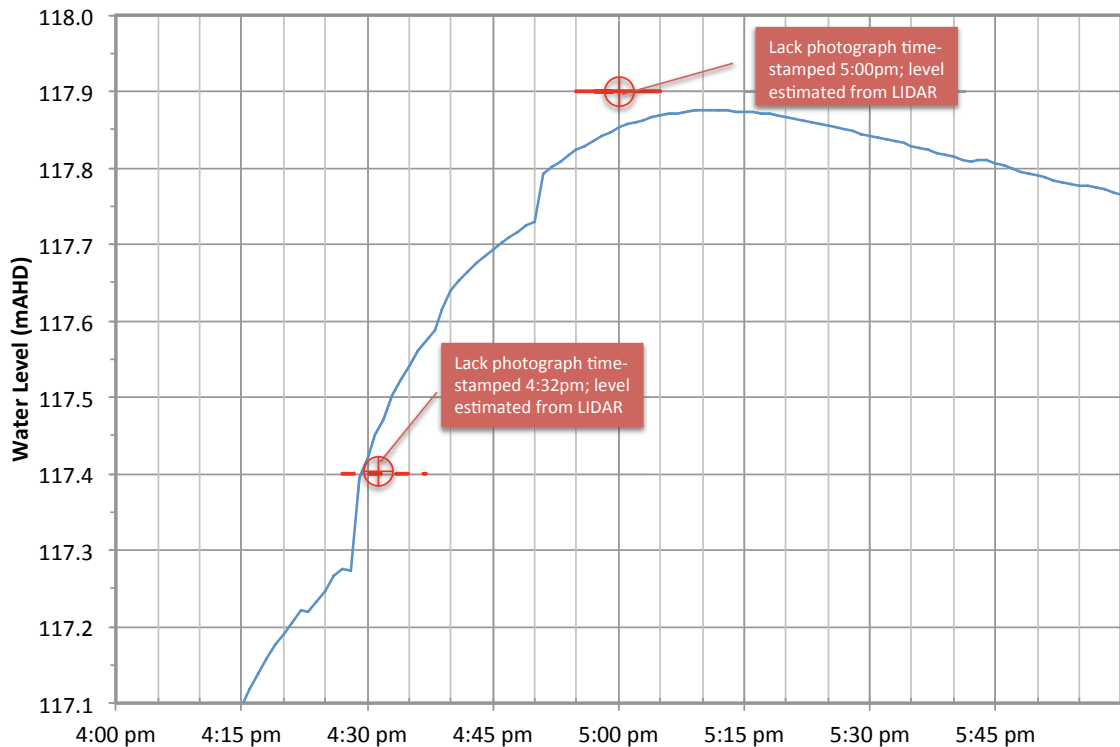
Figure 13.28 – Simulated Water Level at Location L

to simulation, and my estimated level for the 5:00pm photograph appears to be about 50mm different to that simulated.

491. My overall consideration is that there appears to be good corroboration between Mr Lack’s observations and simulation results covering all stages of flood rise to close to the peak at around Location L.

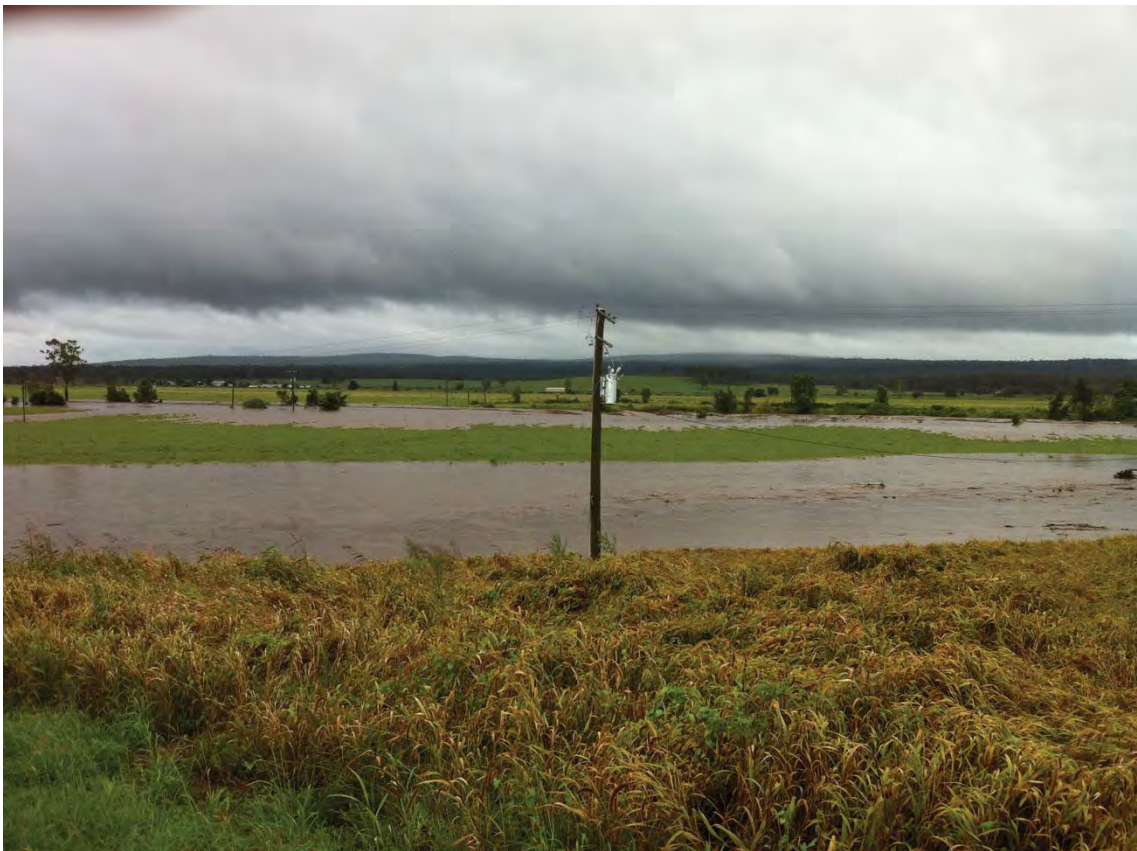
Figure 13.32 – Lockyer Creek at 3:15pm Location N (Image IMG_0228.JPG)

499. The significance of this photograph is that in the background it captures the approximate point in time when Lockyer Creek appears to be just starting to break its banks at Location N. In the foreground the inundation is on account of water backing up along a natural drainage depression that runs west (left) to east (right) and joins Lockyer Creek near to the quarry.
500. I have extracted a simulation graphic of inundation and flow intensity at around location N at 3:10pm as shown in Figure 13.33.

501. While I observe that this image is associated with a simulation time of 3:10pm, 5 minutes earlier than that for the photograph shown in Figure 13.32, it shows a good visual comparison between simulation and in the photograph.
502. I found visual comparisons of the oblique flood inundation photo shown in Figure 13.32 difficult to interpret as scale, local relief and the effects of ground cover all introduced uncertainty. Given this I consider there is reasonable corroboration.
503. Mr McIntosh has also provided a photograph taken at 4:41pm that captured the extent of floodwater at that time from his residence at Klucks Road, with a line of sight from his residence extending to the Gatton-Helidon Road in the north and to the western side of the Grantham Quarry to the north-east. A copy of the photograph is at Figure 13.34.

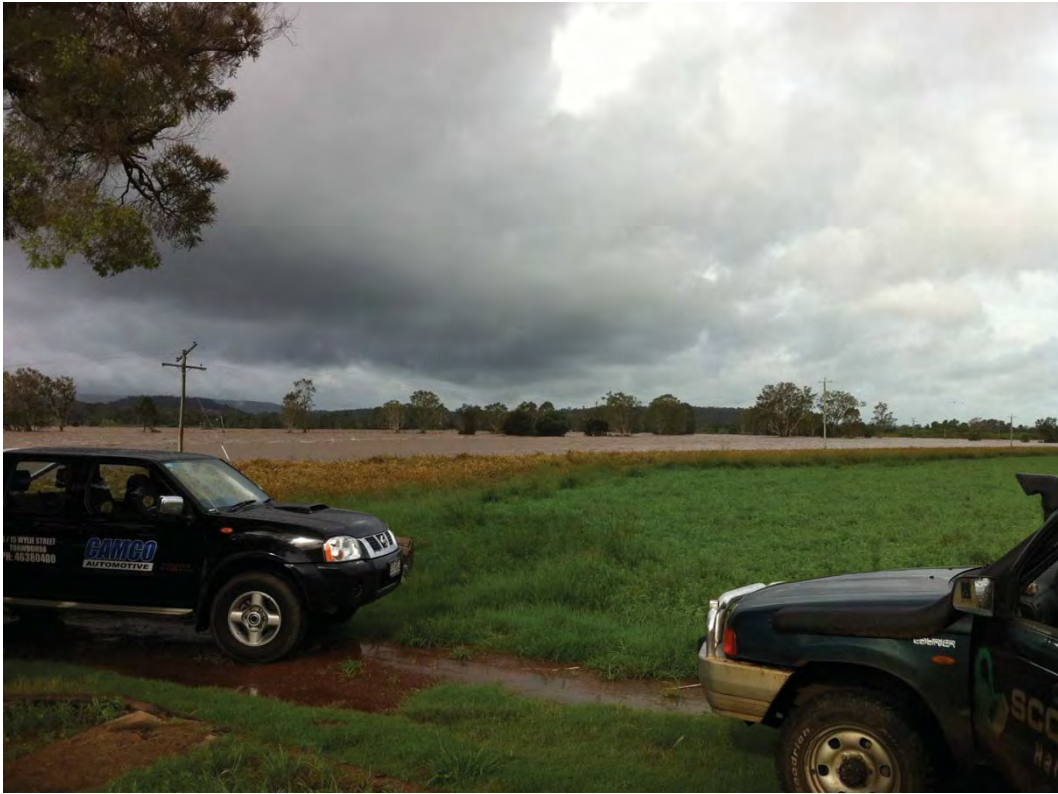
Figure 13.34 – Photograph of Lockyer Creek Floodplain at 4:41pm Location N, Mr McIntosh's Residence (IMG_0236.jpg)

505. By comparison between the photograph at Figure 13.34 and simulation outcomes shown in Figure 13.35, I observe good correlation with the extents of the inundation. I also observe raised
