GRANTHAM QUARRY - GEOTECHNICAL INVESTIGATIONS & EXPERT OPINION ON FORMATION OF EARTHWORKS - SUPPLEMENTARY REPORT CONCERNING PRE-QUARRY TERRAIN AT SAND BATCHING PLANT

Grantham Floods Commission of Inquiry

Report Number. 1532696-003-Rev2

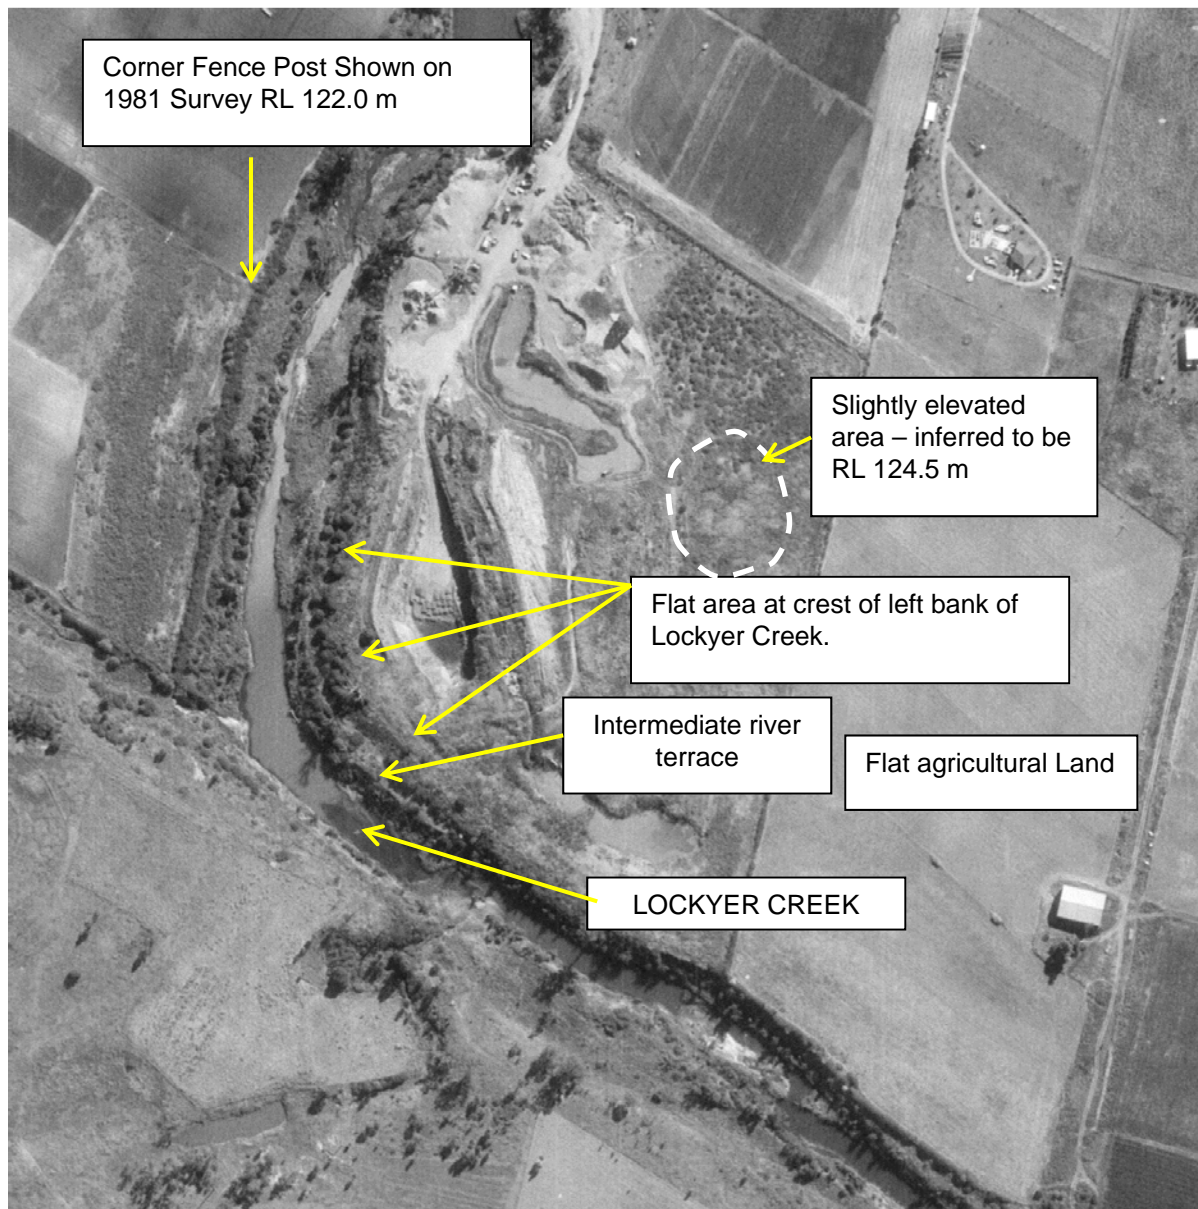
Plate 1: Portion of 1982 Air photo showing SE corner of site and initial stage of processing plant.

22. I can see from Plate 1 that there is an undisturbed area between the crest of the left bank of Lockyer Creek and the earthworks and pond associated with the processing plant in 1982. I deduce from comparing the contours shown on Figure 12 with the topography on Plate 1 that the crest of the bank is at about AHD 124 m.

- 23. I can also see from comparing Figure 12 with Plate 1 that:
 - a. There is an intermediate river terrace at about 120 m AHD.
 - b. There is a small area to the east of the Batching Plant which is at a slightly higher elevation than the flat area surrounding. This is marked on Plate 1, and based on the contours shown on Figure 12, I believe the elevation of this area is about 124.5 m AHD. In my opinion, this area which is shown in the 1982 photo probably had the same elevation before the quarry development.
- 24. I have compared Plate 1 with the 1981 Survey Plan that was provided to me during the course of my evidence at the hearings (presented as Exhibit 94).
- 25. I can recognise a corner of an agricultural field on the right bank of Lockyer Creek which has an RL at the base of a fence post of 122.0 m – refer to 1981 survey plan (see Plate 2).

26. On examining the 1982 air photo under a stereo viewer, I can detect that the fence post location is slightly lower than the crest of the creek bank on the opposite (eastern) side of Lockyer Creek. I have marked the fence post location on Plate 1.

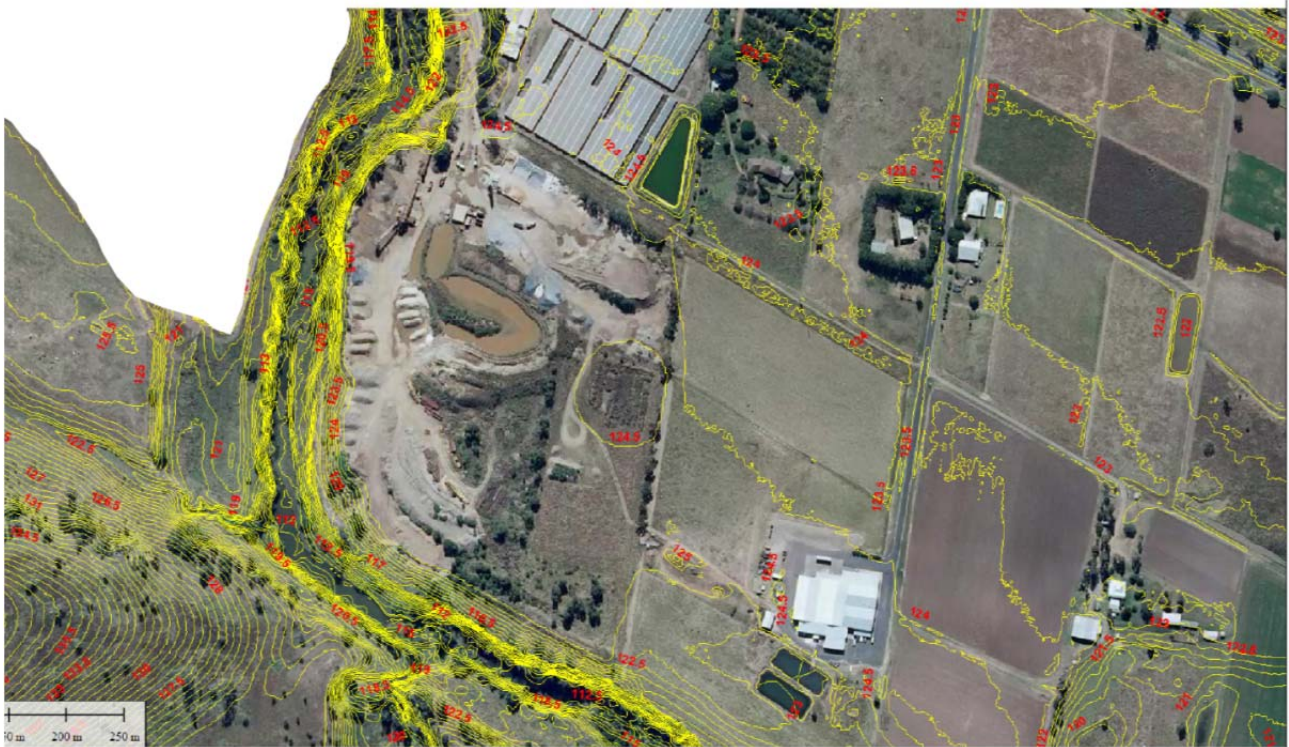
27. I have created a pre-quarry contour plan based on the inferences outlined above. This is reproduced below as Plate 3. It should be noted that the reconstructed contours apply only to the batching plant area on the left bank of Lockyer Creek i.e. on the right side of plate. The contours on the right bank near the quarry lake have not been adjusted (but I have blanked out the area of the quarry lake and associated earthworks).

Plate 3: Reconstructed topographic plan of Batching Plant Site superimposed on LiDAR survey

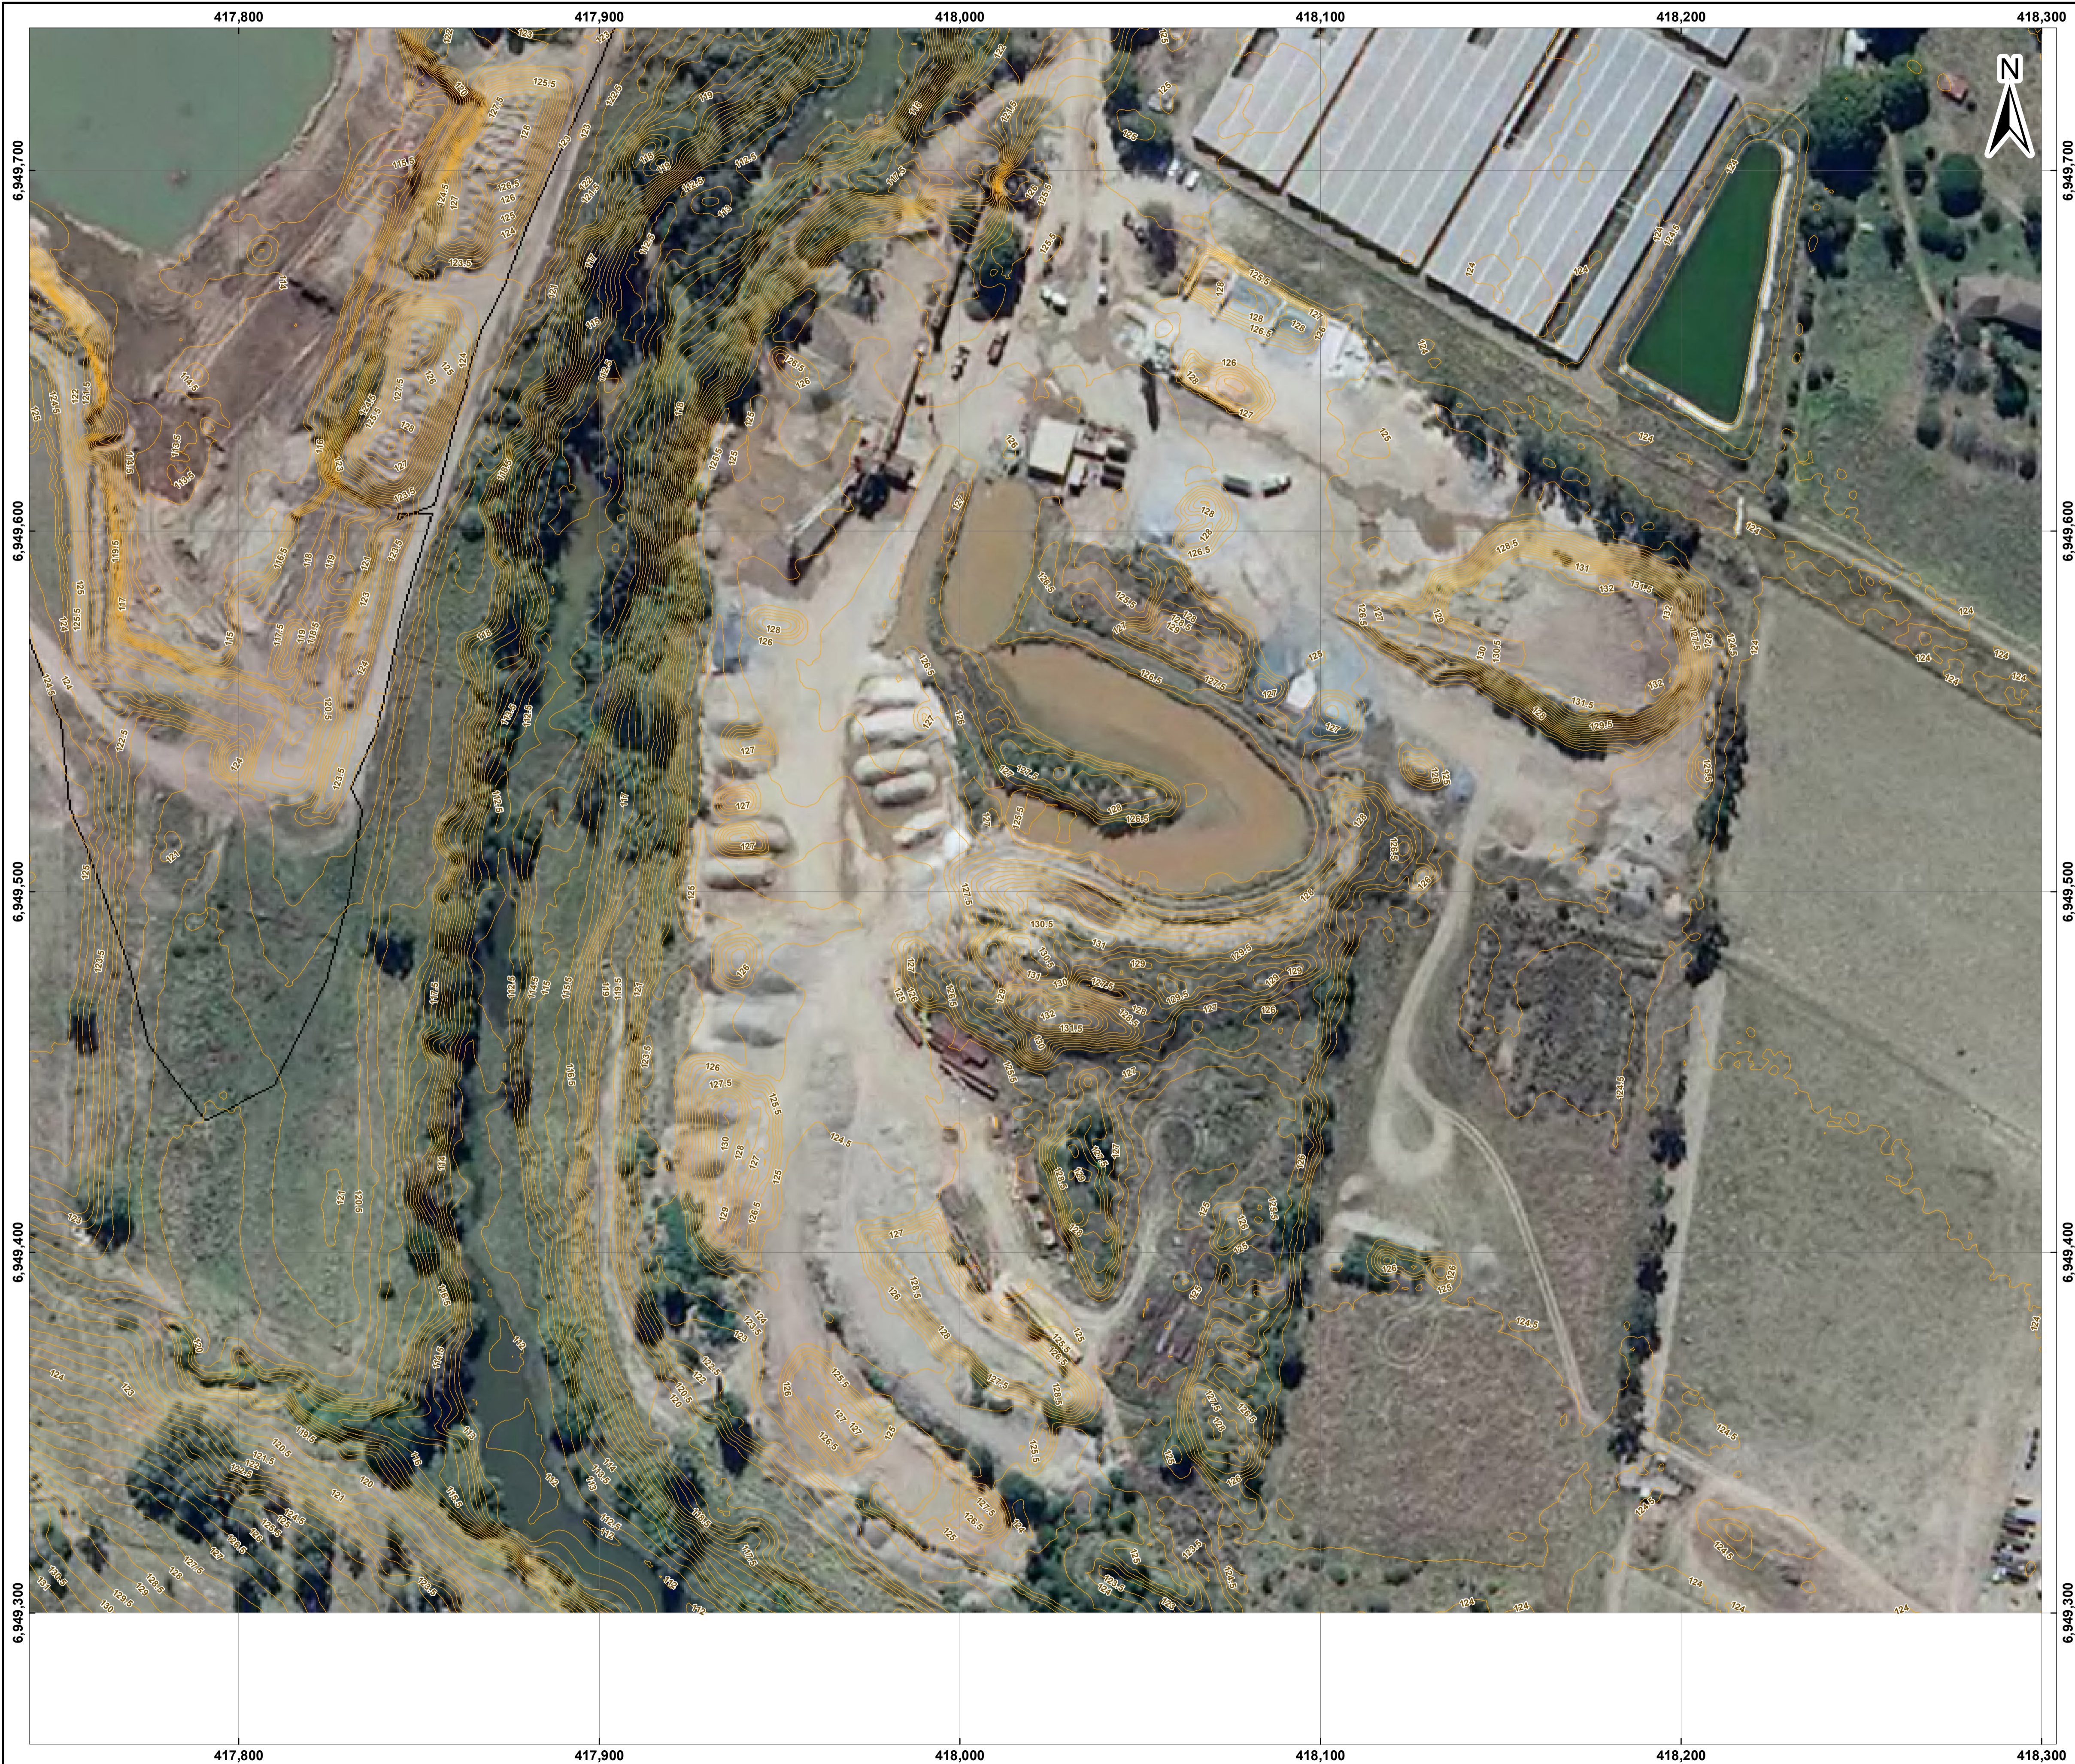
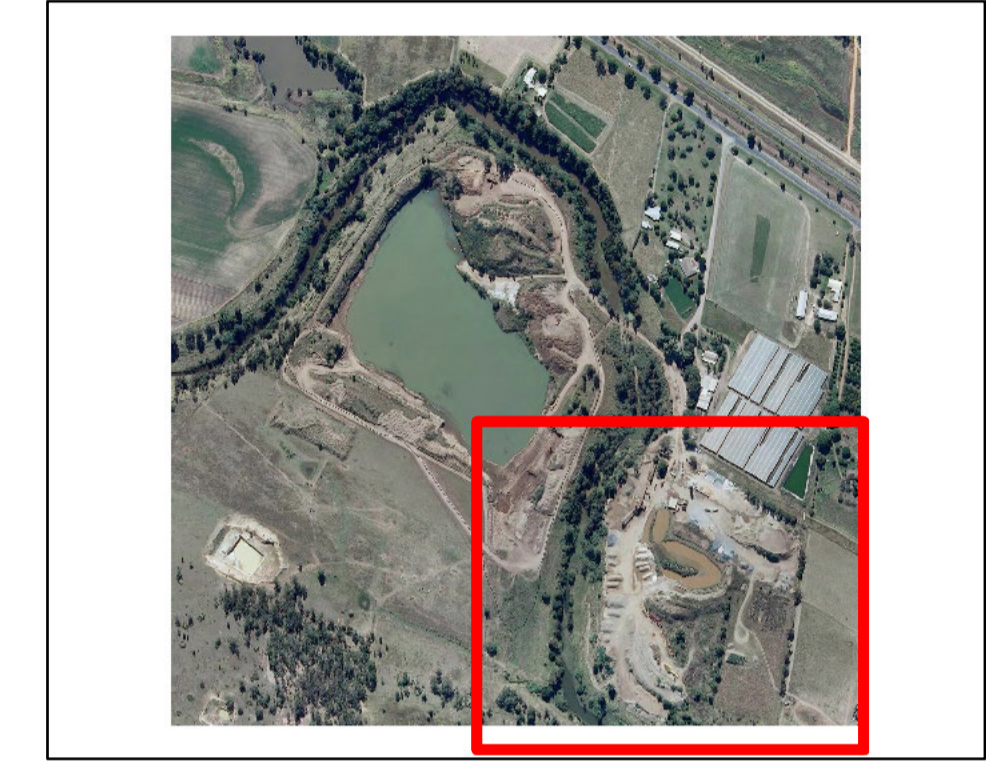
FIGURE 12

19. The LiDAR data has been plotted by Golder GIS expert Travis Brousseau under my direction and presented on Figure 12.
20. Stereographic air photo images have been obtained from Department of Natural Resources and Mines. I have been provided with a series of stereo images of air photos covering the Helidon/Grantham area for the years 1982, 1988, 1992, 1997, 2001, 2009, 2010 and 2011.
21. I have compared Figure 12 with an enlarged section of the 1982 air photo shown in Plate 1. I have made a stereo pair of this enlarged area by utilising adjacent photos QAP4014-12 and 13 (flown on 13 May 1982).

**PRE FLOOD CONTOURS
SOUTHEAST**

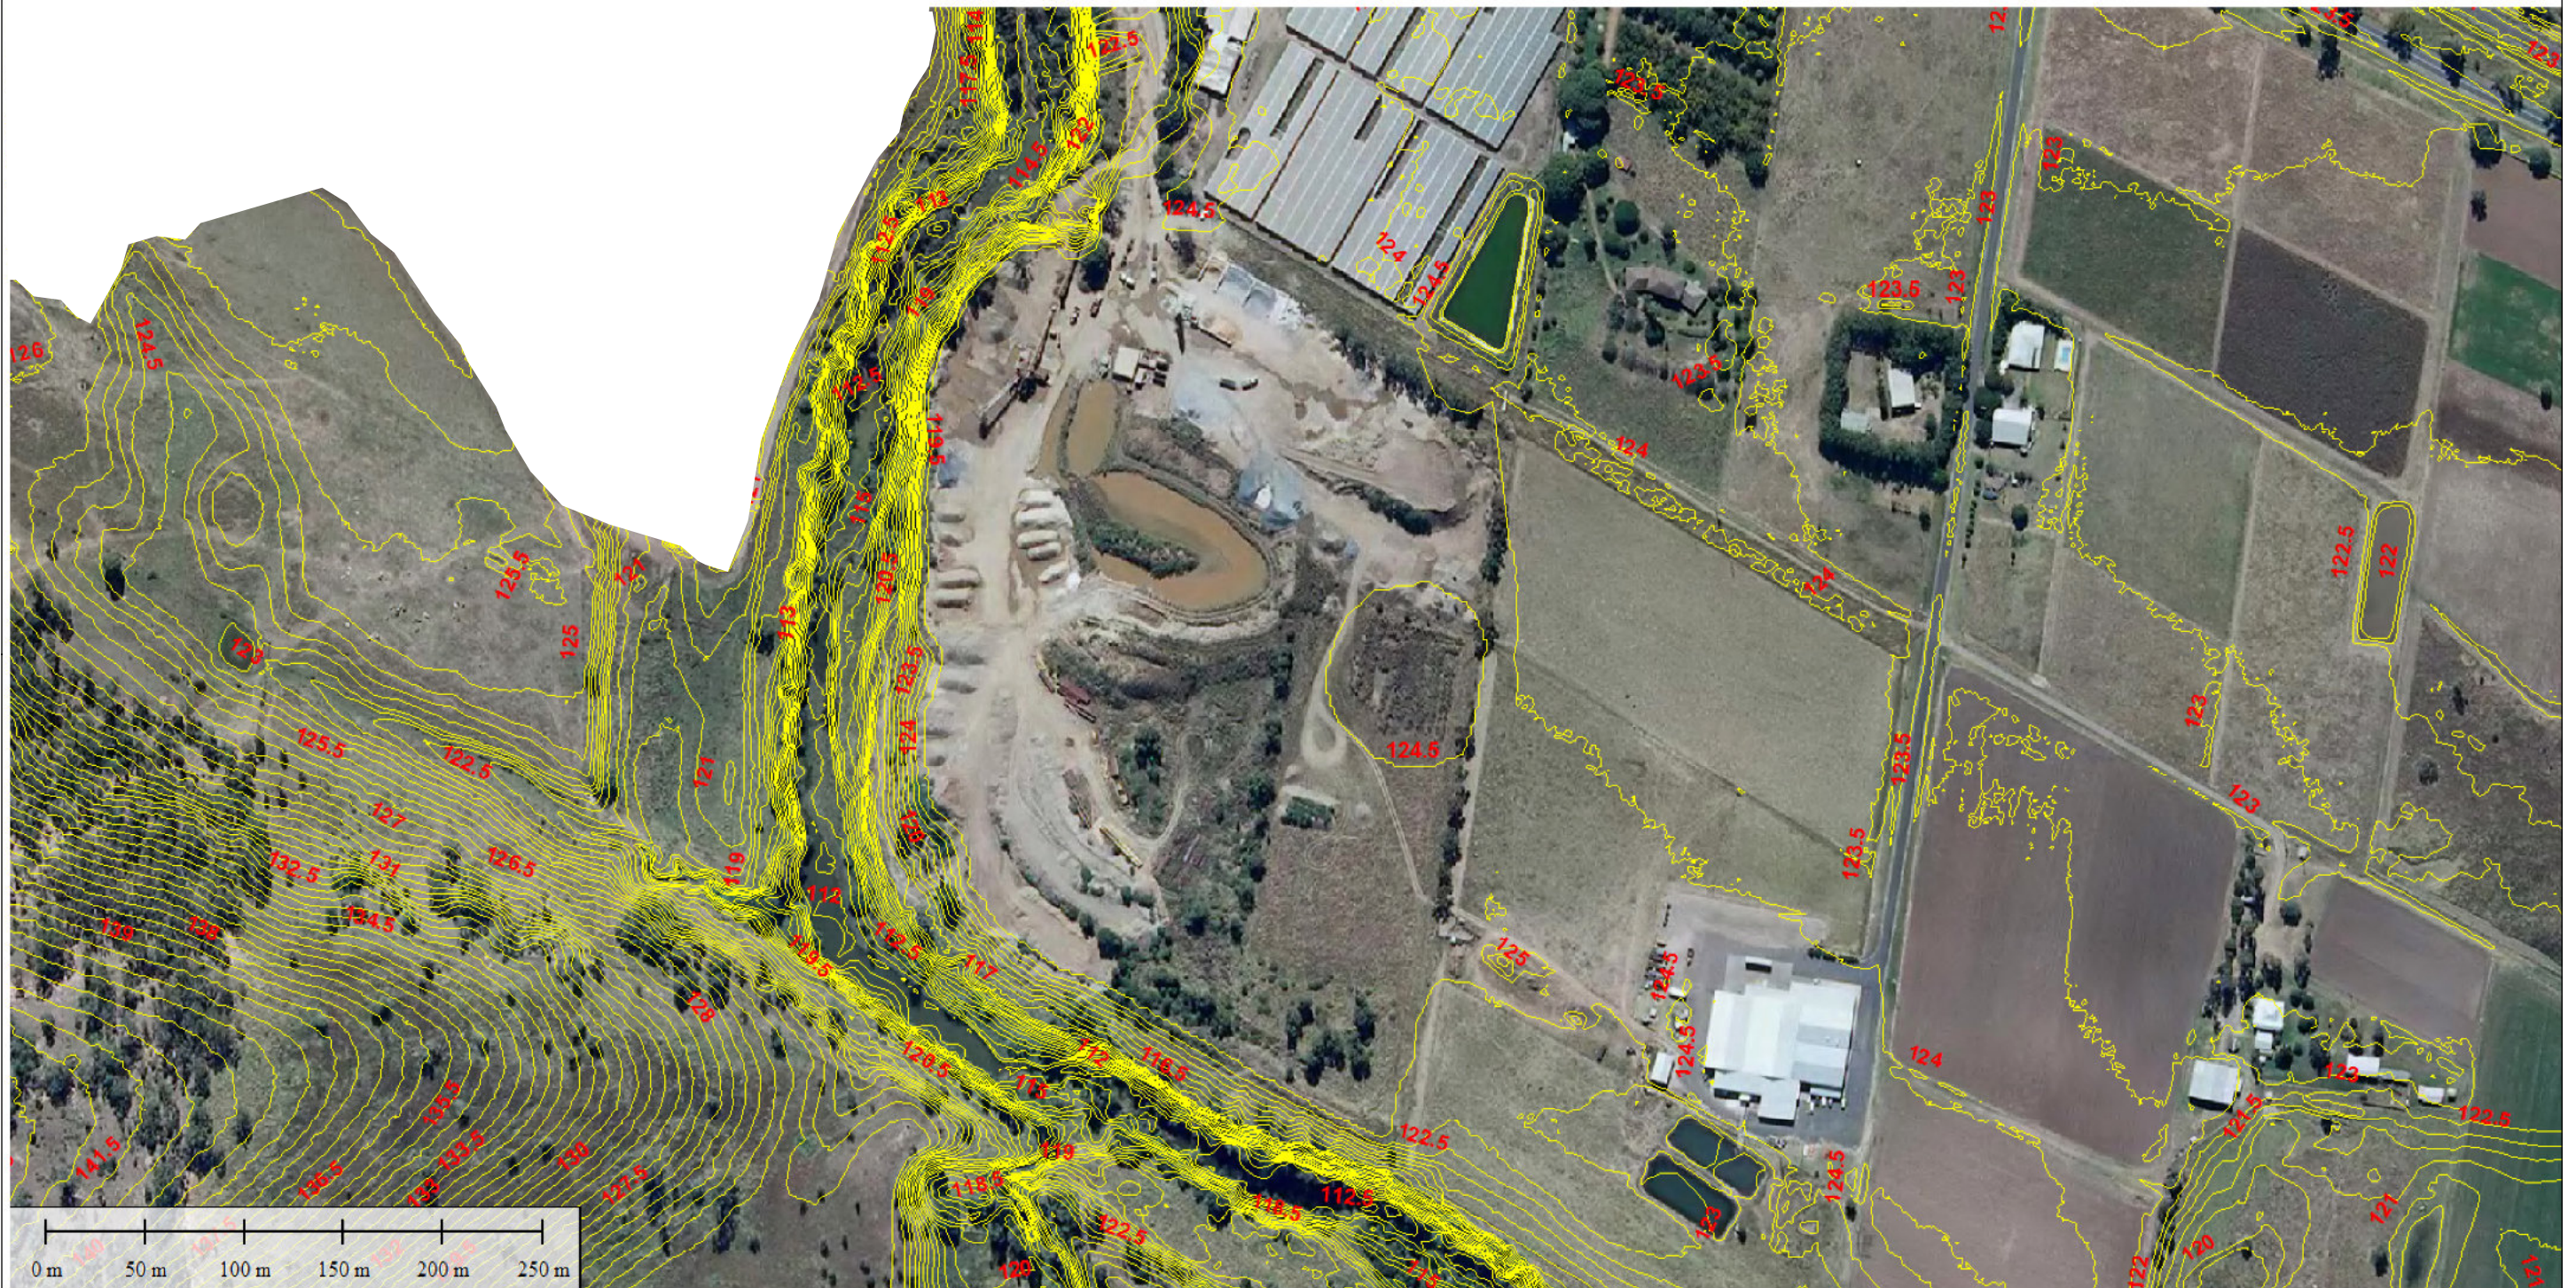
FIGURE 13

28. The version of this plan produced for the purposes of making a digital terrain model is presented as Figure 13. Again, it should be noted that the reconstructed contours apply only to the batching plant area.

RECONSTRUCTED PRE-QUARRY CONTOURS SOUTHEAST

Note: reconstructed contours
apply to Batching Plant Area only.
