28 August 2015

GRANTHAM QUARRY - GEOTECHNICAL INVESTIGATIONS & EXPERT OPINION ON FORMATION OF EARTHWORKS

Grantham Floods Commission of Inquiry

Report Number. 1532696-001-R-Rev2

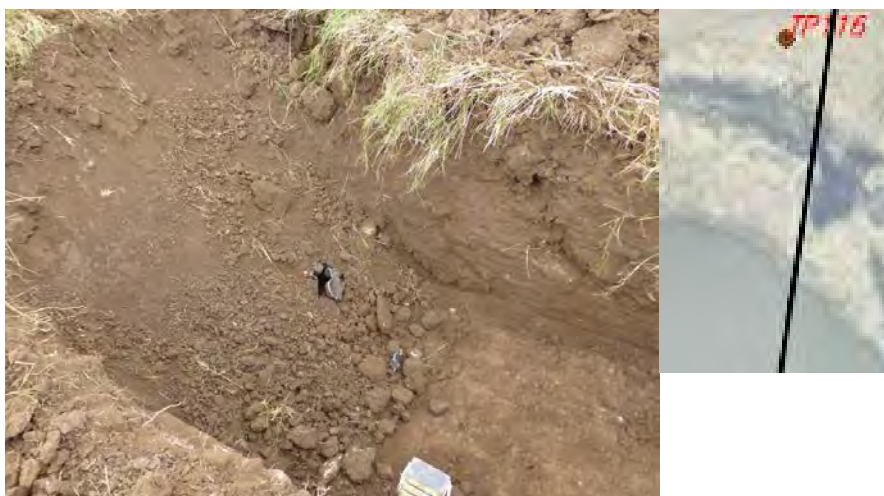
- g. Fill material used to backfill the main breach at the northern end of the western bund. I infer that this operation included levelling and infilling of a low spot immediately north east of the breach, as TP116 encountered at least 1.6 m of fill containing concrete waste, boulders and plastic (see Plate 16). I note that there was formerly a haul road to the quarry lake at this location (see Sections 10.0 and 12.0 of this report).

Plate 16: Fill material adjacent to main breach backfill area, TP116

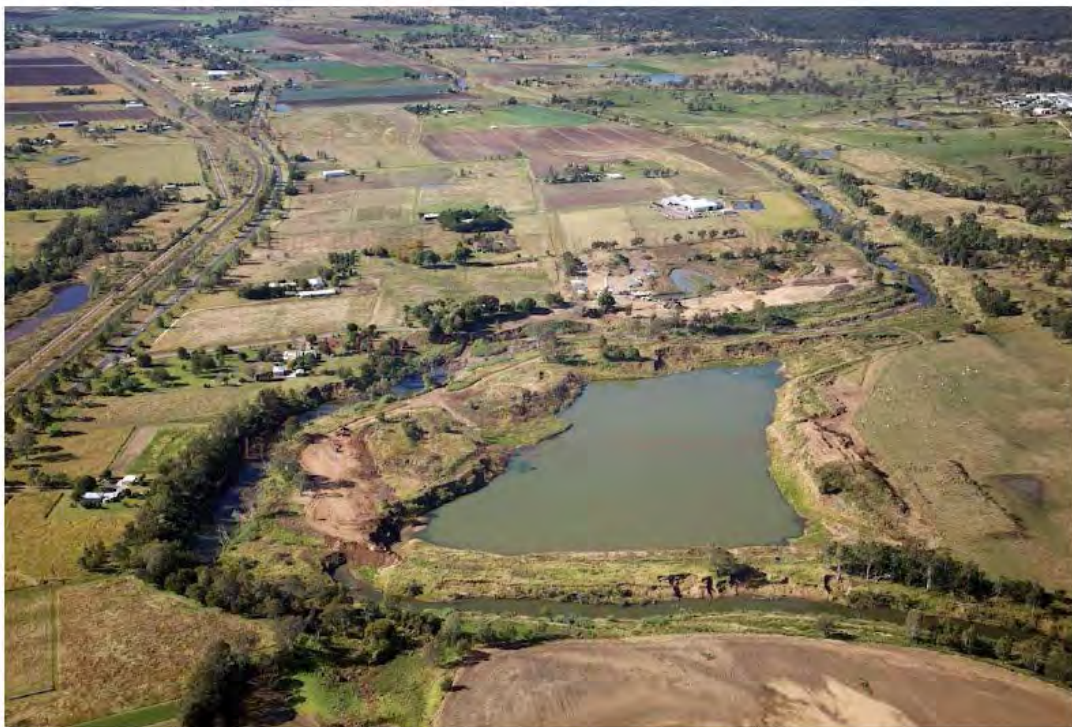
Aerial photo 2011 post-flood, looking east from the quarry and showing the remains of the northern wall around the quarry being demolished. Grantham town is in the top left of the photo.

Plate 23: Oblique air photo included in submission prepared by Amanda Gearing taken in 2011 (exact date and source unknown).

131. I infer from examining this photograph that material forming a stockpile in the NW corner of the site and visible on Figure 4 (differences in heights between the pre-flood and post-flood LiDAR contours – Plan North), was used to fill the breach in the western levee. I can see that the breach has been partially filled at the time the photo was taken.
132. A further photo included in the submission by Amanda Gearing shows earthmoving equipment (see photo below reproduced as Plate 24).

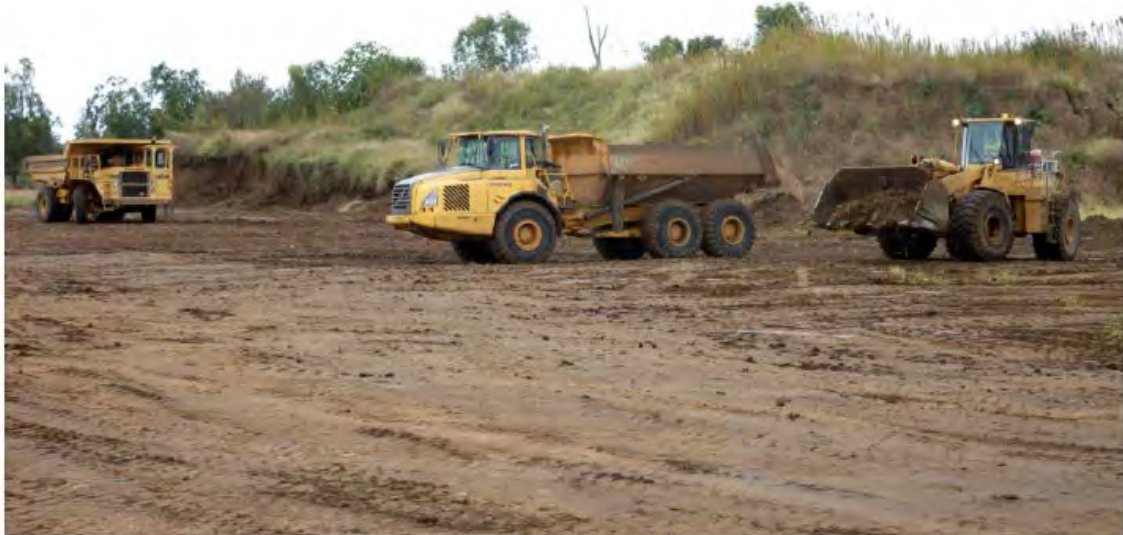
Heavy equipment demolishing part of the remaining earthen wall on the northern side of the Grantham quarry.

Plate 24: Photo of earthmoving equipment included in submission prepared by Amanda Gearing (exact date unknown).

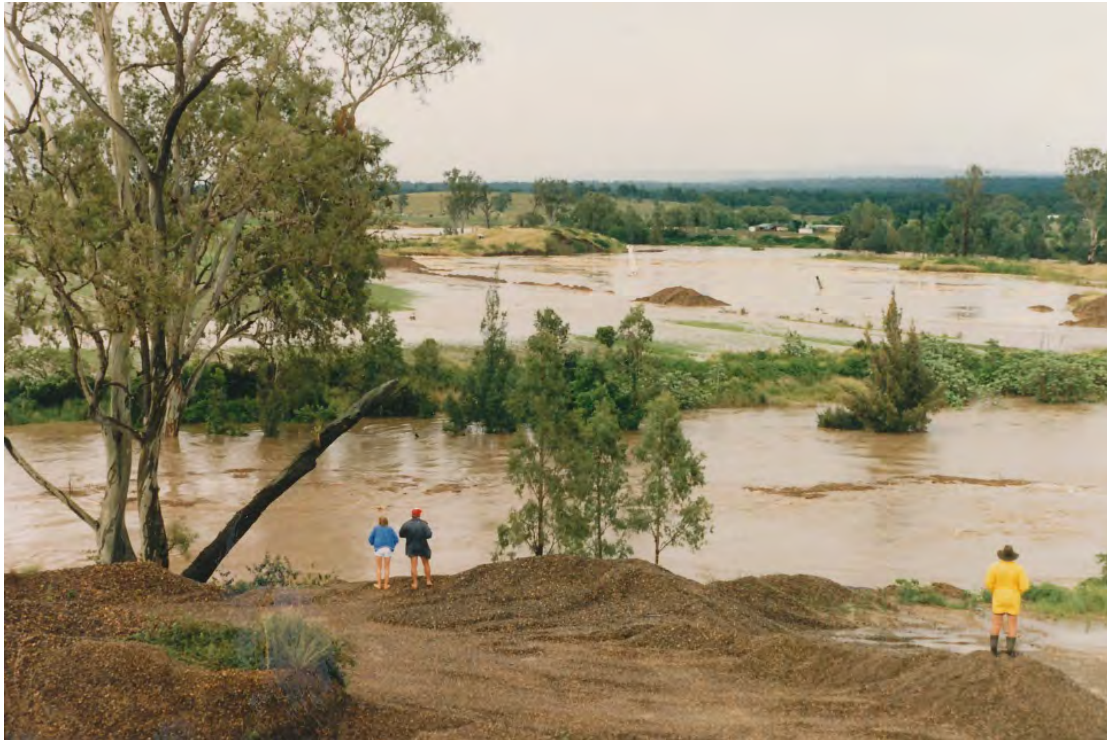
Plate 30a Photo taken during 1996 floods by J Gallagher (witness statement PJG-1)

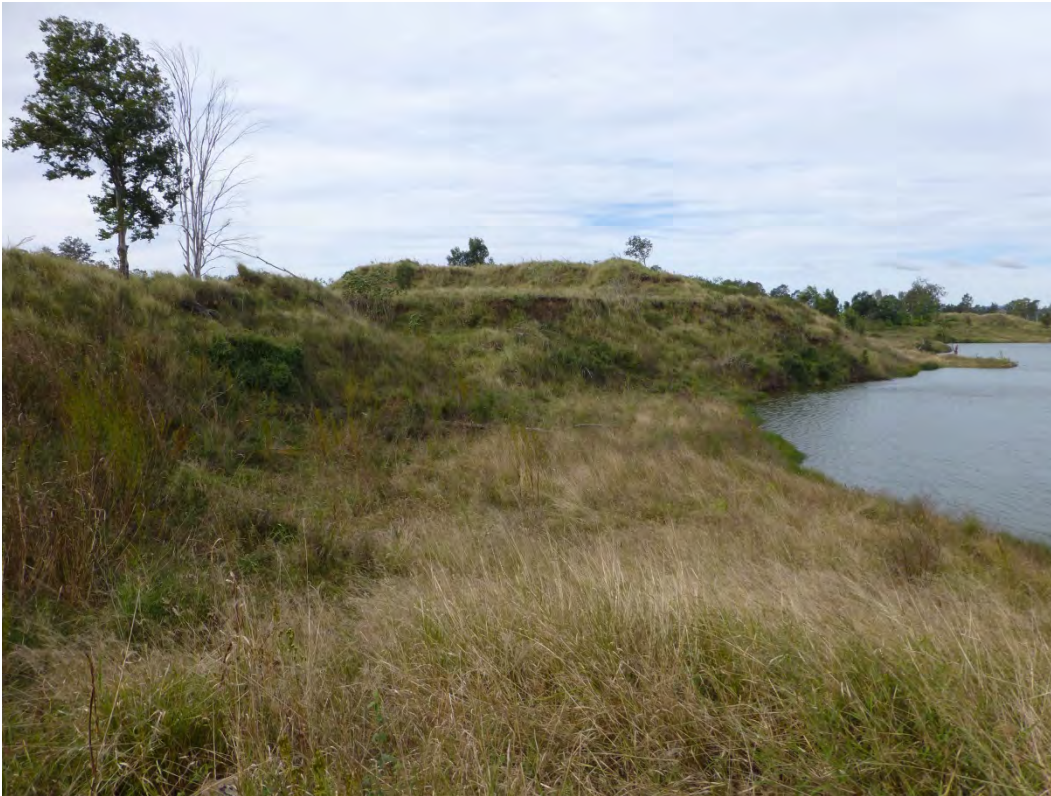
Photograph B1: Grantham Quarry – View from main breach towards East.

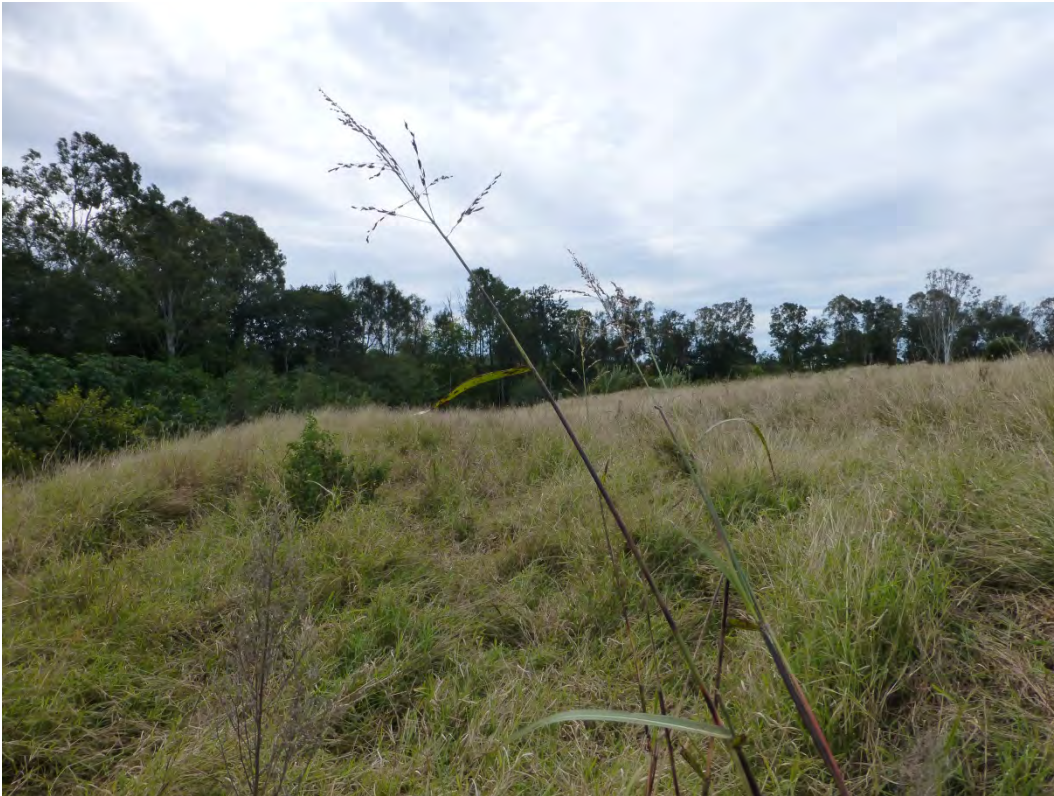
Photograph B3: Grantham Quarry – View along Western levee bank showing terrace.

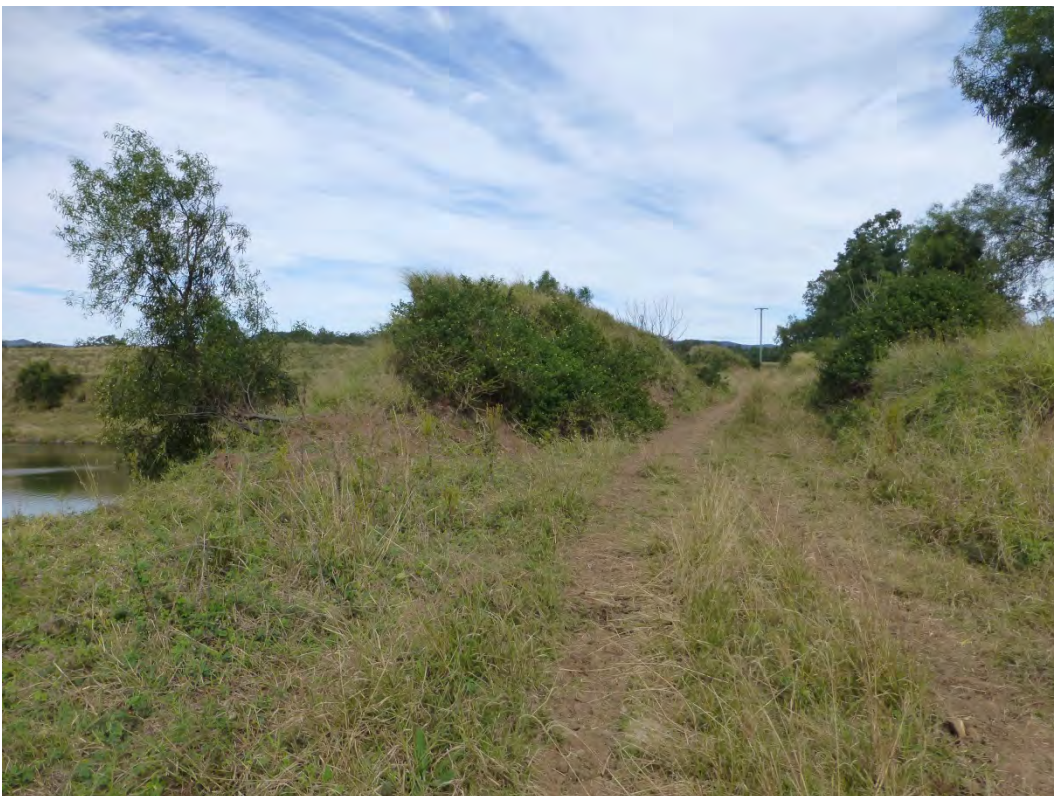
Photograph B4: Grantham Quarry – Track along Western levee – view towards South.

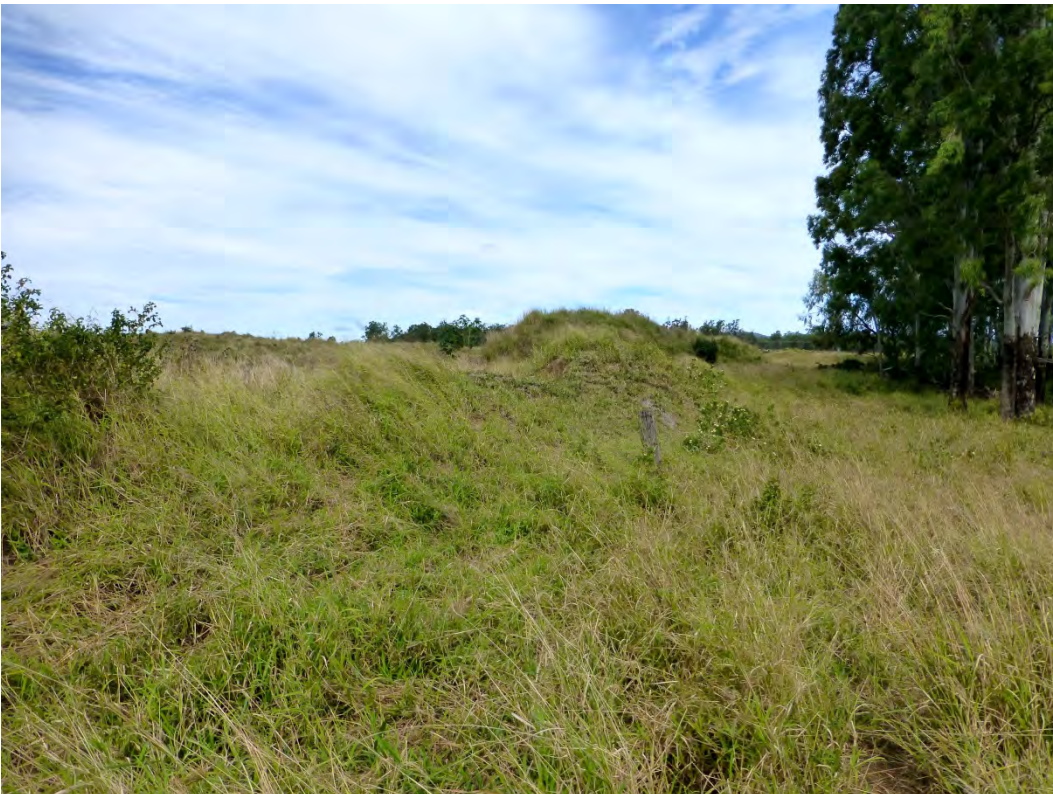
Photograph B10 Grantham Quarry – Original fence line along Western levee.

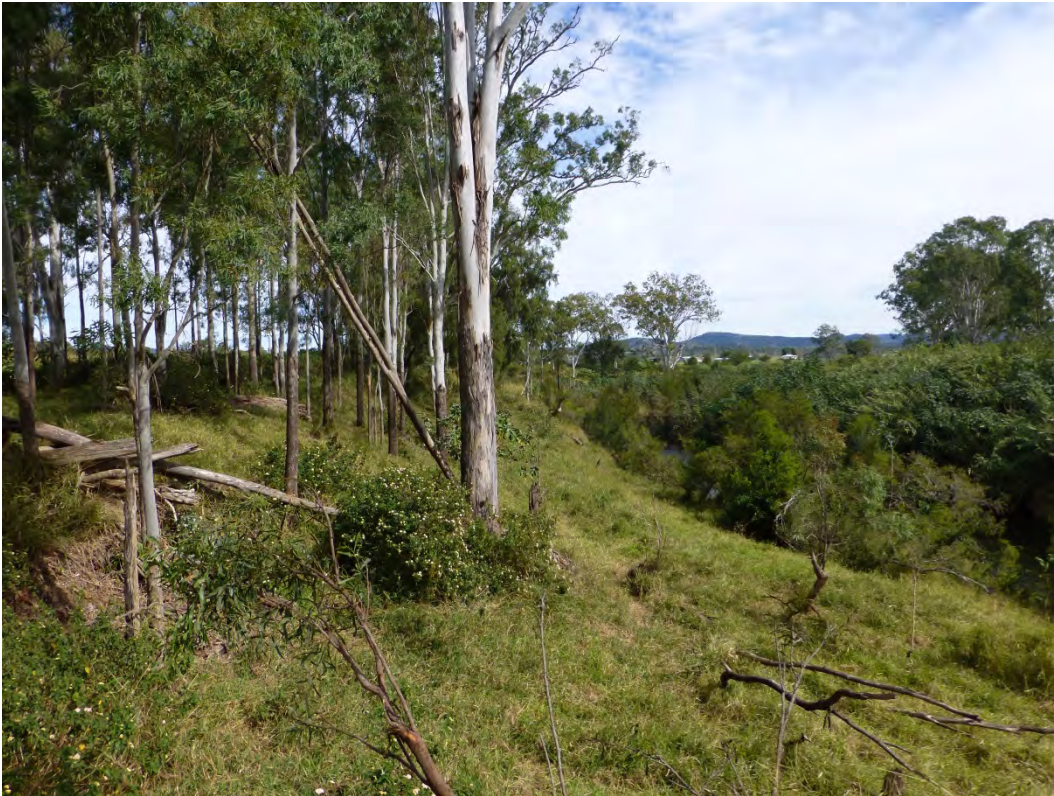
Photograph B11 Grantham Quarry – Lower terrace at Southern end of Western levee.

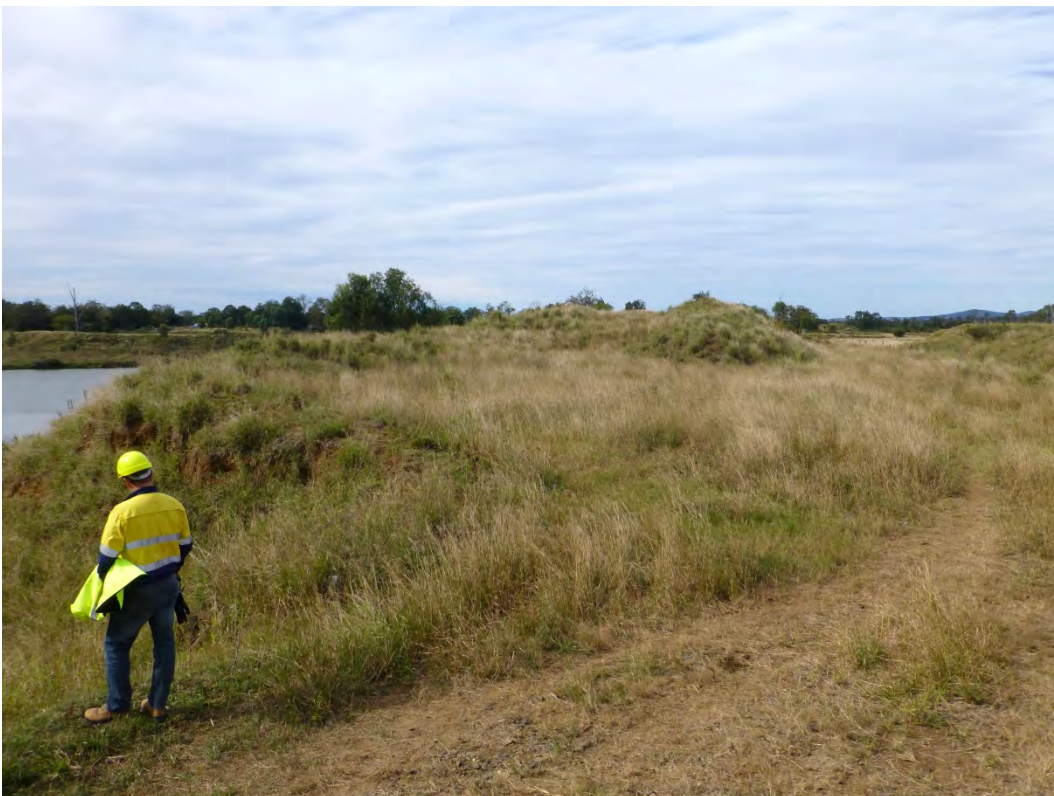
Photograph B12 Grantham Quarry – Track on South Side – viewed towards East.

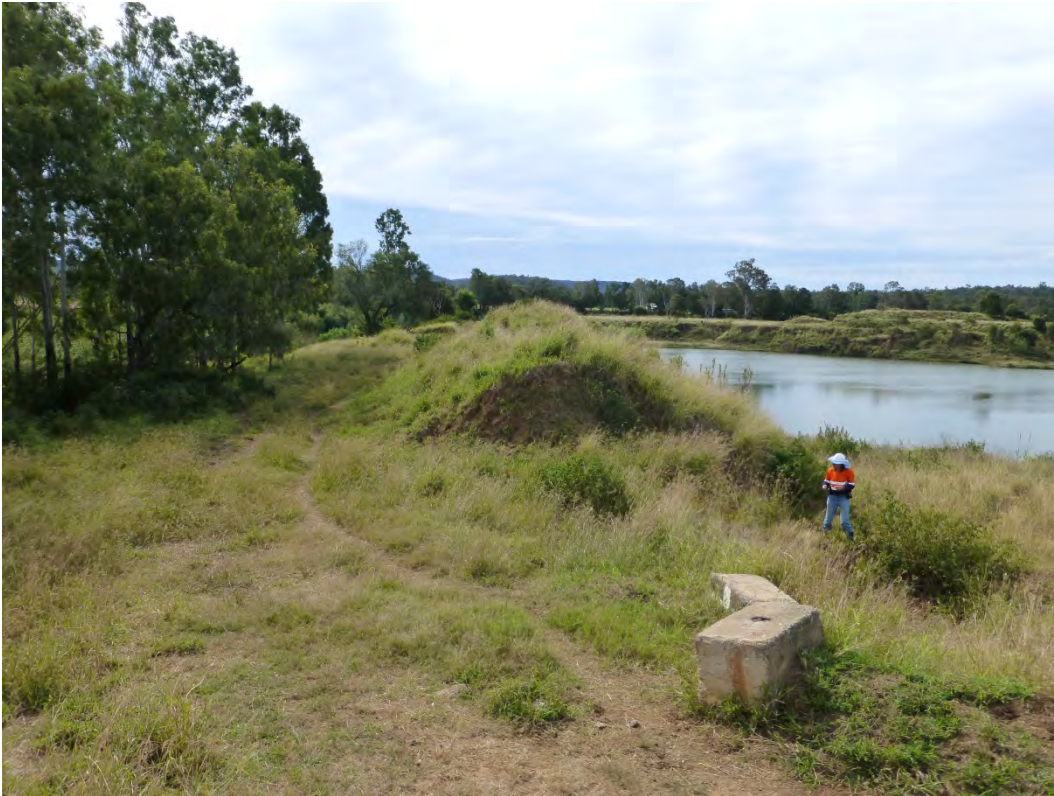
Photograph B13 Grantham Quarry – View along Western levee trace – towards North.

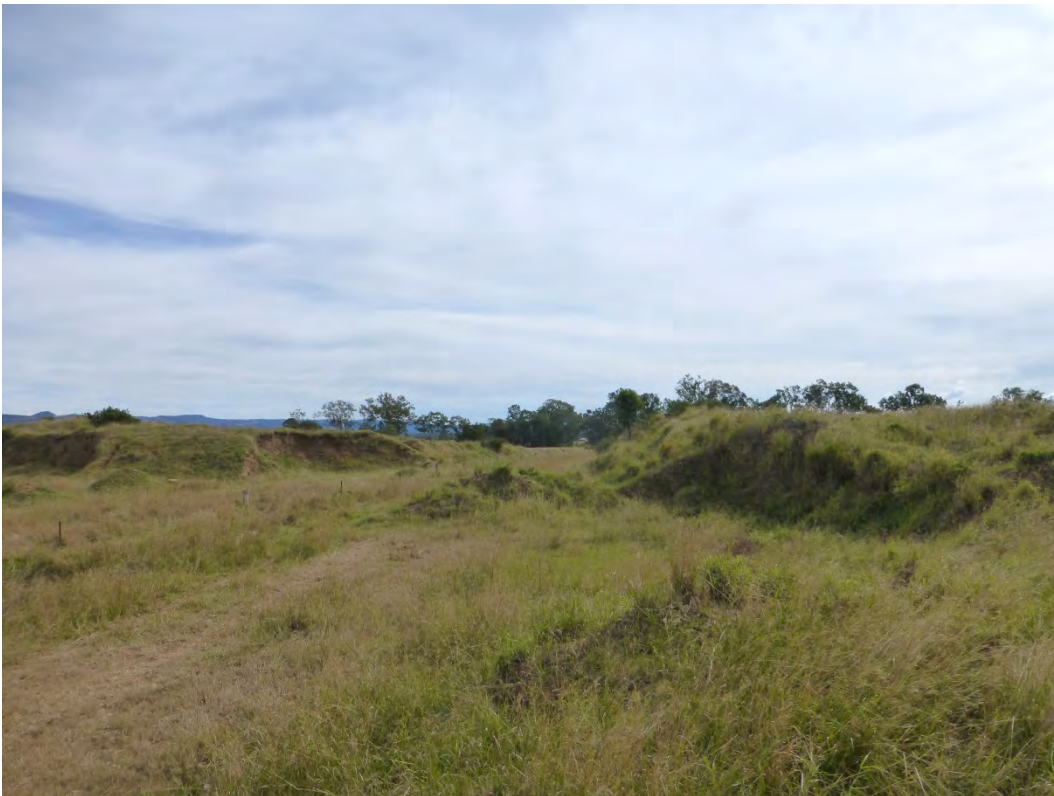
Photograph B14 Grantham Quarry – East end of Southern track.

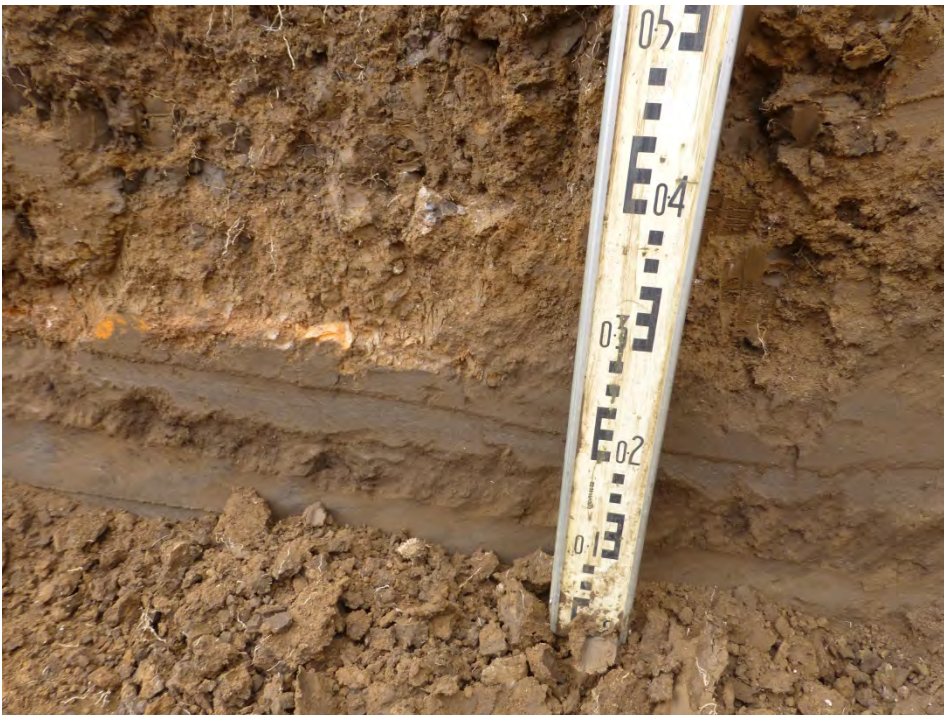
Photograph D45 – TP115 – Details of fill contact.

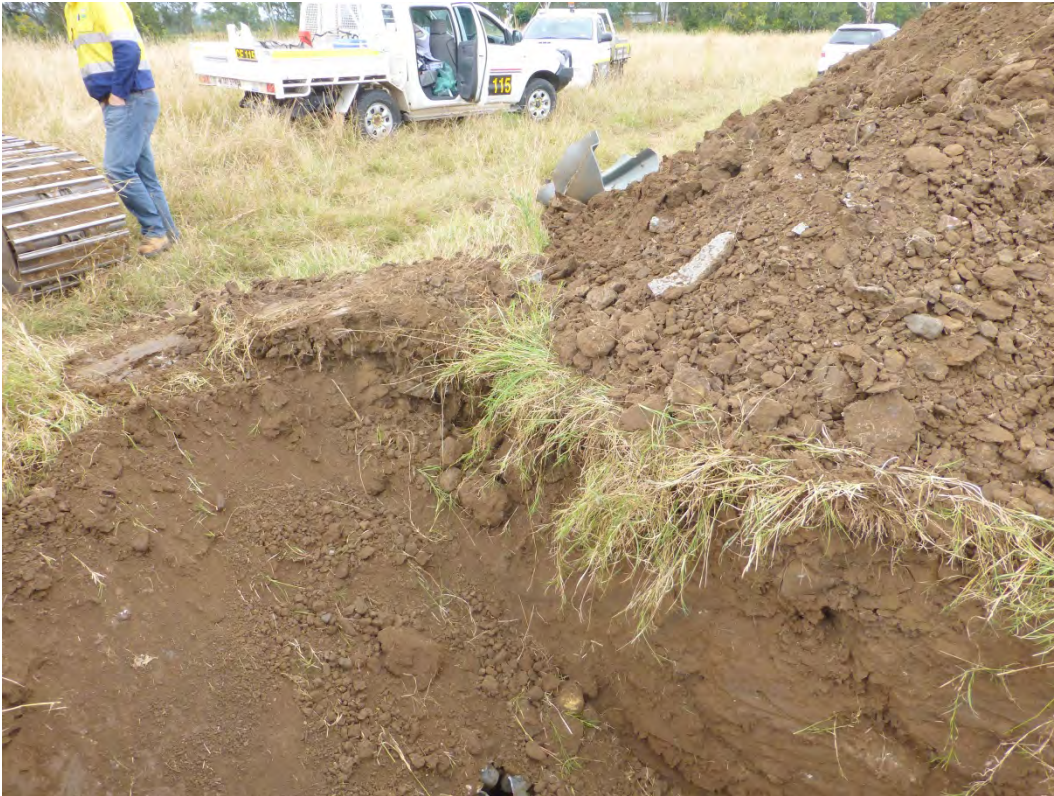
Photograph D46 – TP116 – Backfilling breach

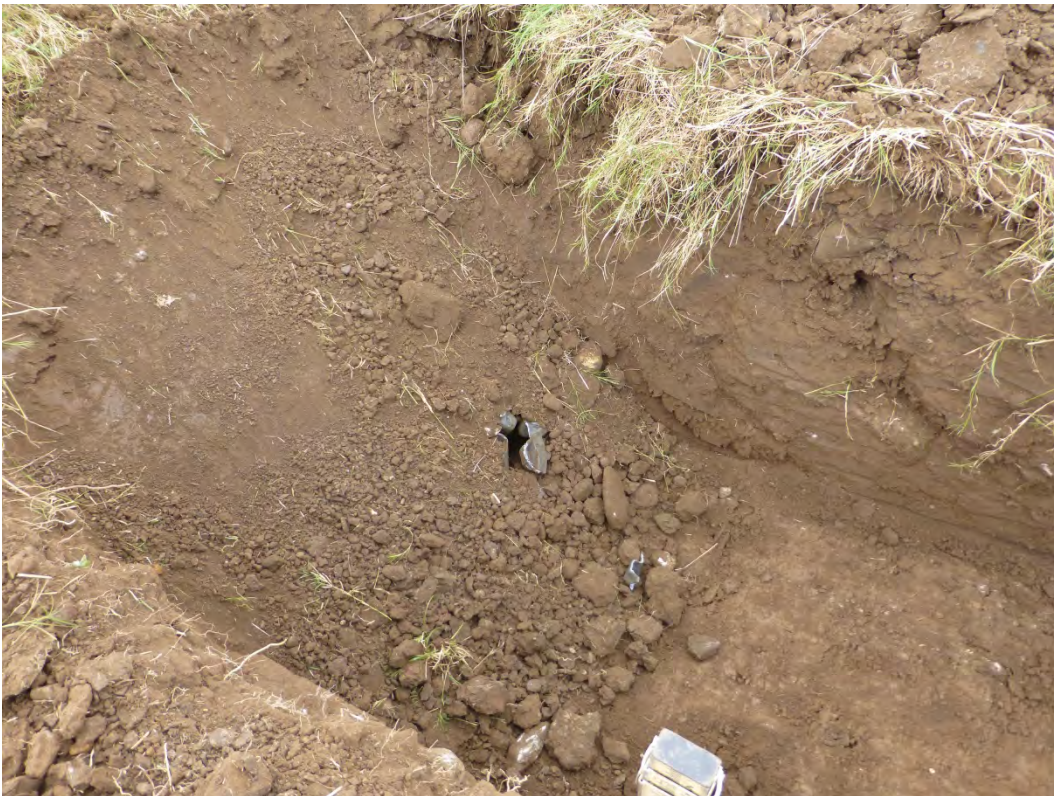
Photograph D47 – TP116 – Backfilling breach
