# GRANTHAM QUARRY - GEOTECHNICAL INVESTIGATIONS & EXPERT OPINION ON FORMATION OF EARTHWORKS - SUPPLEMENTARY REPORT CONCERNING LOCATION OF FAILED POWER POLE P182127

## Grantham Floods Commission of Inquiry

**Report Number.** 1532696-002-Rev1

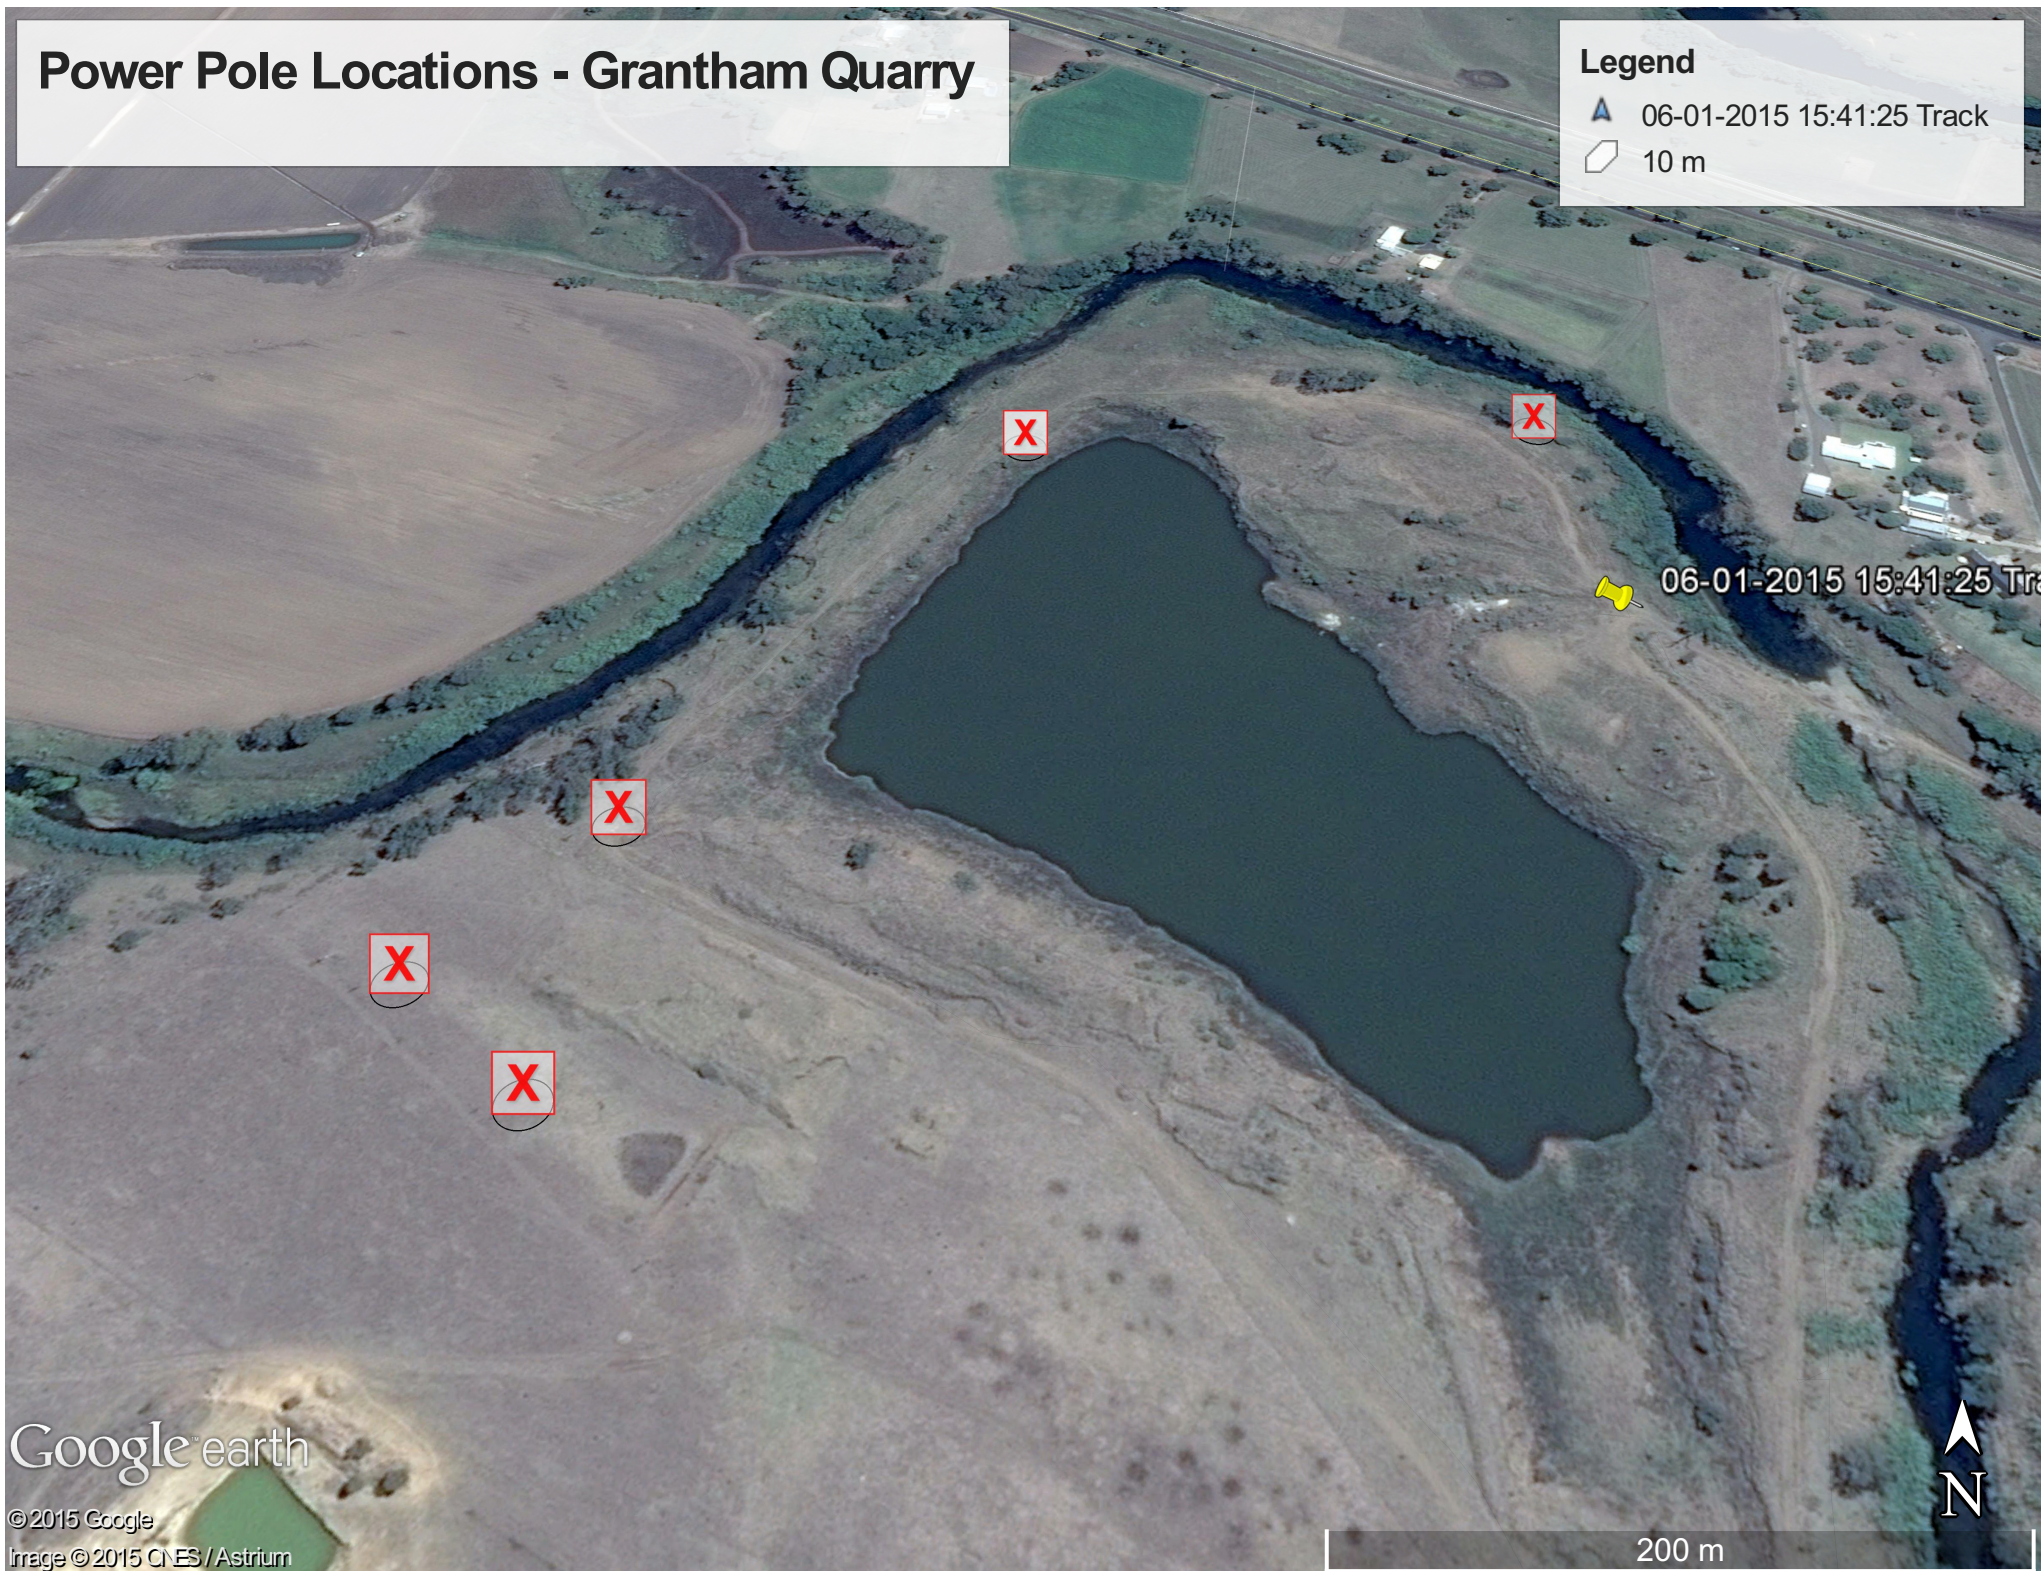
26. I can see from examining the path taken during the site inspection that I passed by the location of the Broken Pole, which is at the northern end of the western levee. The location of the Broken Pole as I observed it is shown in Plate 1 below, which is based on a kml file superimposed on the 2015 Nearmap image of the Quarry.

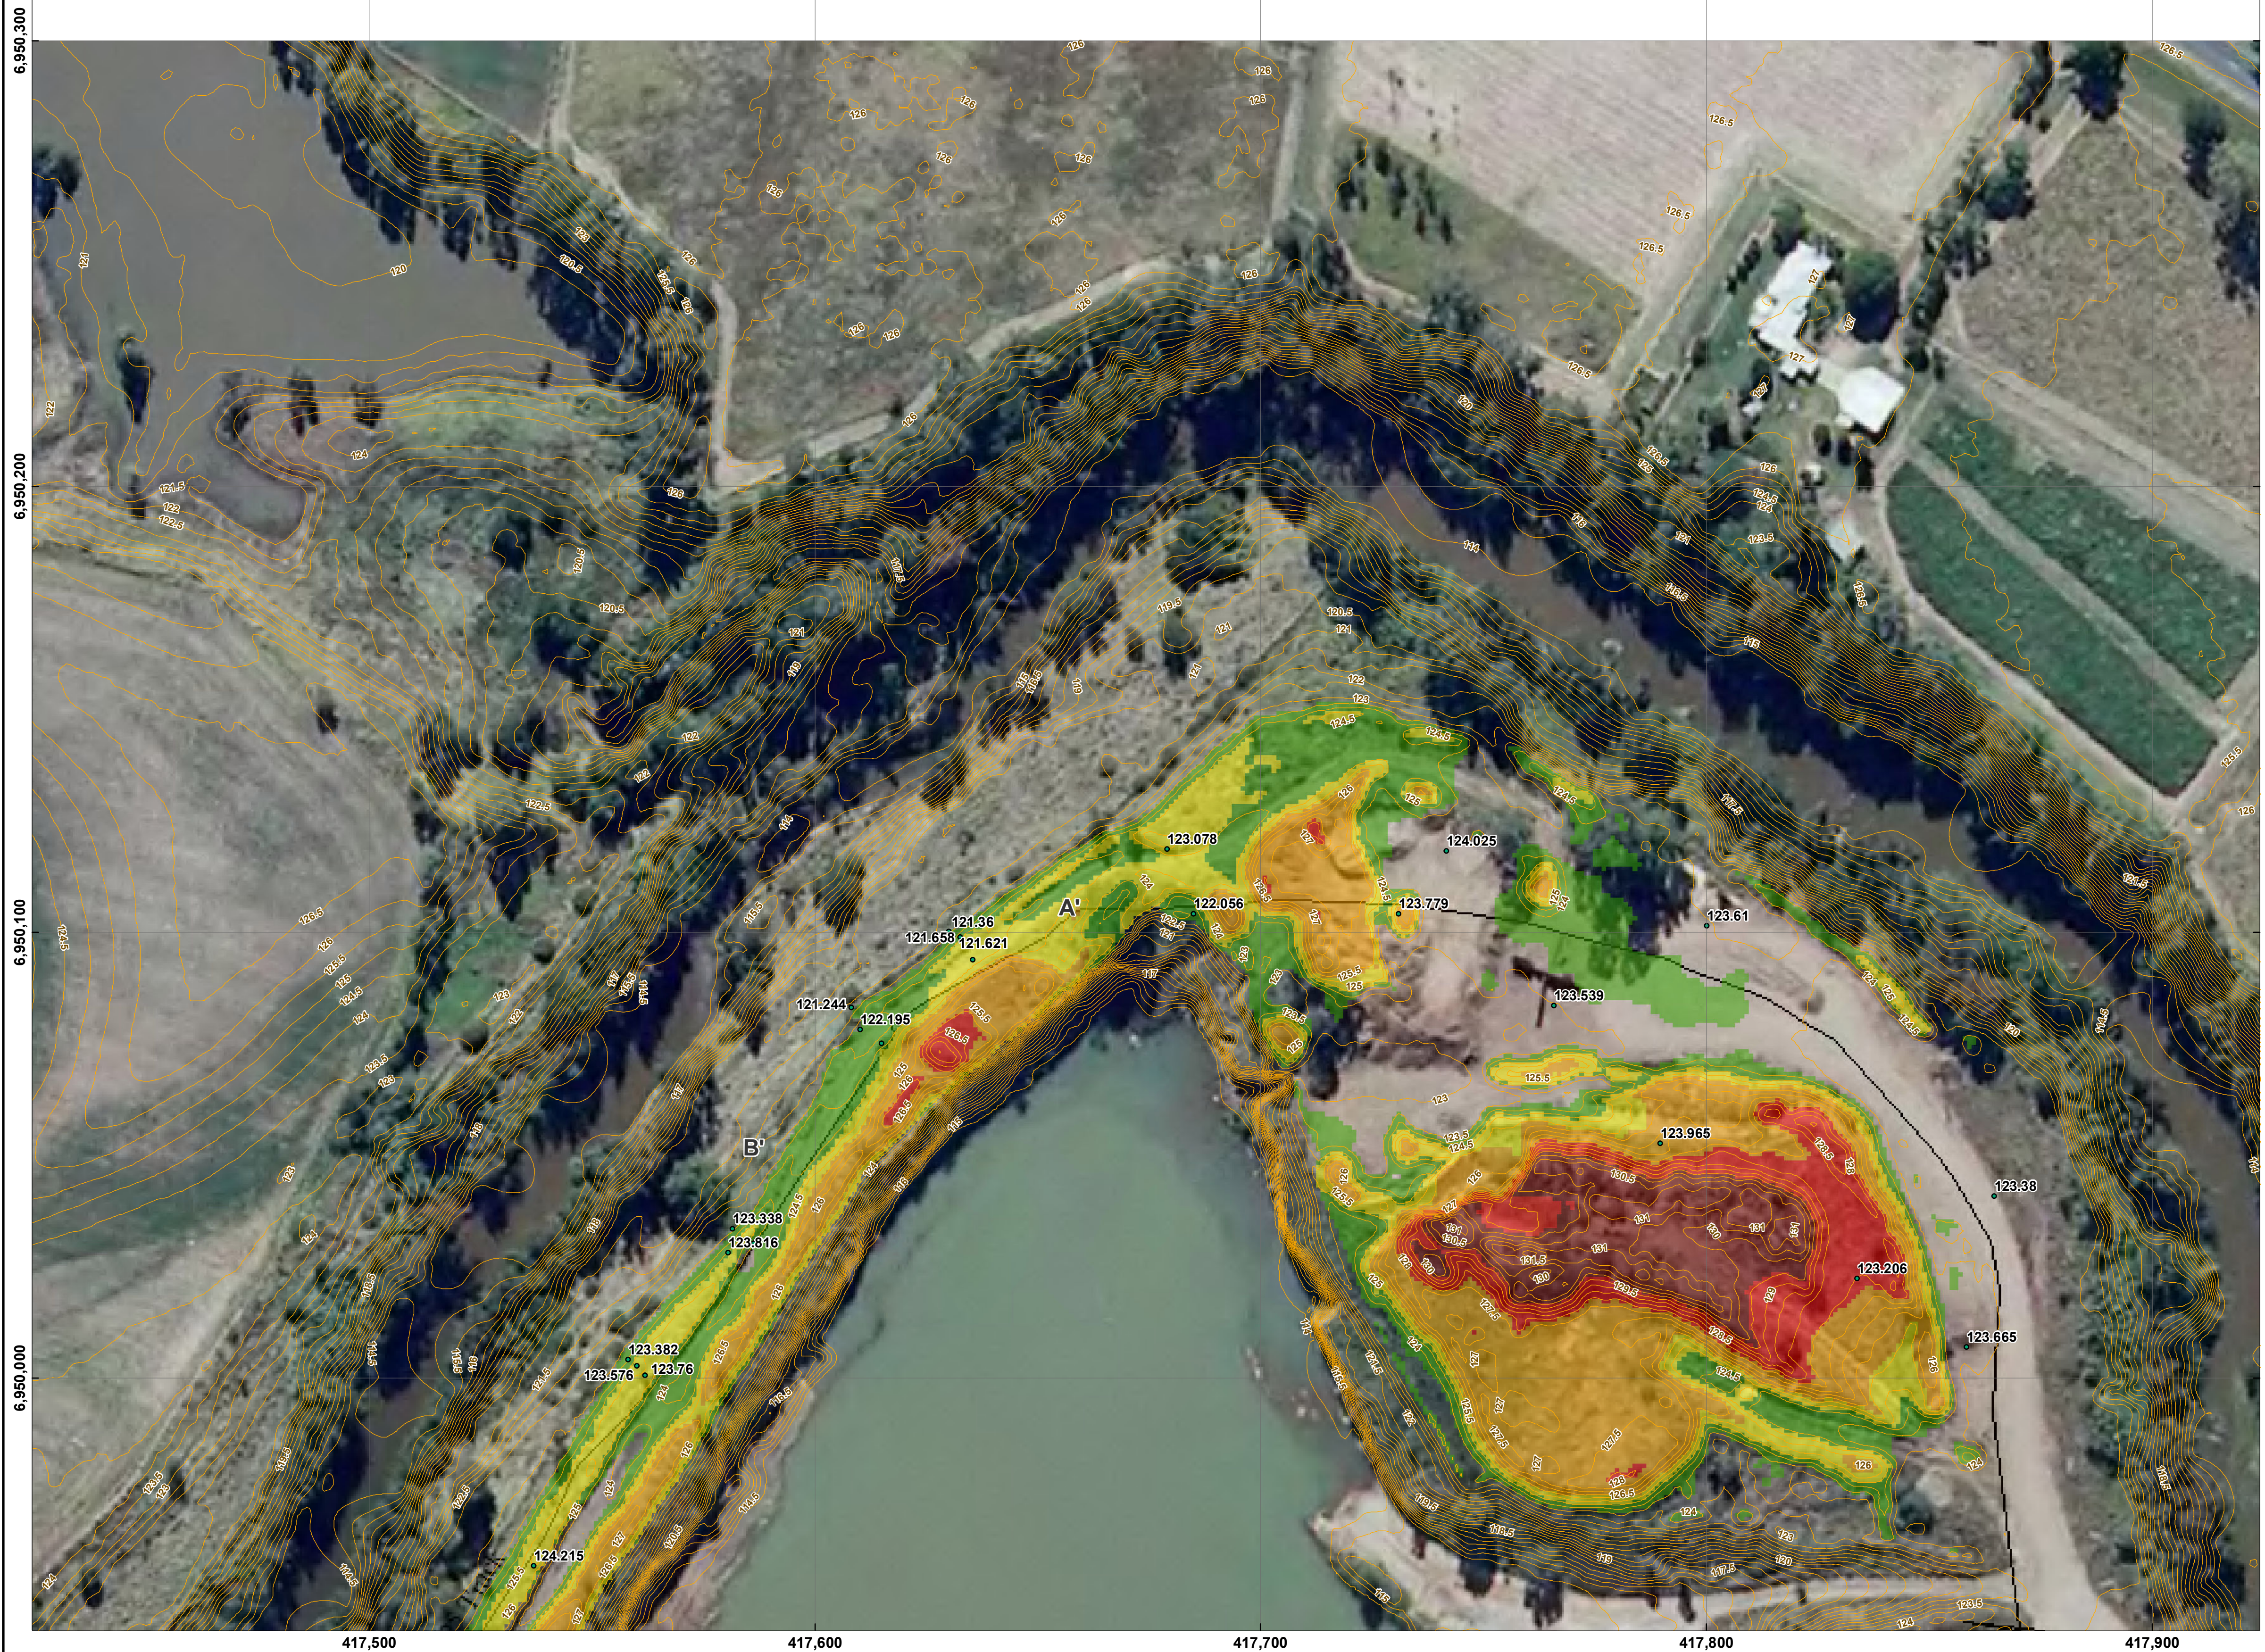
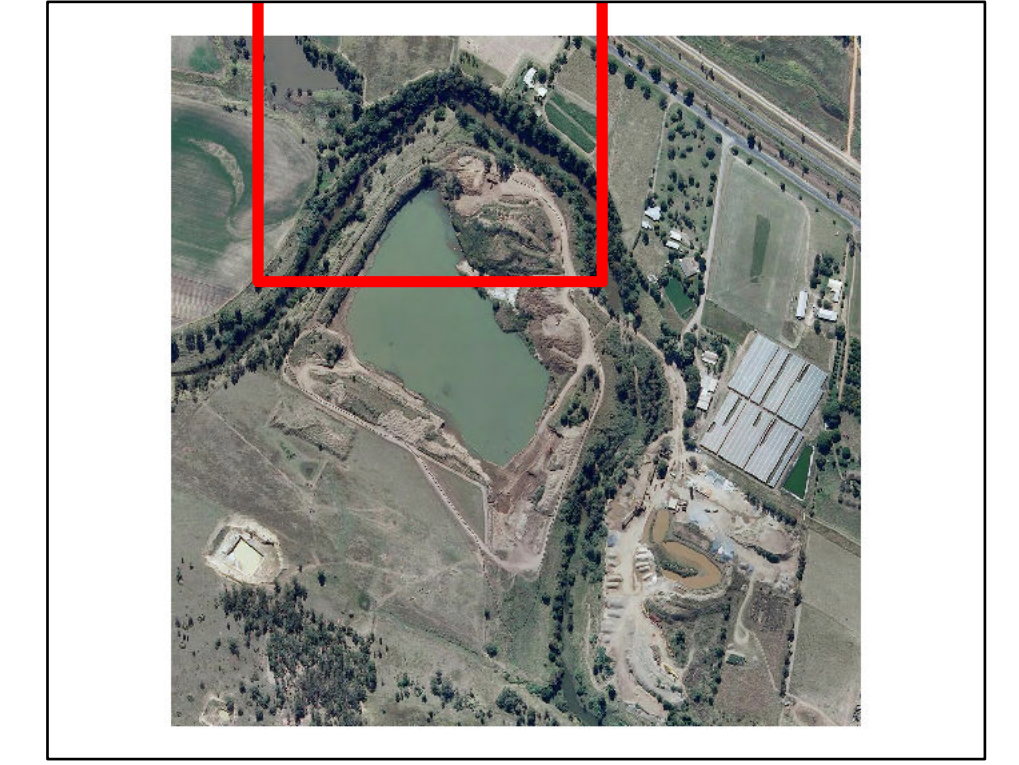
FIGURE 1A

31. I have also reviewed the pre-flood LiDAR contours which are shown in Figure 1A included in my Main Report. Plate 4 is an extract from Figure 1A which shows pre-flood colour coded heights of fill.
32. For clarity I have shown the location of the pole on an extract of the contour plan without colour coding (Plate 5).

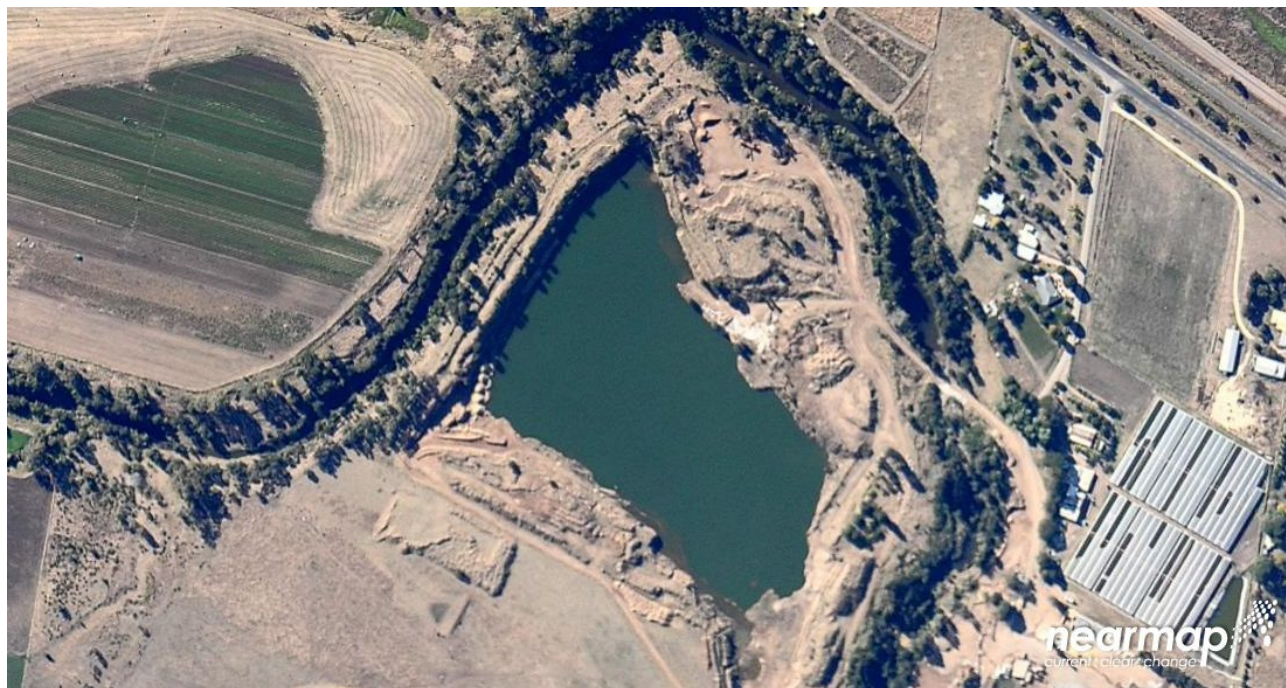
Date: Sat, 17 Jul 2010

29. The annotations on both Plates 2 and 3 indicate the base of the power pole and the shadow cast by the pole, depending on the location of the sun at the time the image was taken. I note that on 17 July 2010 (Plate 3), the shadow is almost in exact alignment with the pole, making it difficult to recognise the base location easily. However, I can see a slight bend in the shadow, where it passes over the adjacent section of bund, hence aiding identification of the base.
30. The Eastern Bund is labelled on Plates 4 and 5, and is also shown in cross sections in the Main Report as Plates 1 and 2.
