Report to: Grantham Commission of Inquiry- Investigation of timber utility pole failure

Re-issued on 4 Aug 2015

1.0 Executive Summary

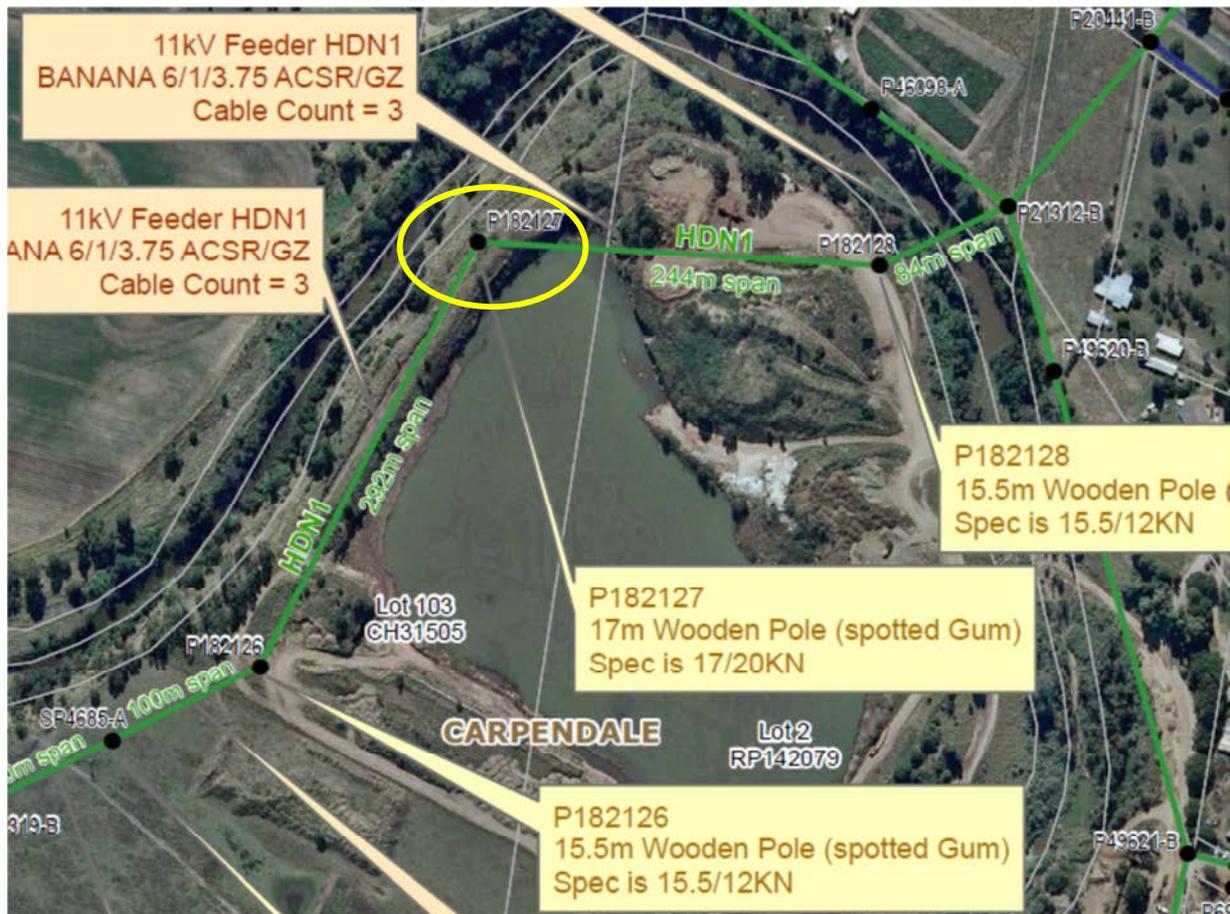
Image 1. – Location of failed pole 182127.

- 5.3.1 I identified the Failed Pole location (Pole 182127) to be consistent with the location identified by Energex. (Ref. 12.1). It is located on an embankment adjacent to a water body (presumably a disused water filled quarry). Also refer to Image 1. below reproduced from Reference 1.

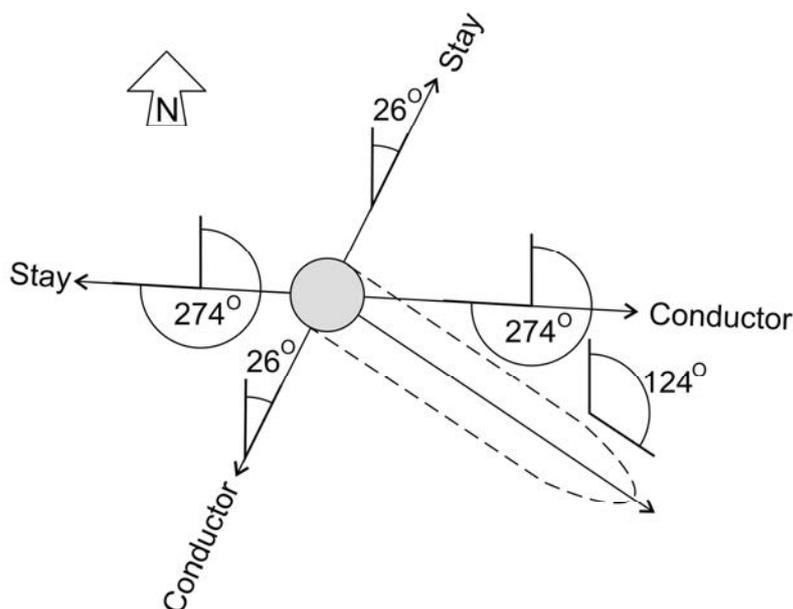
Figure 1 – Pole 182127 Orientation

By use of an "I phone" compass app, the north point and the direction of lean of the pole were estimated by me. The approximate north point was marked on the pole with a paint dot by Mr Lex Somerville. See Photo 1, Appendix 3 that shows the approximate north point on the leaning pole. I found the pole to be leaning in a SE direction at approximately 124° of North. Refer Figure 1. Figure 1 also indicates the approximate orientation of the stays that had been attached to the top of the pole as advised (Ref 12.1.).

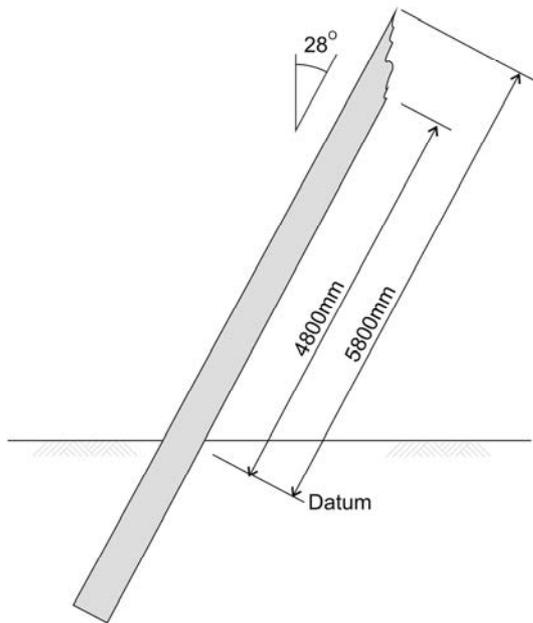
Figure 2 – Pole Length

Under my direction, the distance from the mean ground line to highest point of the fracture was measured by Mr Somerville and Mr Simpson using the measuring rod provided by Mr Simpson and found to be approximately 5800mm and to the lowest point of the fracture on the opposite side 4800mm. Mr Somerville and I, using a large carpenter's adjustable protractor and a spirit

level found the pole was leaning at approximately 28° to the vertical. This was also confirmed independently by an 'I phone' app by Mr East. See Figure 2.

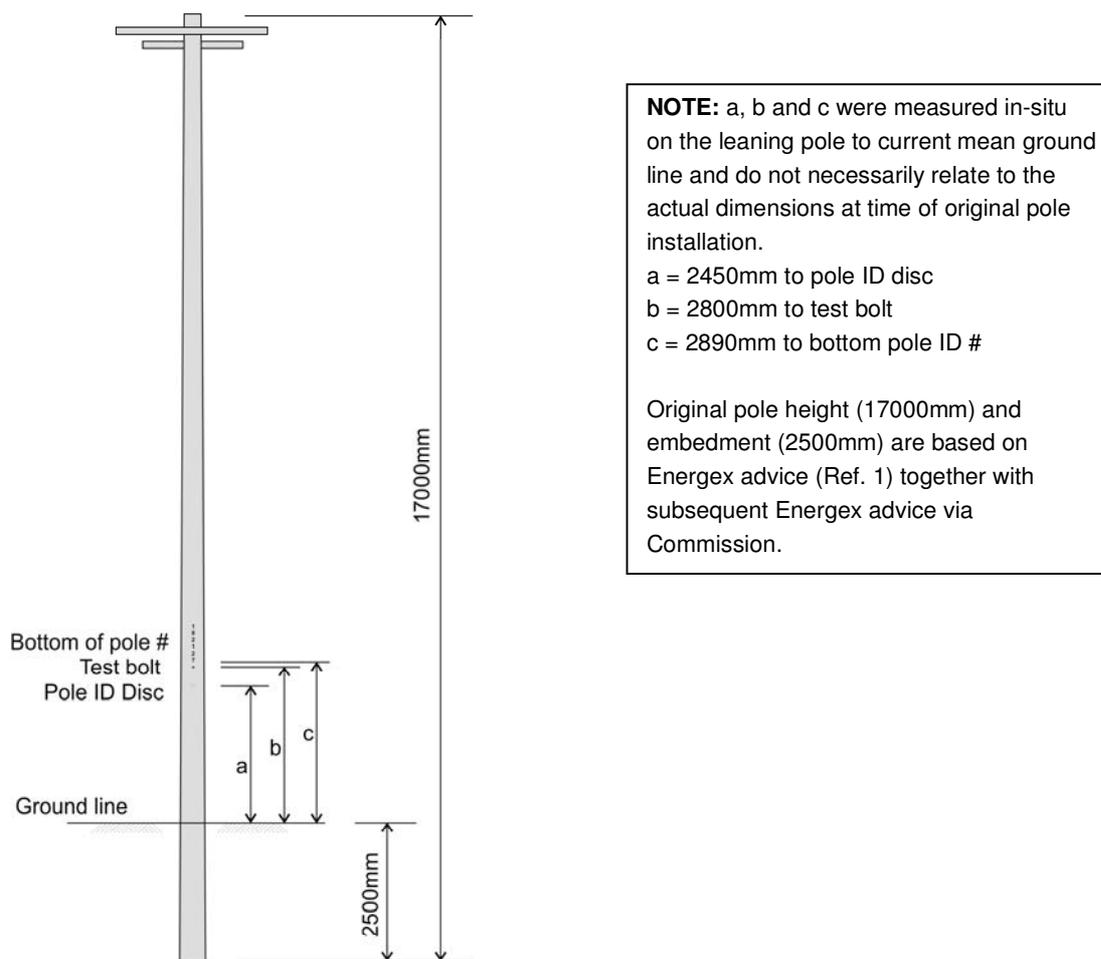
Figure 3 – Failed Pole (Pole 182127) - Measured ID locations and assumed original pole installed depth and height

- 6.3.1 Figure 3 provides assumed original pole installation height and embedment depth as previously advised by Energex (Ref 12.1) and in the Commissions Instructions (Appendix 5) as well as measured distances from current mean ground level to pole identification disc, pole # and test point. Mr Somerville undertook these measurements on site under my direction using a steel tape.
- 6.3.2 Refer to Paragraph 6.7 for further information and discussion on the assumed original embedment depth versus that measured on site.

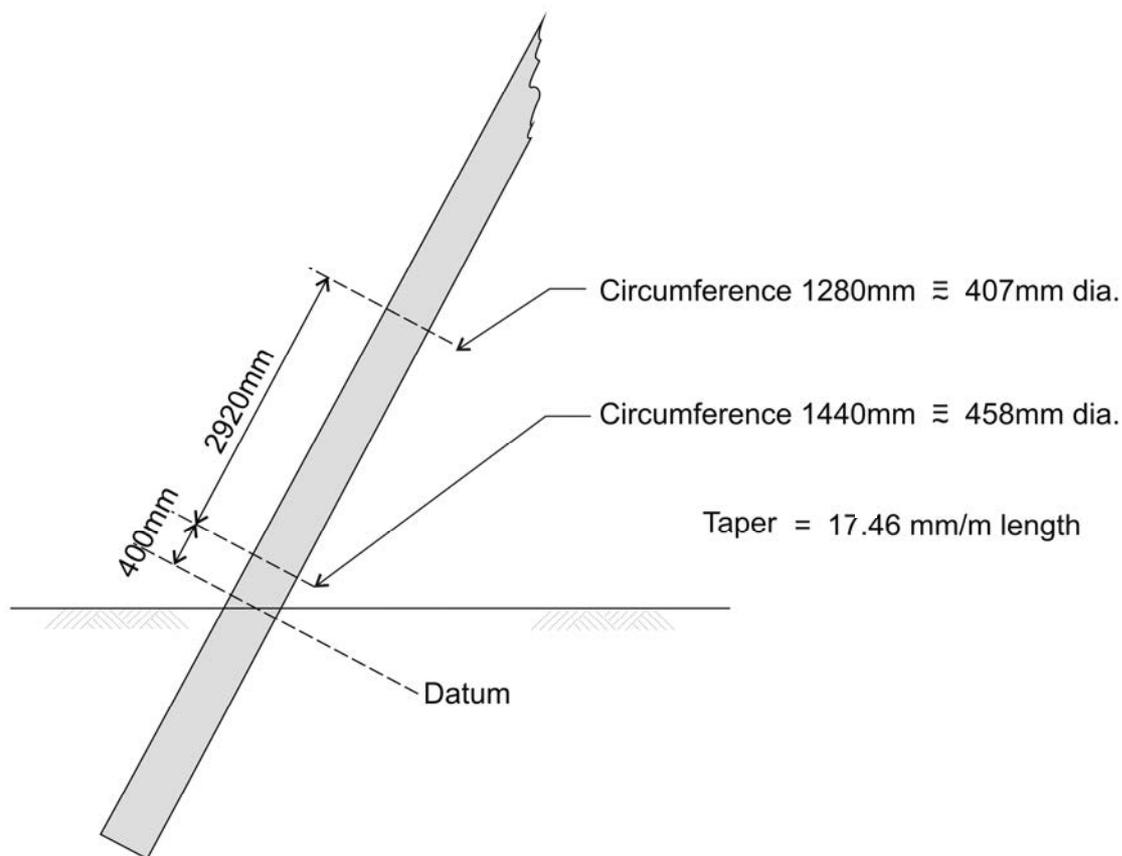
Figure 4 – Pole Circumferences and Taper

- 6.4.1 Under my direction, the circumference of the pole was measured at two locations by Mr Somerville using a steel tape. The first being as close to the ground as possible (approximately 400 mm up from mean ground level) and the second as high as could be reached safely from a step ladder being 2920 mm from the first location. Results obtained were 1440mm and 1280mm respectively. Refer to Figure 4.

- 6.4.2 From this, I estimated the diameters at each location as 458mm and 407mm respectively. The taper in the pole diameter was then calculated from these values by me and found to be approximately 17.4 mm/m length of pole.

- 6.4.3 Extrapolating these measurements I estimated pole diameters at the highest point of the fracture and lowest point of the fracture of 364 mm and 381 mm respectively and at ground line of 465 mm and an estimated diameter at the pole tip of approximately 220 to 230 mm.

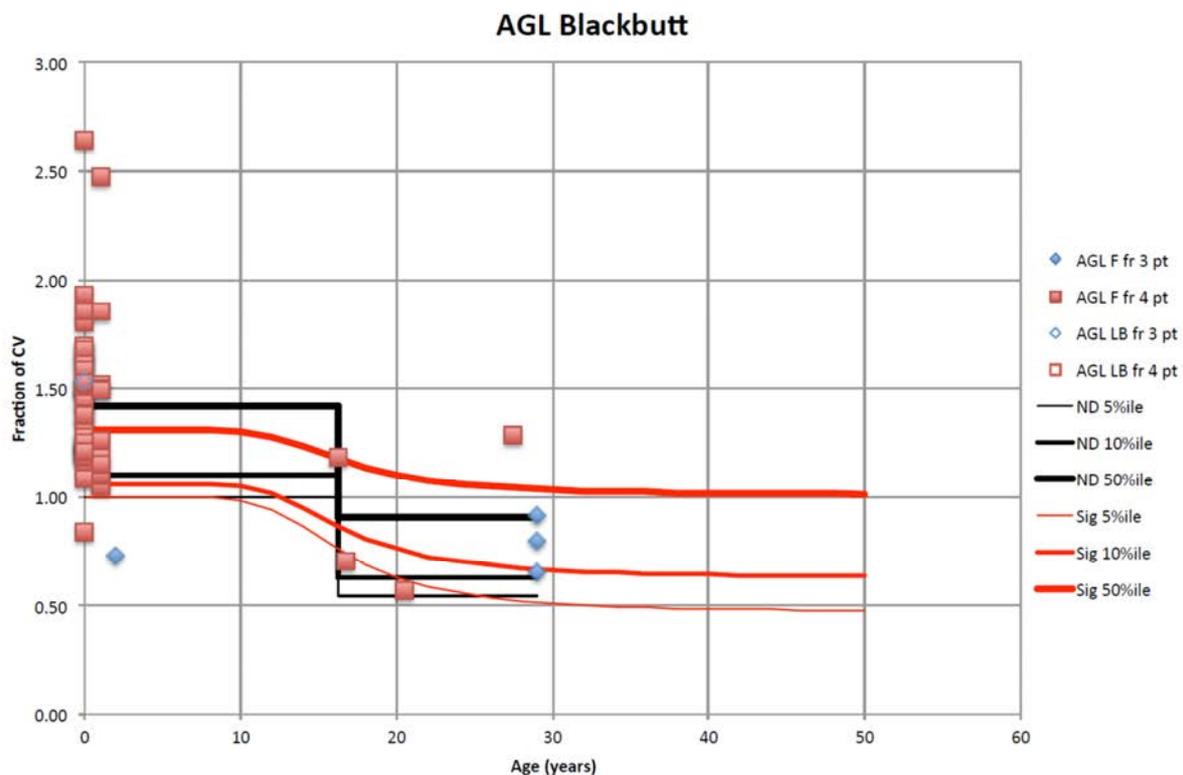
Figure 8 – Loss of Strength with Time – Blackbutt Poles (Source: Dr Geoffrey Boughton, TimberEd Services Pty Ltd)

7.2.8 However, more recent strength loss data that was provided to me by Dr Geoffrey Boughton, TimberEd Services Pty Ltd, has been derived from pole testing as shown in Figure 8. From this, for Blackbutt, a strength loss factor approximately equal to 0.8 would appear more applicable for mean strength loss for poles that have been installed for 20 years. Alternatively, to convert the Characteristic Value (CV) (60.1 MPa) to a mean bending strength taking into account strength time loss would require the CV to be multiplied by approximately 1.1. I have considered and accepted this information.

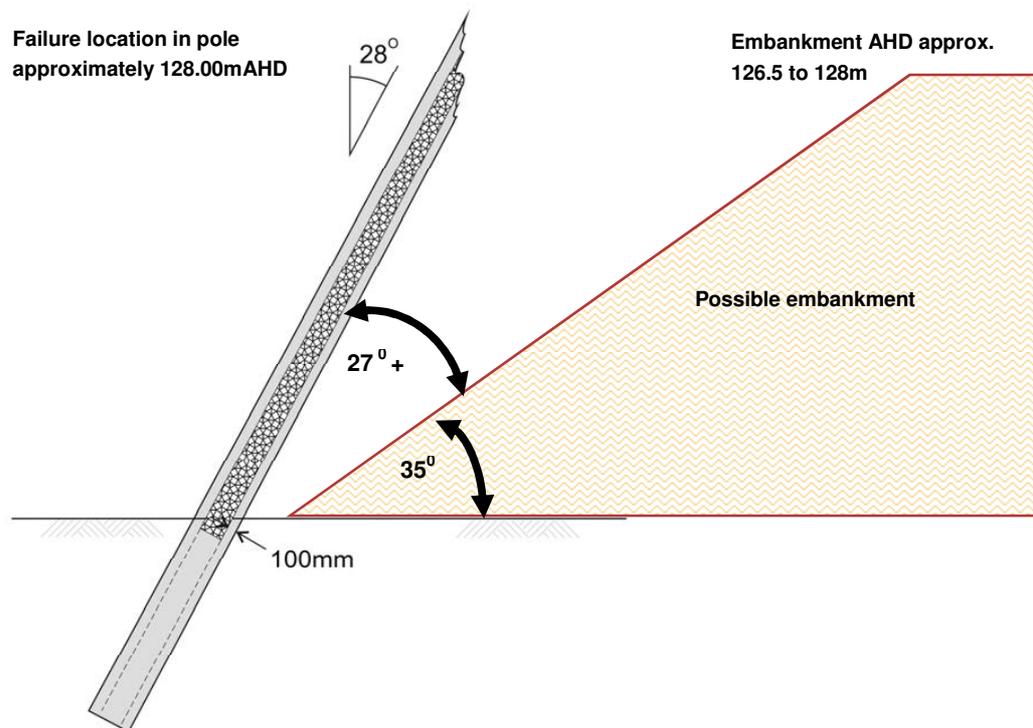
Figure 10. – Possible embankment

- a. I also considered or undertook a sensitivity check to address additional pole restraint options as detailed in Instruction Letter #2 (Appendix 5) being:
 - i. Assuming the actual ground level around the pole or ground level of an adjacent embankment to the SE of the pole at the time of failure was 2.0 m to 5.0 m higher than used in the above calculations (i.e. a pole embedment depth or adjacent ground level of 4.5 to 7.5 m. i.e. ground at approximately 125m AHD to 128m AHD).
This check did not materially alter the failure location or stresses induced in the pole at the failure location.
 - ii. Assuming that at the time of failure, the pole was restrained by the top of an embankment to the SE of the pole, adjacent to the pole and being significantly higher (for example 130m AHD) than the level at point of fracture of the pole.

- b. This scenario would alter the probable location of maximum stresses and failure point in the pole resulting in failure significantly above the current actual fracture location.
- c. Also, the current lean on the pole is approximately 62° ($90 - 28$ deg) to the horizontal. For the assumptions given in Instruction Letter #2 (Appendix 5) regarding the slope of the embankment being 35° to the horizontal, the pole would have had to have rotated (leaned) an additional 27° or greater for the embankment to have provided sufficient restraint on the pole for this to have contributed to failure. Refer Figure 10.
- d. I do not consider this option to have caused or contributed to the pole failing at the point observed.

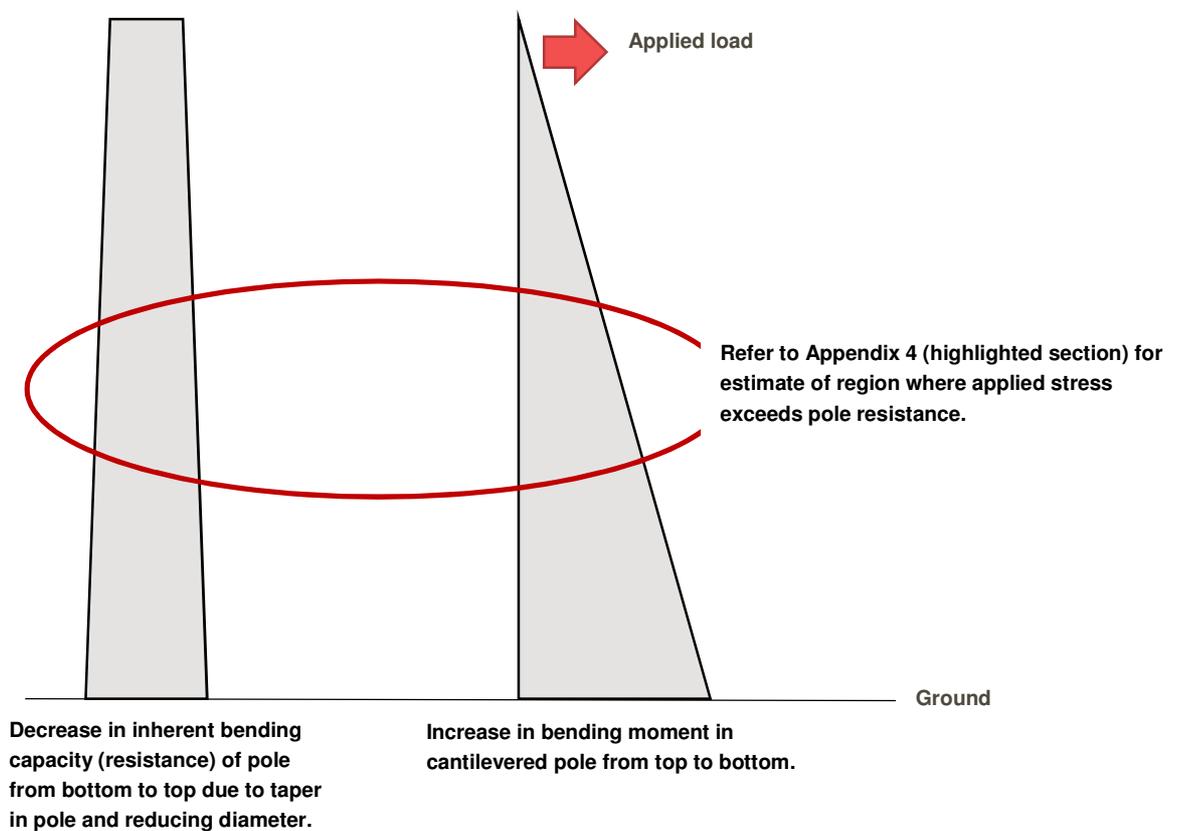
Figure 11 – Illustration of Bending Capacity of Pole vs Applied Bending Moment

9.1.2 Figure 11 provides a simple illustration of the inherent strength of the pole (assuming constant timber properties along its length) to the bending moment induced in the pole (assuming the pole is a simple cantilever with a load applied close to top of pole).
