28 August 2015

GRANTHAM QUARRY - GEOTECHNICAL INVESTIGATIONS & EXPERT OPINION ON FORMATION OF EARTHWORKS

Grantham Floods Commission of Inquiry

Report Number. 1532696-001-R-Rev2

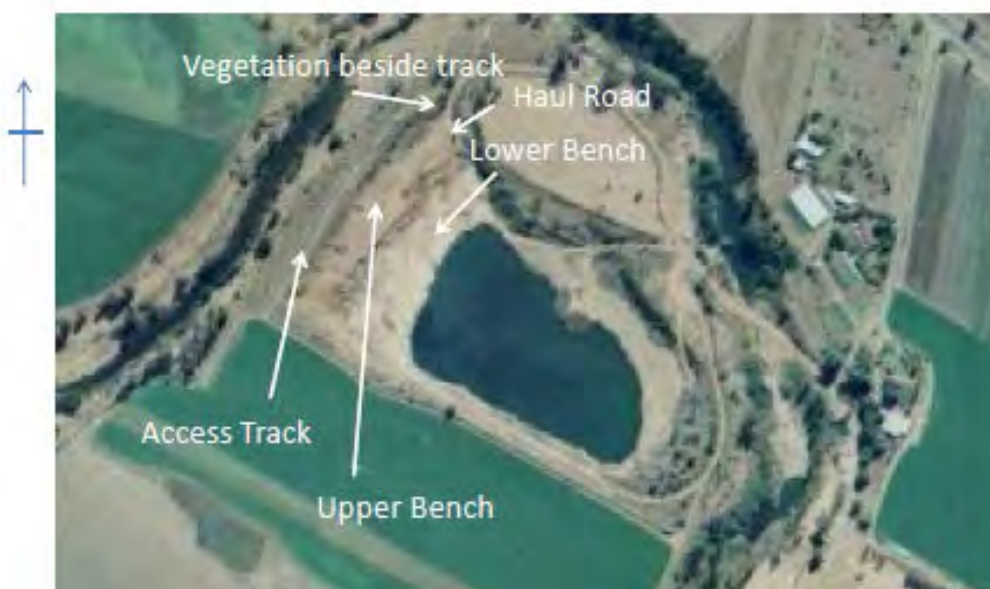
Plate 3: Annotated version of air photo from 1997 (discussed in Section 12.5 of this report)

12. From my examination of oblique air photos, personal photos contained in various witness statements, Wagner’s survey plan of 2008, and stereo air photo examinations covering the years 1997, 2001 and 2009, it is my opinion that the construction of bunds either side of the access track along the western levee of the quarry site commenced after August 1997 and before June 2001, and the bund construction continued from 2001 until about 2005.
13. The data I particularly rely upon to make this conclusion is as follows:
 - a. Witness statement J Gallagher – (which includes an oblique air photo, Plate 30a, Section 12.4 of this report), indicates that there was no wall along western side of quarry at the time of a previous flood event in 1996.
 - b. Stereo air photos from 1997 showing no earthworks along the western levee (see Plate 3).

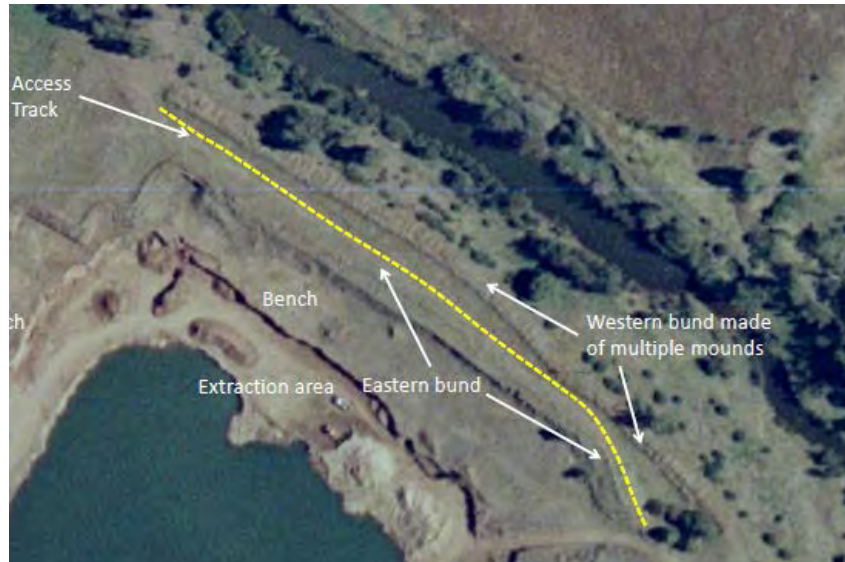
Plate 4: Annotated version of air photo from 2001 (discussed in Section 12.5 of this report)

- c. Stereo air photo images for 2001 show multiple mounds of earth along the western side of the track. There is also a bund along the eastern side of the track. It is not possible to determine the exact height of these bunds from stereo viewing, but the mounds along the western side appear to be higher than along the east side (see Plate 4).

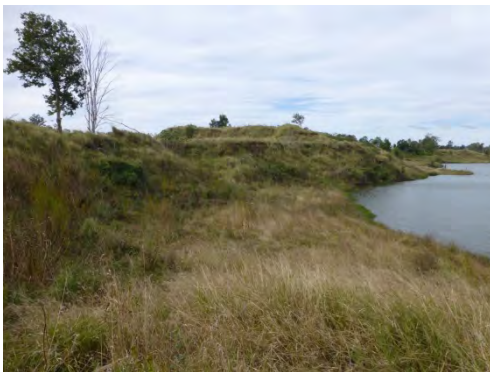
53. I have numbered the photo images approximately in the order taken, and these are designated B1 to B15 in Appendix B.
54. Photo B1 shows the north bank of the quarry lake, viewed from the in-filled main breach. A platform can be seen which approximates to the interpreted natural ground level, above which there is stockpile.

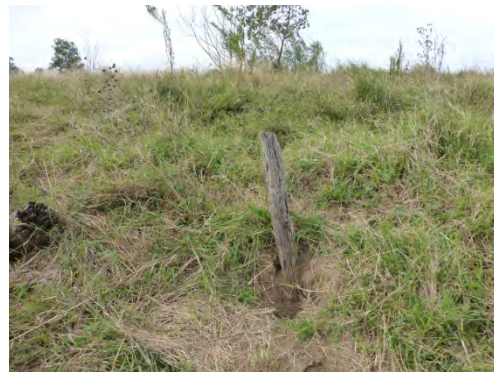
55. Photo B2 shows an original fence post on the western side of the western levee. In my opinion, the fence line was close to the crest of the upper terrace which existed before quarrying operations. (Test Pit 101 was subsequently excavated close to this location).
56. Photo B3 shows a terrace along the western side of the quarry. I infer that there is at least one terrace below the top of the pre-existing natural river bank.

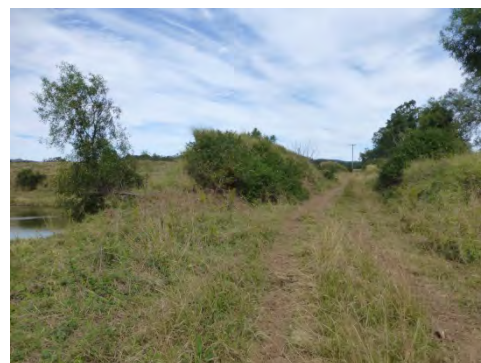
57. Photo B4 shows the track along the western side of the quarry flanked by remnants of bunds erected either side of this track. The height of these bunds prior to the flood event is considered in Section 10 of my report.
58. Photo B5 shows the northern end of the remnant bund on the west side of the path depicted in Image B4. The fill used for construction of the bund is exposed. I infer that the portion of the bund north of this point was eroded by the flood event.

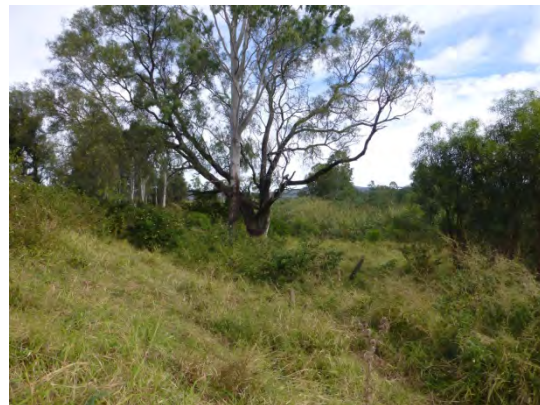
59. Photo B6 shows an original fence post on the lower river terrace towards the southern end of the western levee. The terrace appears to be widest at the southern end of western levee bank.
60. Photo B7 depicts an erosion scar on the western levee bank, which I believe to be a result of the 2011 flood, based on post-flood imagery discussed in Section 6.0 of this report.

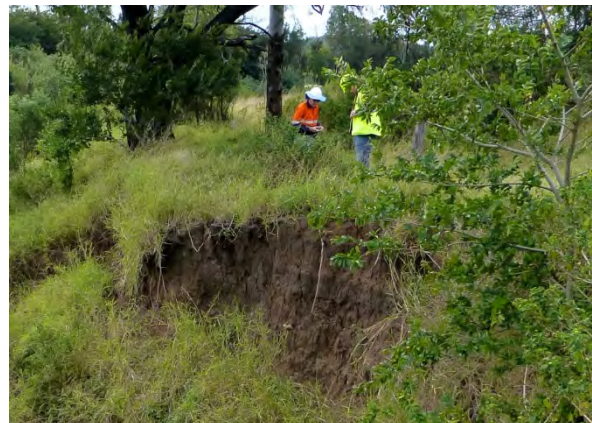
61. Photo B8 shows layered bands of clayey silt and sand within the alluvial deposits exposed in an erosion scar on the western side of the levee bank.
62. Photo B10 shows a fence post believed to have been present before commencement of quarrying operations in about 1982. The fence line ran approximately north south along this section of the Lockyer Creek bank. I infer that the higher land to the left of the fence post is part of the remnants of a man-made bund situated to the west of the access track at the top of the levee.

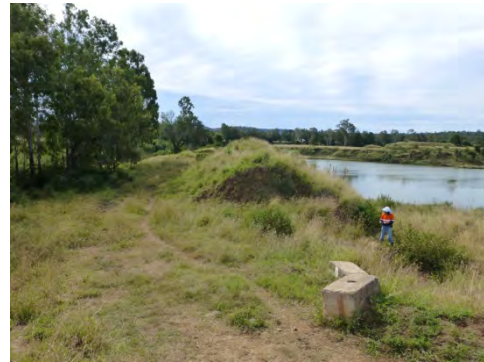
65. Photo B13 shows the track along the western side of the quarry, viewed from the south. A remnant of the bund on the eastern side of this track can be seen (I estimate that its maximum height is about 4 m).

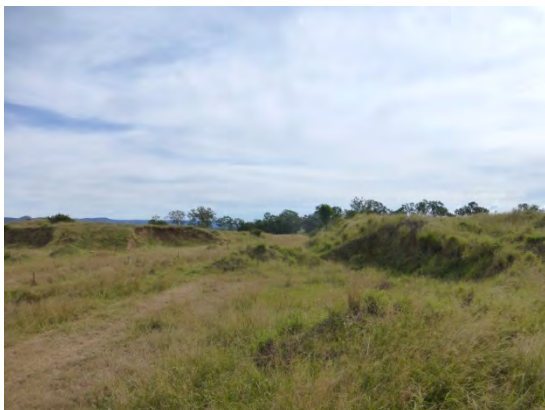
66. Photo B14 shows the track on the southern side of the quarry viewed from the west. A stockpile to the south of the track reveals two faces where material has been removed. I note that these faces appear fresh on the Google Earth image of 5 January 2012.

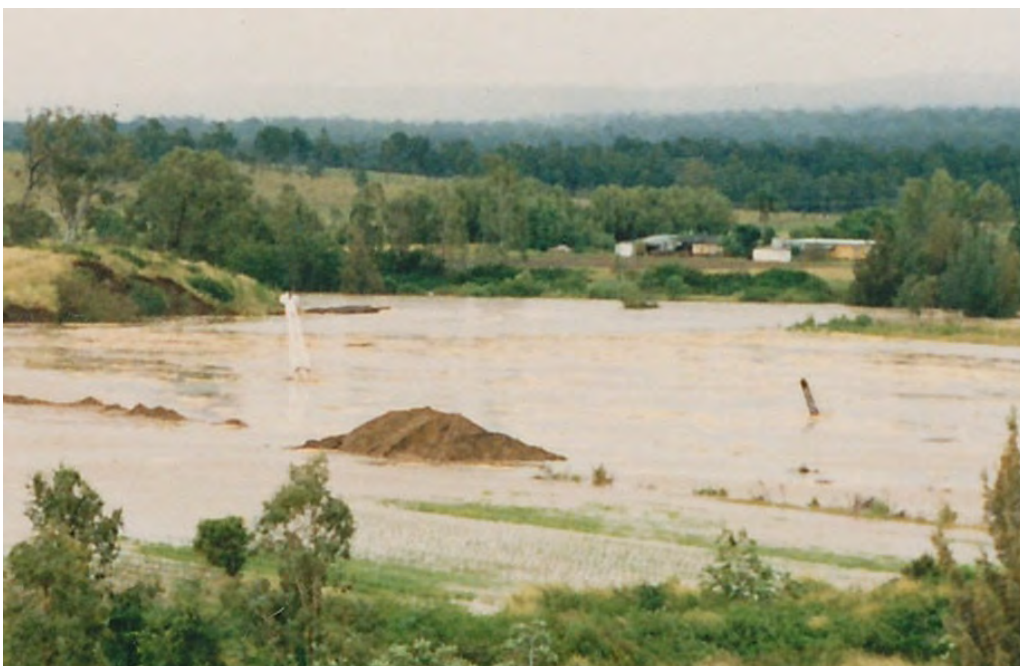
Plate 30b (cropped section) of Plate 30 taken during 1996 floods by J Gallagher (witness statement PJG-1)

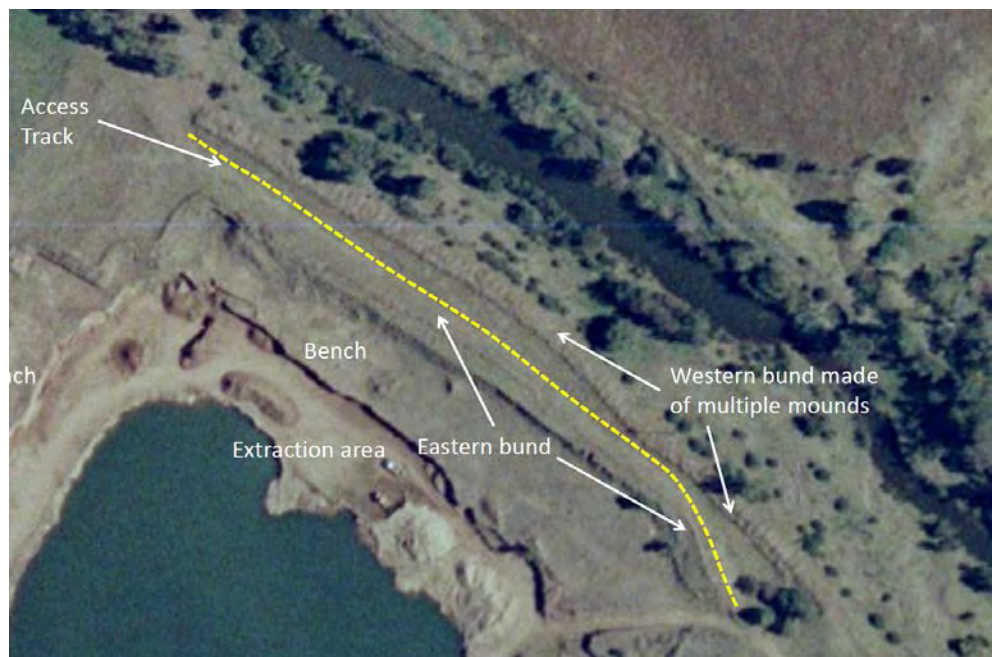
Plate 32b: Enlargement of 2001 air photo showing western levee – note multiple mounds of earth on west side of access track

158. Plate 32b shows an annotated enlargement of the 2001 air photo detailing the western levee. It is noted that the access track has migrated further west compared with 1997.

159. It appears that multiple mounds of earth along the western side of the track were formed by repeated dumping from a truck or front end loader. It is not possible to determine the exact height of these mounds from stereo viewing, but I estimate that it could be in the range of 1 to 2 m.

160. There is also evidence of a bund along the east side of the track, although it appears to be less wide and less high than the more recent western bund. The east side may also have been formed by repeated dumping from a front end loader (based on close examination of the air photo).

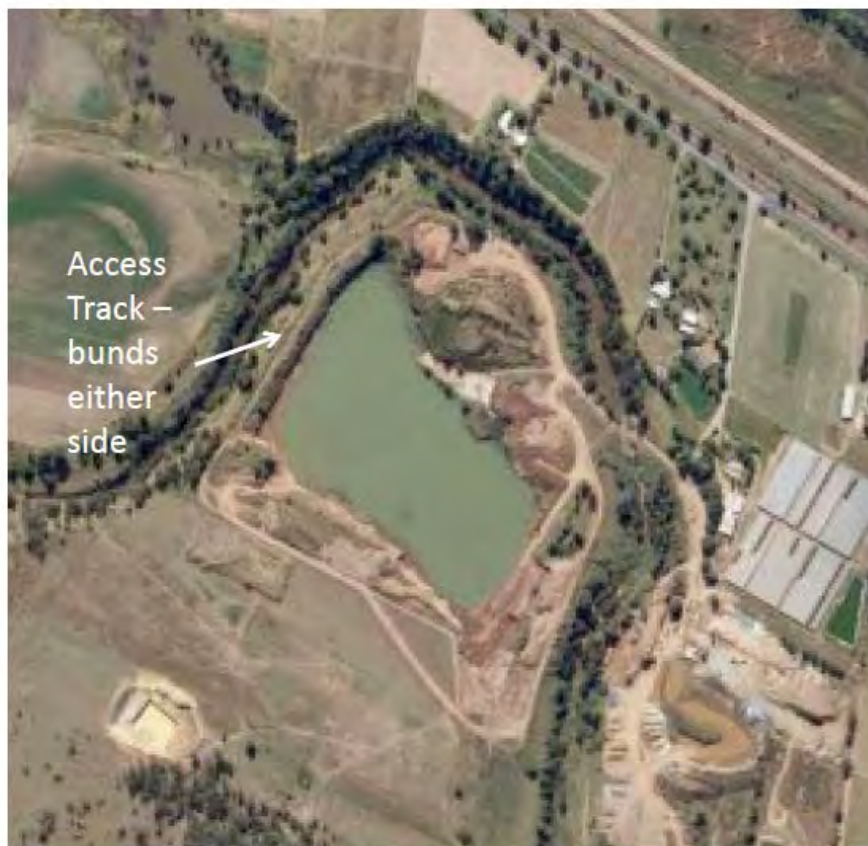
Plate 33 Air photo of Grantham Quarry, 2009

161. Plate 33 shows an annotated view of an enlarged section of air photo from 2009 (ref DIG70033 296), flown on 28 June 2009.

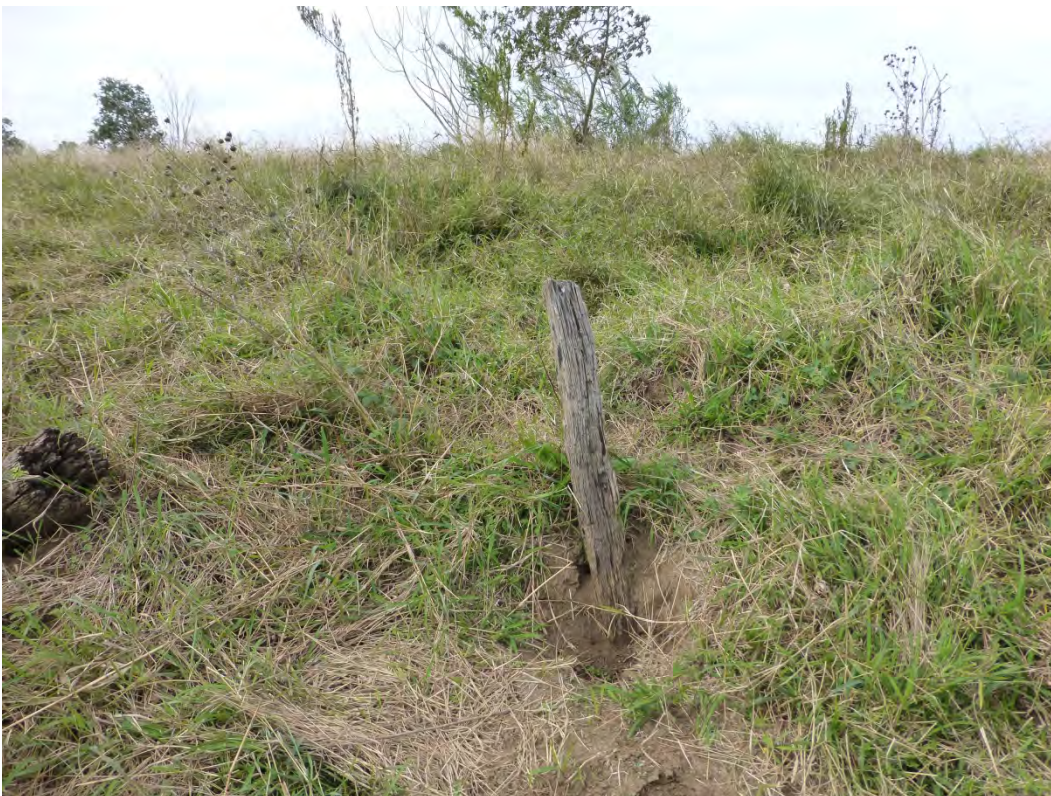
Photograph B2: Grantham Quarry – Original fence post – West side of levee.

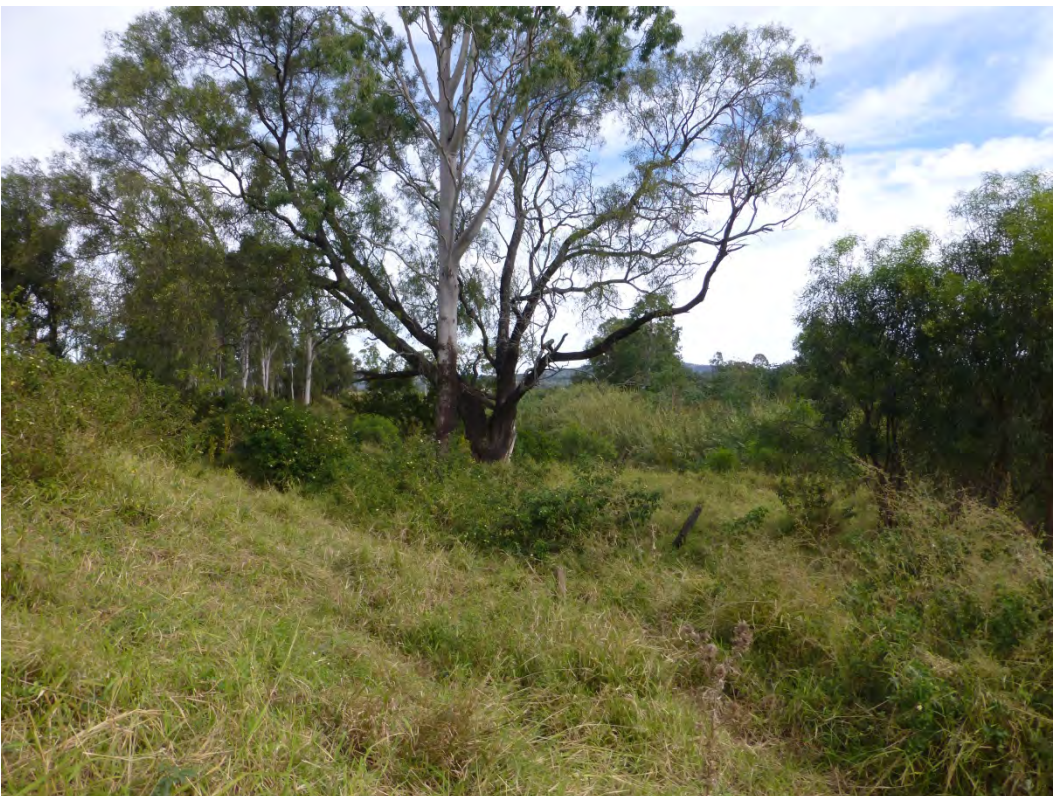
Photograph B6: Grantham Quarry – Lower terrace along Western arm of Lockyer Creek.

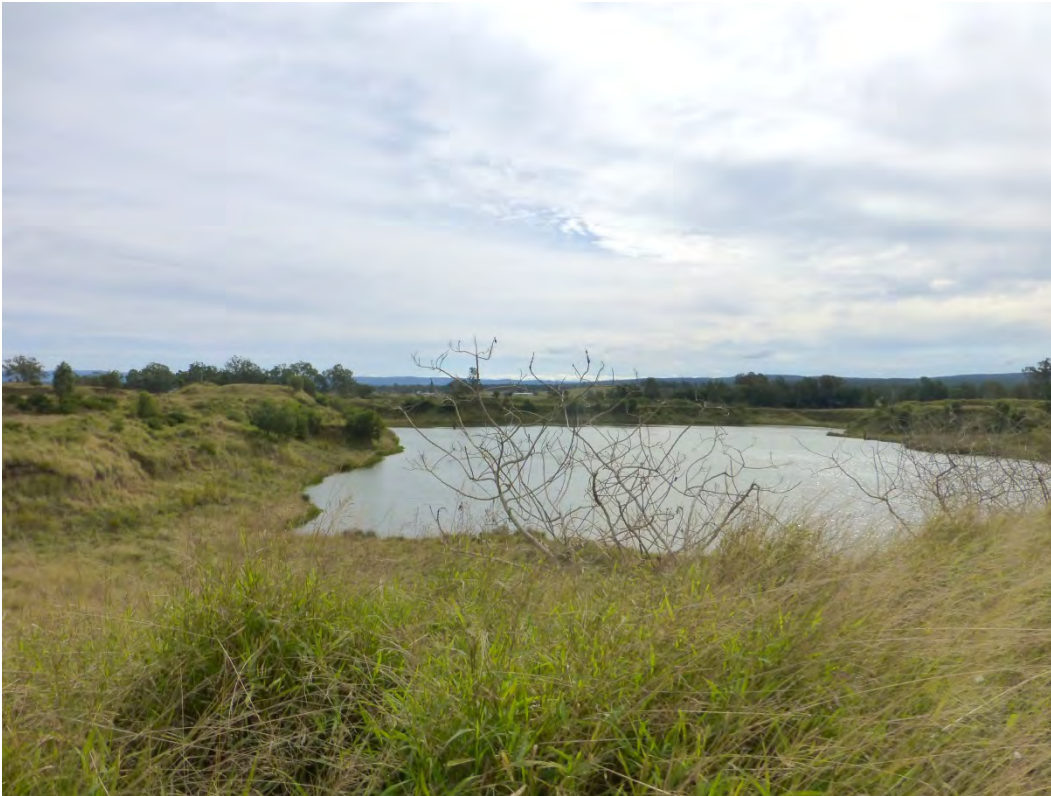
Photograph B15 Grantham Quarry – View of Quarry from South-eastern corner.

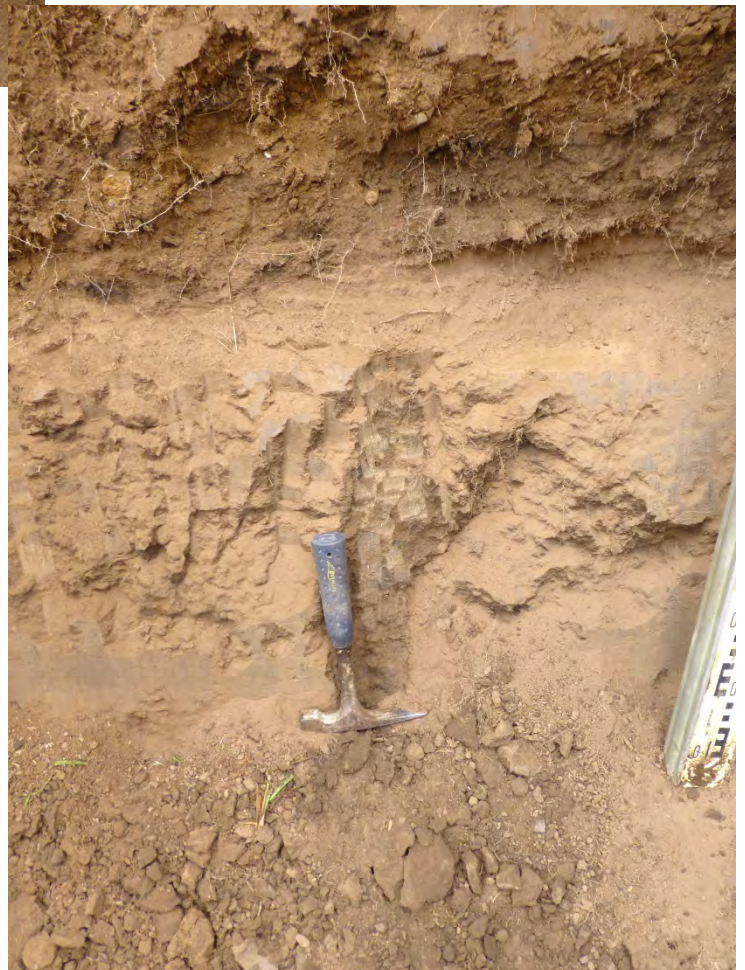
Photograph D32 – TP112– Detail of fill contact

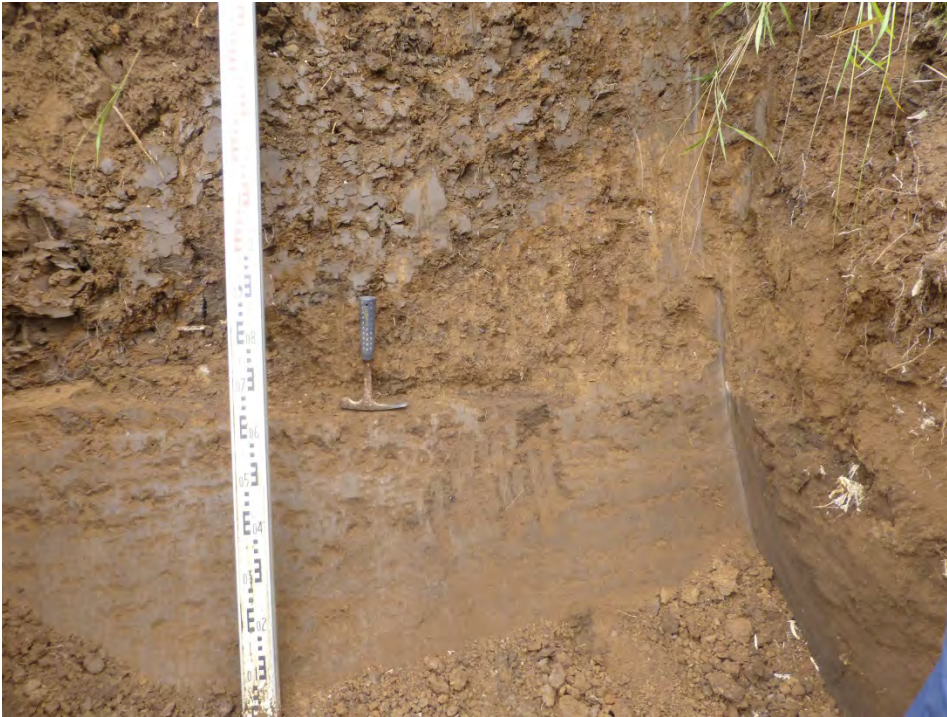
164. Some of the test pits along the western levee were excavated to reveal the contact between natural alluvium and remnant bunds. The face revealed in Test Pit 113 indicates that this section of bund was constructed in at least two stages, as illustrated in Plates 34 and 35.
165. I consider it likely that more extensive excavations would have found further evidence of stages of bund construction as revealed in TP 113, which was located at the northern end of a remnant bund on the western side of the track (see Plate 22, on page 31).
166. Based on the height and shape of the lower stage of bund construction revealed in Plate 34, it may be representative of the mounds observed in the 2001 air photo. I am not able to determine the time difference between the upper and lower portions.

Photograph D36 – TP113– North face – fill contact

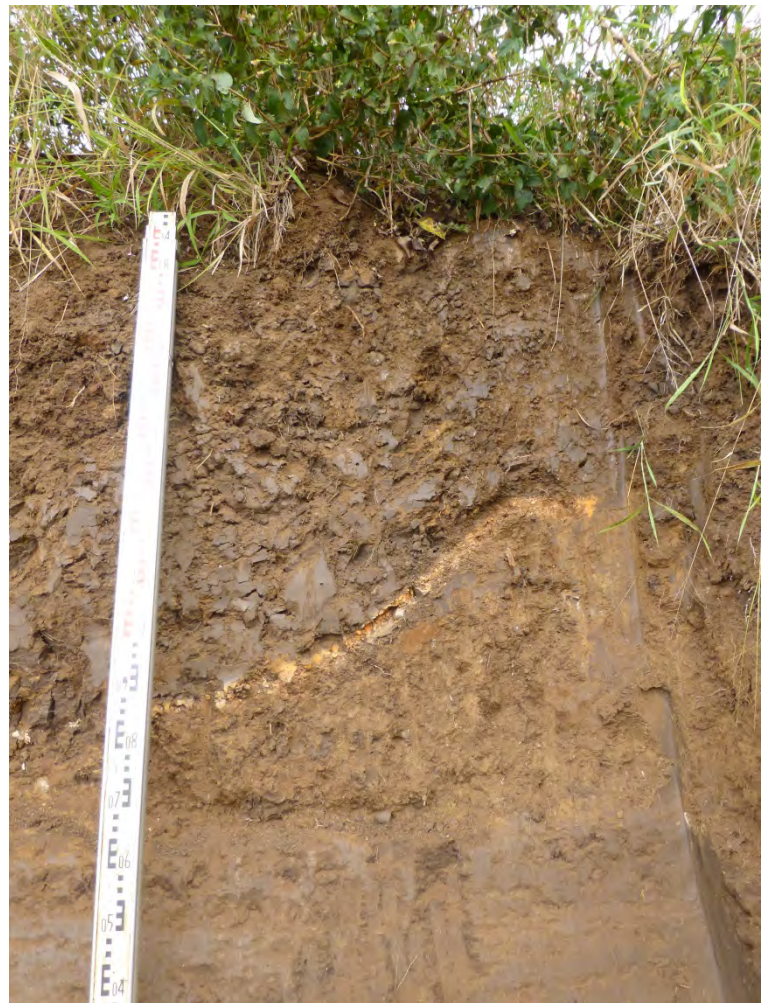
*Photograph D37 – TP113– Contact between two
fill layers*

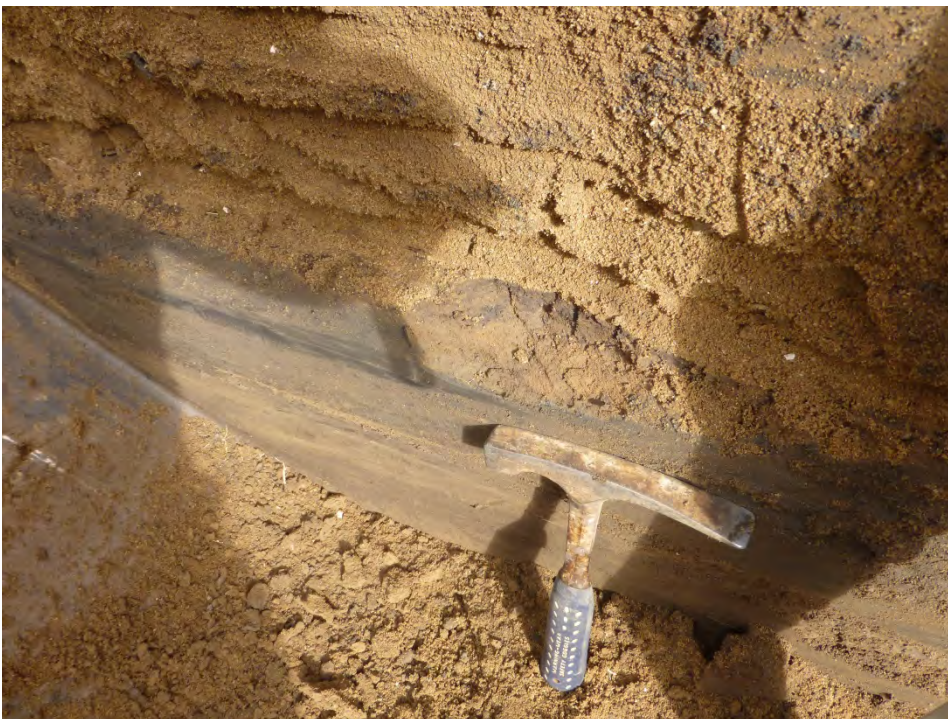
Photograph D49 – TP117 – Detail contact coarse sand layer.

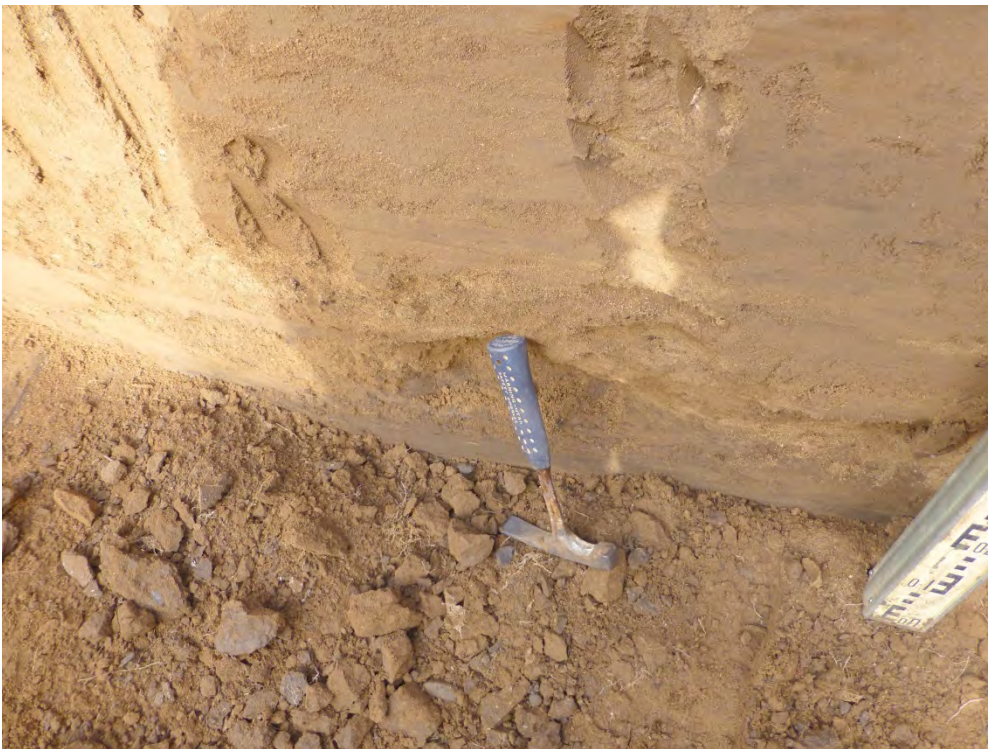
Photograph D51 – TP118 – Details of contact coarse sand.

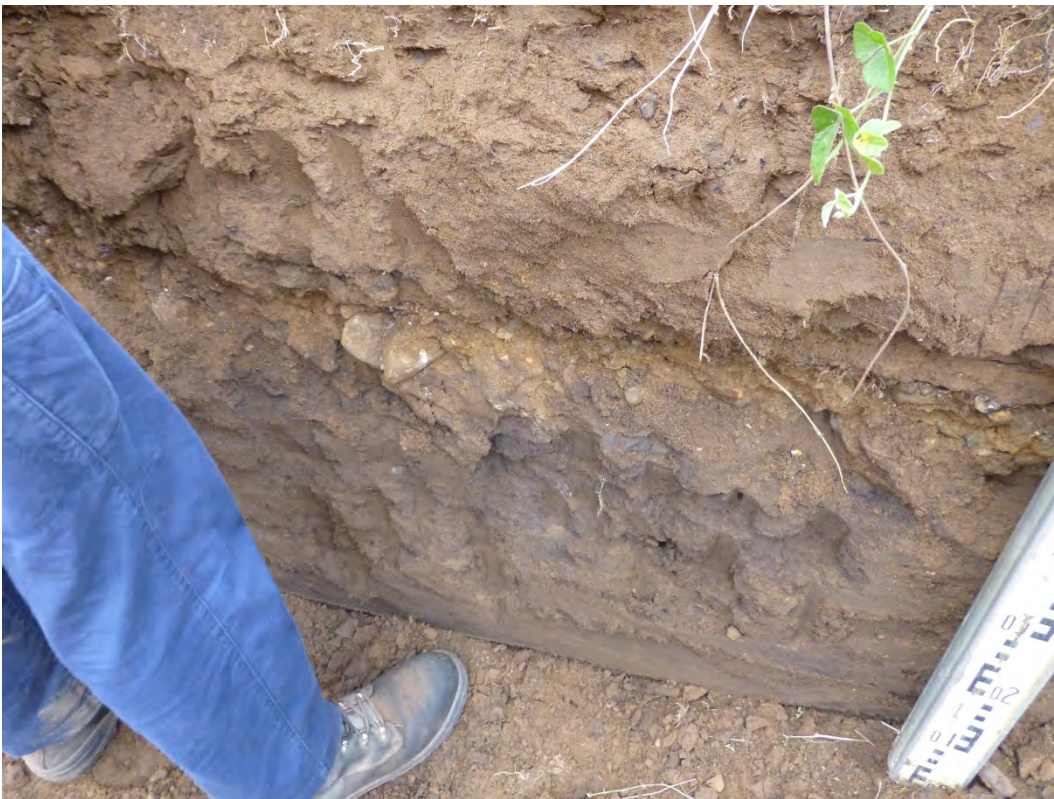
Photograph D56 – TP121 – Fill interface
